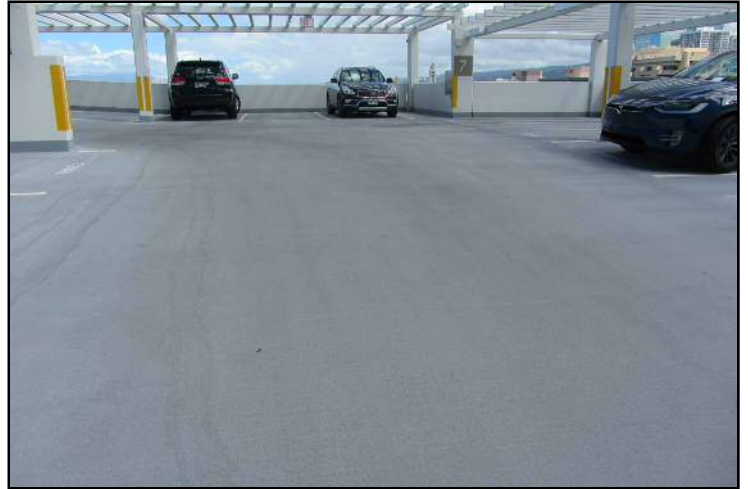
Component: 271 - Parking Deck - Seal/Repair

Evaluation: Exposed areas of parking garage are sealed.

Surface is new and in good condition. Top floor of structure has drainage issues and will have accelerated aging from exposure. Noted issues with water ponding on 7th floor.

Evaluation: Recommend immediate drainage evaluation to minimize future ponding issues.

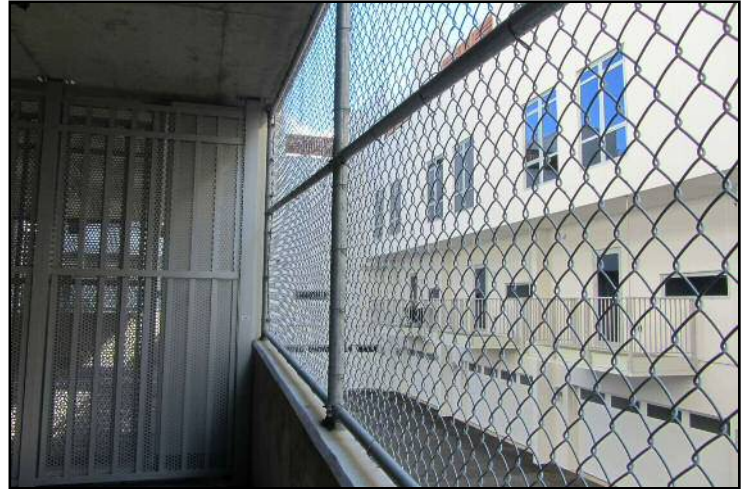
Component: 309 - Chain Link Fencing - Replace
Location: Parking garage
Cost Source:
Best Case:
Worst Case:

Evaluation: Chain link fencing is in good condition. Recommend repair and replacement as needed under the Operating Budget.

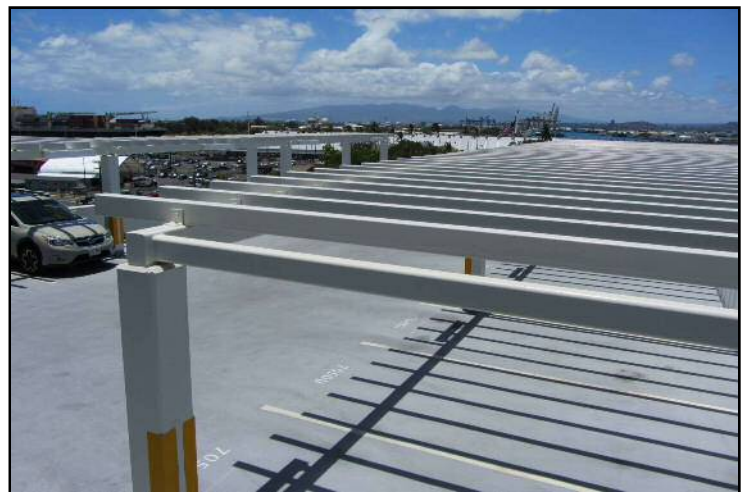
Component: 319 - Metal Trellis - Paint
Location: 7th Parking
Cost Source:
Best Case:
Worst Case:

Evaluation: Painted metal trellis on parking structure is a long life component with frequent painting and eventual section repairs. Ease of access recommend handling painting under the Operating Budget.

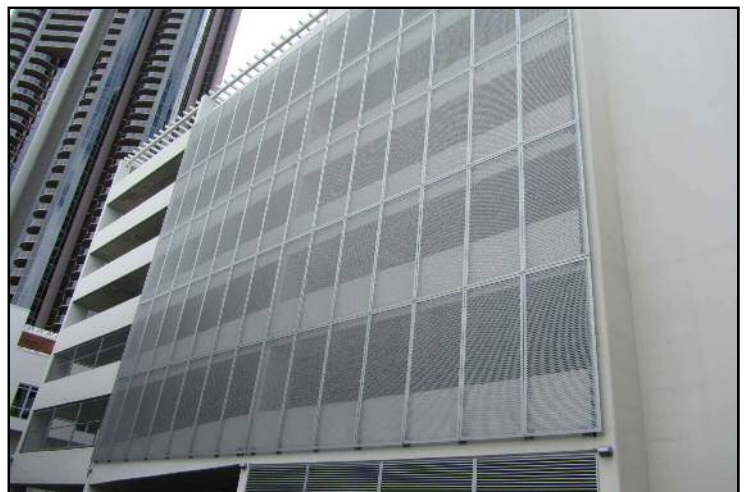
Component: 325 - Metal Panel - Replace
Location: Parking Garage
Cost Source: Budget estimate
Best Case: \$258,750 Estimate to replace panel
Worst Case: \$345,000 Higher estimate

Evaluation: Aluminum panels are in good condition. Estimate for full replacement cost. Recommend maintaining and sectional replacement as needed under the Operating Budget to avoid this expense.

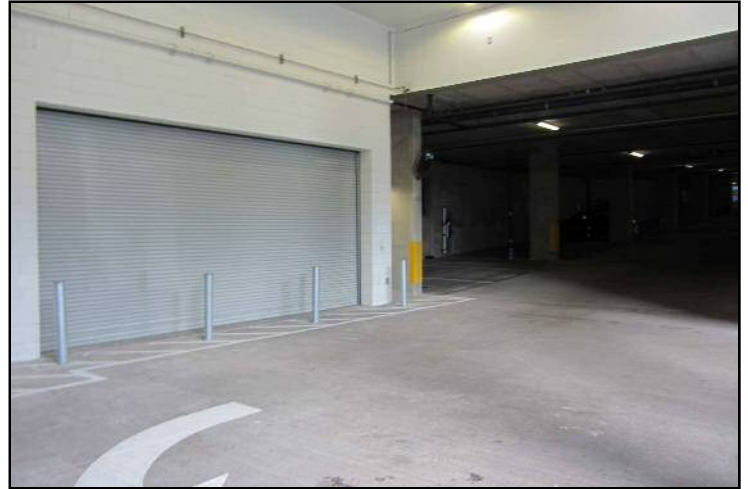
Component: 404 - Roll Up Door - Replace
Location: Lower level parking garage
Cost Source: Akamai Reserves Cost Database
Best Case: \$15,000 Estimate to replace door
Worst Case: \$17,000 Higher estimate

Evaluation: Roll up doors are new and in good condition.

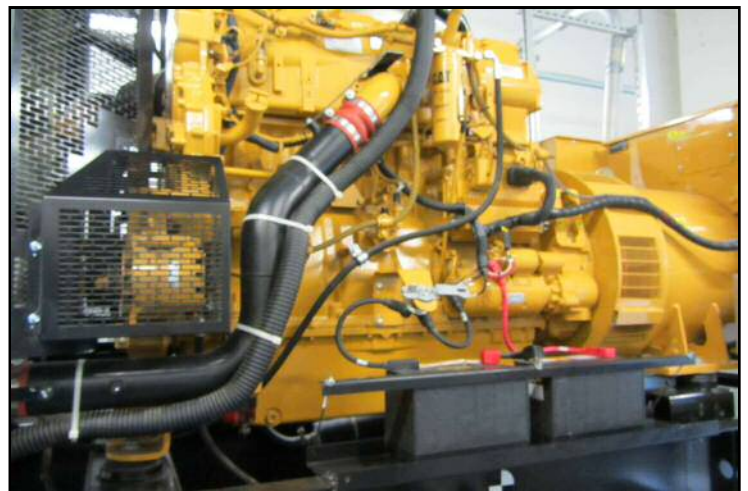
Component: 410 - Generator - Rebuild
Location: Level 1 Generator room
Cost Source: Akamai Reserves Cost Database
Best Case: \$55,000 Estimate to rebuild
Worst Case: \$65,000 Higher estimate

Evaluation: Caterpillar generator is new and in good functional condition.

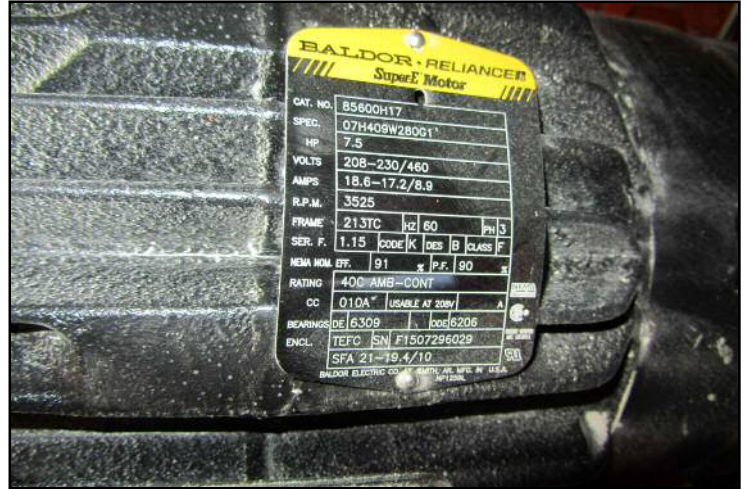
Component: 472 - Dom. Water Booster Pumps -Replace
Location: Tower; Ground floor mechanical room
Cost Source: Akamai Reserves Cost Database
Best Case: \$30,000 7.5 HP Pump; Estimate to replace
Worst Case: \$36,000 7.5 HP Pump; Higher estimate

Evaluation: Smaller 7.5 HP pumps are in good functional condition.

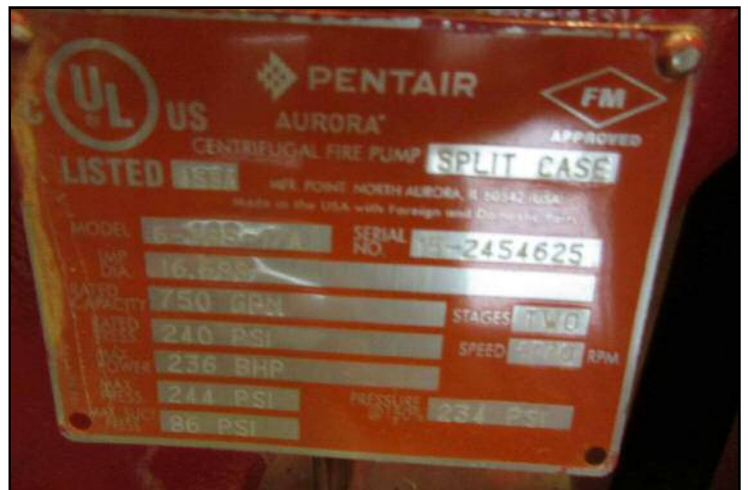
Component: 476 - Fire Pump - Replace
Location: Ground floor of pump room
Cost Source: Akamai Reserves Cost Database
Best Case: \$50,000 Estimate to replace pump
Worst Case: \$60,000 Higher estimate

Evaluation: Fire pump is new and in good condition.

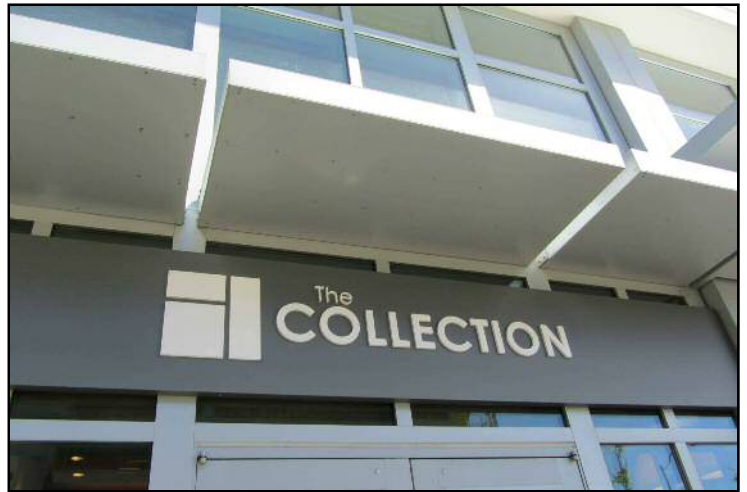
Component: 530 - Front Sign - Repair/Replace
Location: Entrance and intersections
Cost Source:
Best Case:
Worst Case:

Evaluation: Signs are in good attractive condition. Recommend repair and replacement as needed under the Operating Budget.

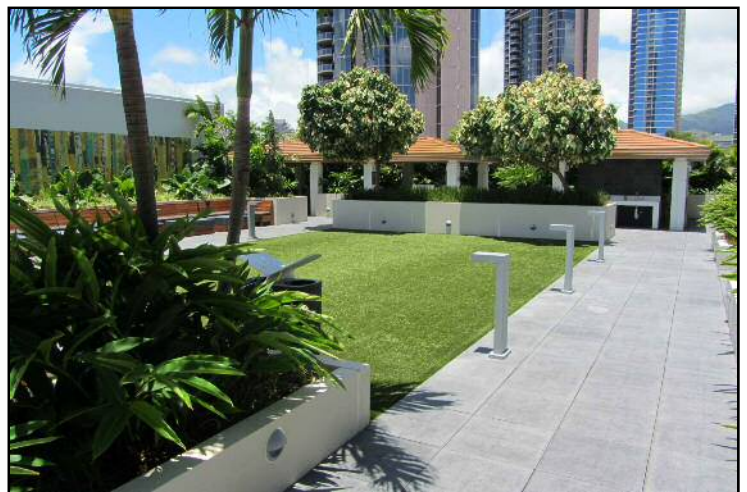
Component: 280 - 7th Floor Pavers - Replace
Location: 7th floor recreation deck
Cost Source: Akamai Reserves Cost Database
Best Case: \$111,250 Estimate to repair
Worst Case: \$133,500 Higher estimate for subsurface repairs

Evaluation: Tiles are new and in good condition. Recommend replacing broken tiles as needed under the Operating Budget as needed between full replacement.

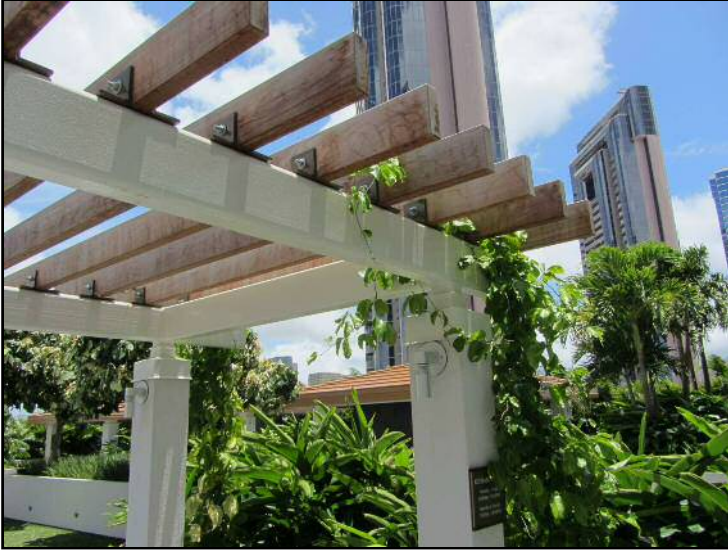
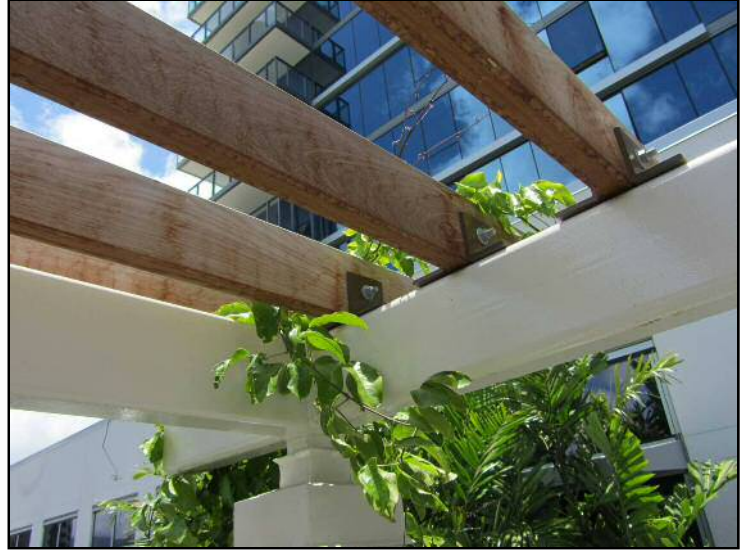
Component: 318 - Wood Trellis - Repair
Location: Pool area
Cost Source:
Best Case:
Worst Case:

Evaluation: Metal and wood trellis is in fair condition. Plant droppings are staining the pavers. Recommend removing plants from trellis for access to repair, refinish wood, and paint metal.

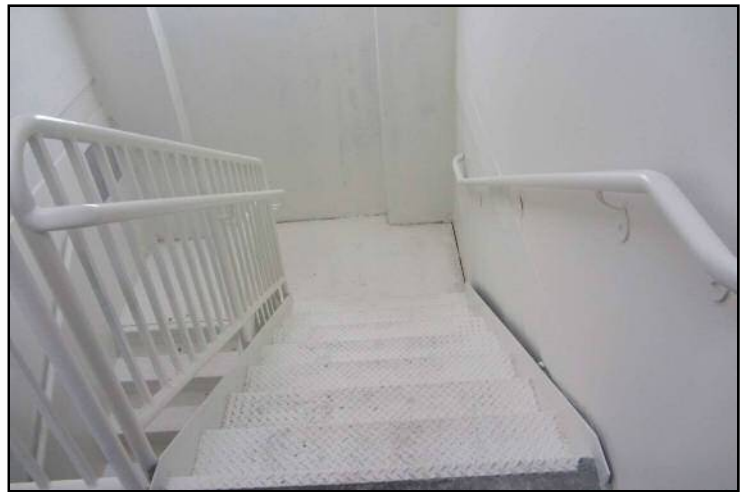
Component: 322 - Metal Hand Rail - Replace
Location: Building stairs
Cost Source:
Best Case:
Worst Case:

Evaluation: With painting and small repairs performed in-house these components are long life with no expectation for full replacement.

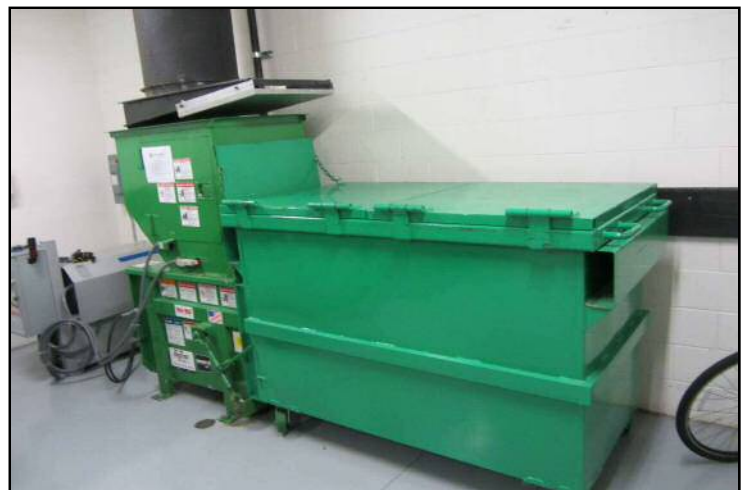
Component: 419 - Trash Compactor Bins - Replace
Location: Level 1 trash room
Cost Source: Estimate provided by client
Best Case: \$12,900 Estimate to replace unit
Worst Case: \$15,000 Higher estimate

Evaluation: Compactor bins are reported to be functional and in good condition.

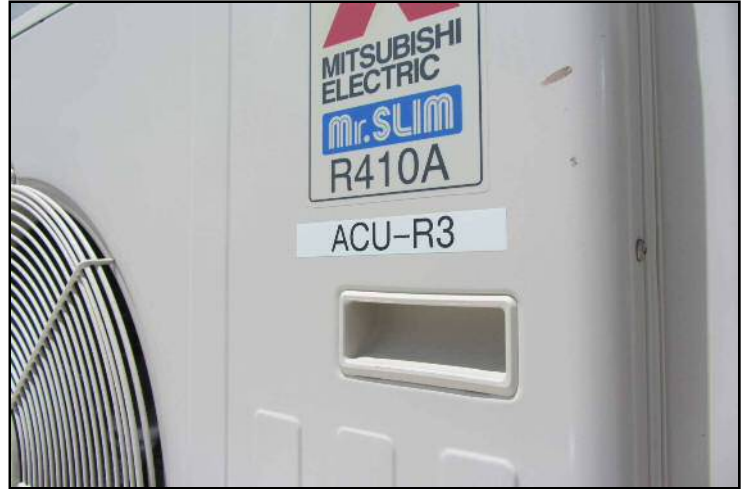
Component: 439 - Spit System Condenser - Replace
Location: Mechanical rooms
Cost Source: Akamai Reserves Cost Database
Best Case: \$12,000 Estimate to replace
Worst Case: \$13,400 Higher estimate

Evaluation: AC units are in good functional condition.

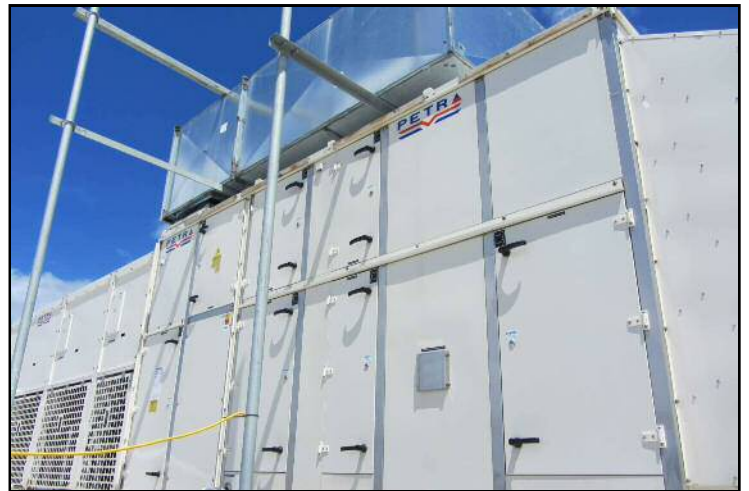
Component: 441 - Outdoor Air Handler - Replace
Location: Building Roof
Cost Source: Budget estimate
Best Case: \$750,000 Estimate to replace
Worst Case: \$1,000,000 Higher estimate

Evaluation: Unit is Quarterly and Monthly inspected and repairs are performed as needed under the Operating Budget. Additional information for future replacement needed.

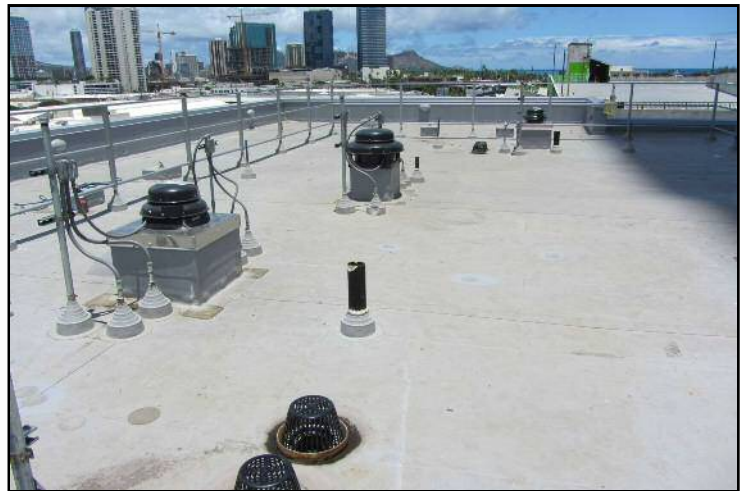
Evaluation: Membrane flat roofing is in good condition. Routine inspection and small repairs recommended under the Operating Budget. Annex and Tower roofs were inspected during site visit. Pool equipment and other small buildings are included in this component, these roofs were not inspected.
