## REQUEST FOR ACTION

<b>To</b>	The Collection Board of Directors				
<b>Subject</b>	Installation of a Two-Way Stop at The Second Floor Garage Intersection Due to Lack of Enforcement of Association Rule 5.13 by The Collection Management and the Board of Directors. Hiring an Outside an Outside Traffic Engineering Group to Evaluate All Garage Safety Issues, and Provide Recommendations for Improvement.				
<b>Preparer</b>	Debra Ishihara-Wong				
<b>Date</b>	07/02/18. Initial request submitted through multiple emails, the beginning of June 2018. I was informed I needed to submit an RFA to get the attention of the board.	<b>For Board</b>	x	<b>Action</b>	<b>Info</b>

INSTALLATION OF TWO-WAY-STOP AT THE SECOND FLOOR GARAGE INTERSECTION DUE TO LACK OF ENFORCEMENT OF ASSOCIATION RULE 5.13 BY THE COLLECTION MANAGEMENT AND THE BOARD OF DIRECTORS. HIRING AN OUTSIDE TRAFFIC ENGINEERING GROUP TO EVALUATE ALL GARAGE SAFETY ISSUES, AND PROVIDE RECOMMENDATION FOR IMPROVEMENT.

November 30, 2017  
 The Collection Board of Directors Meeting  
 General Manager's Report  
 Submitted by Al Guzman

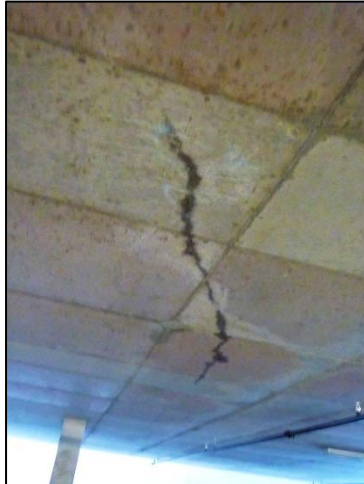
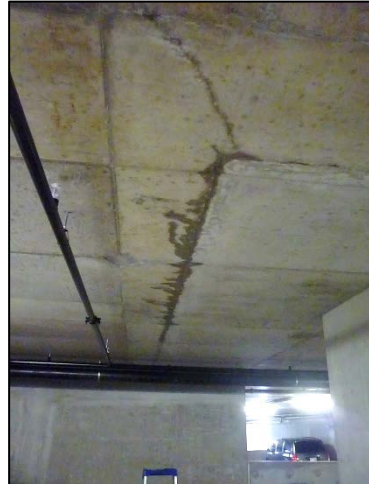
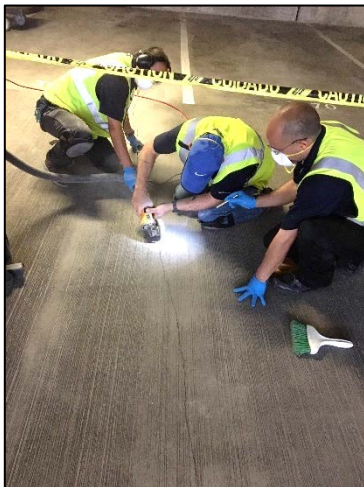
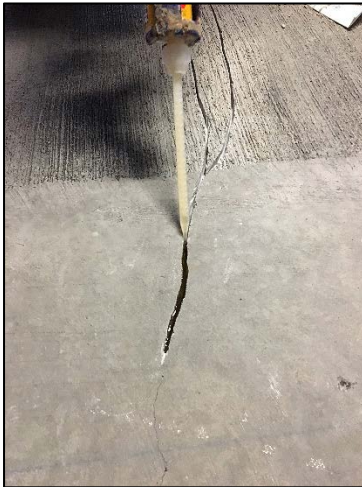
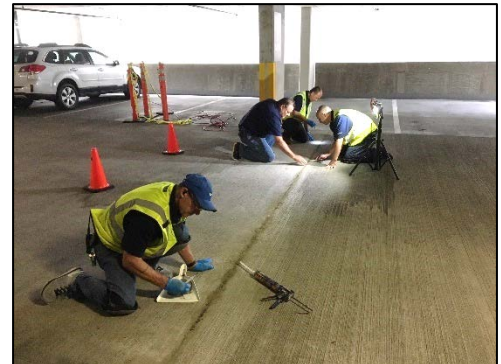
Since opening, The Collection has experienced many heavy down pours. During heavy, wind driven rain, water enters the garage on the Mauka, Ewa and Makai sides. The large ponds and leaks were repaired during the Warranty period. There are several smaller leaks we have identified and repaired. Although small, over time, water will corrode the re-bar and post tension cables causing spalling. Repairs would be costly.

*Small ceiling leaks*

- *Water entry area is grinded open to allow the epoxy to sink in and seal leak.*
- *Epoxy is applied.*
- *Dust coating is then applied to blend the repair to the surrounding concrete.*

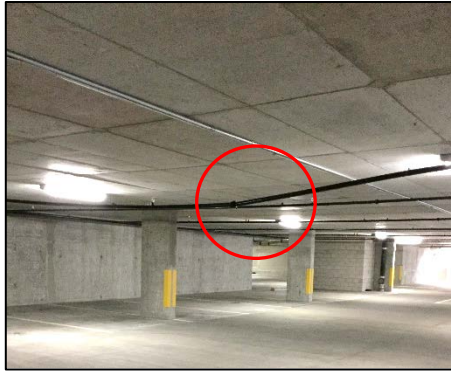
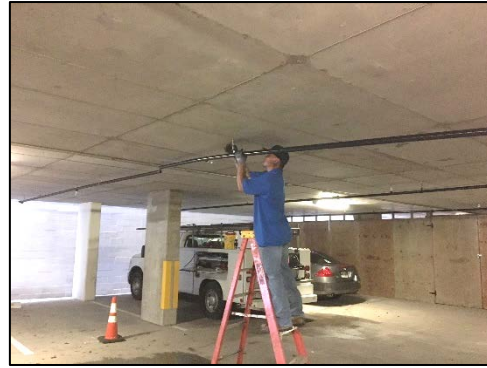
In January 2018, Commercial #4 Tenant began receiving and storing their restaurant supplies. While using a fork lift to transport their items from a container to their storage, the forklift driver hit and damaged the common area sprinkler line. The cost to replace the damaged sections was \$1,346 and the repair was performed by Commercial Plumbing. Tenant was invoiced for the reimbursement.

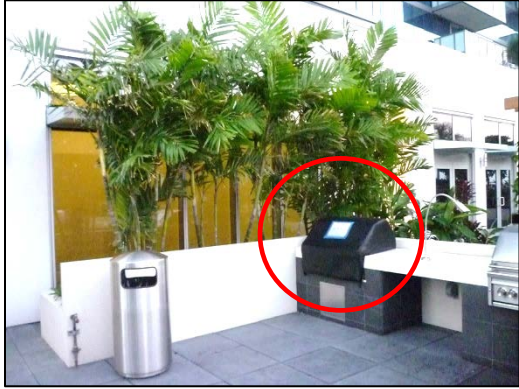
Prior to opening The Collection, the construction General Contractor, Hawaiian Dredging (HDCC) met with The Honolulu Fire Department (HFD) who inspected the site. The primary focus of the of the inspection was to insure the Fire Alarm System was working properly. Although the Department of Planning and Permitting approved HDCC's construction plans, the Fire Department mentioned concern over the proximity of the BBQ Grill being too close to the building (structure). As such, HDCC advised The Collection Management not to put it in use.

The grill was removed but since then, several requests have been made to relocate it.

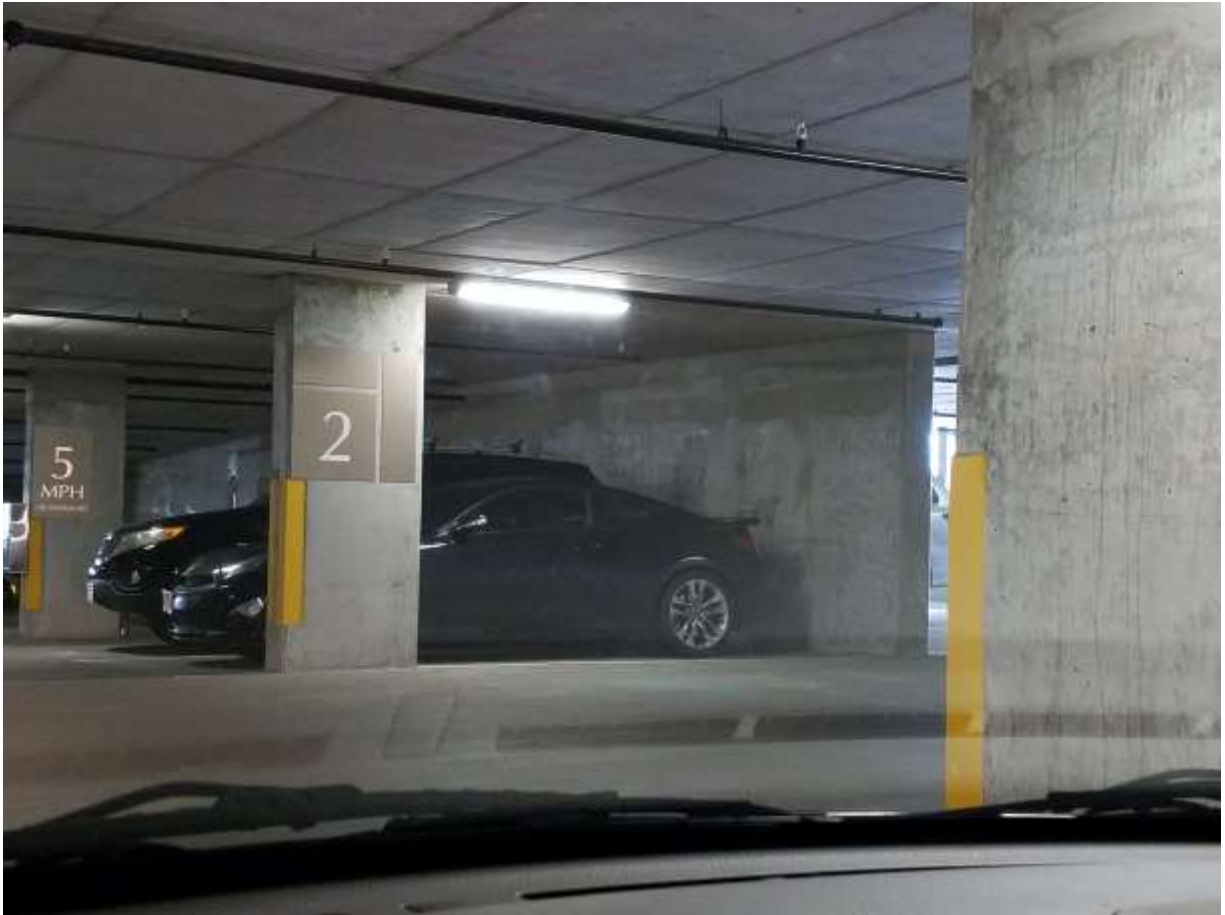
## The Tower Garage Second Floor

Drivers parked on the second-floor tower garage, heading toward the exit garage gate, are currently required to stop at the three-way intersection to provide the right of way to drivers coming down from the third floor. At the stop, a solid concrete wall blocks the driver's sight of vehicles coming down. (See picture below)

Since the problem resides with drivers coming down from the upper floors without their headlights turned on, and no effective action was implemented to stop this behavior, I am requesting that this intersection be changed to a two-way stop. I also request that that the BOD exercise their required due diligence to hire an outside traffic engineering group to evaluate all garage safety issues, and provide recommendations for improvement. Such recommendations should, in the interest of increasing safety and limiting liability, be provided to owners and residents.

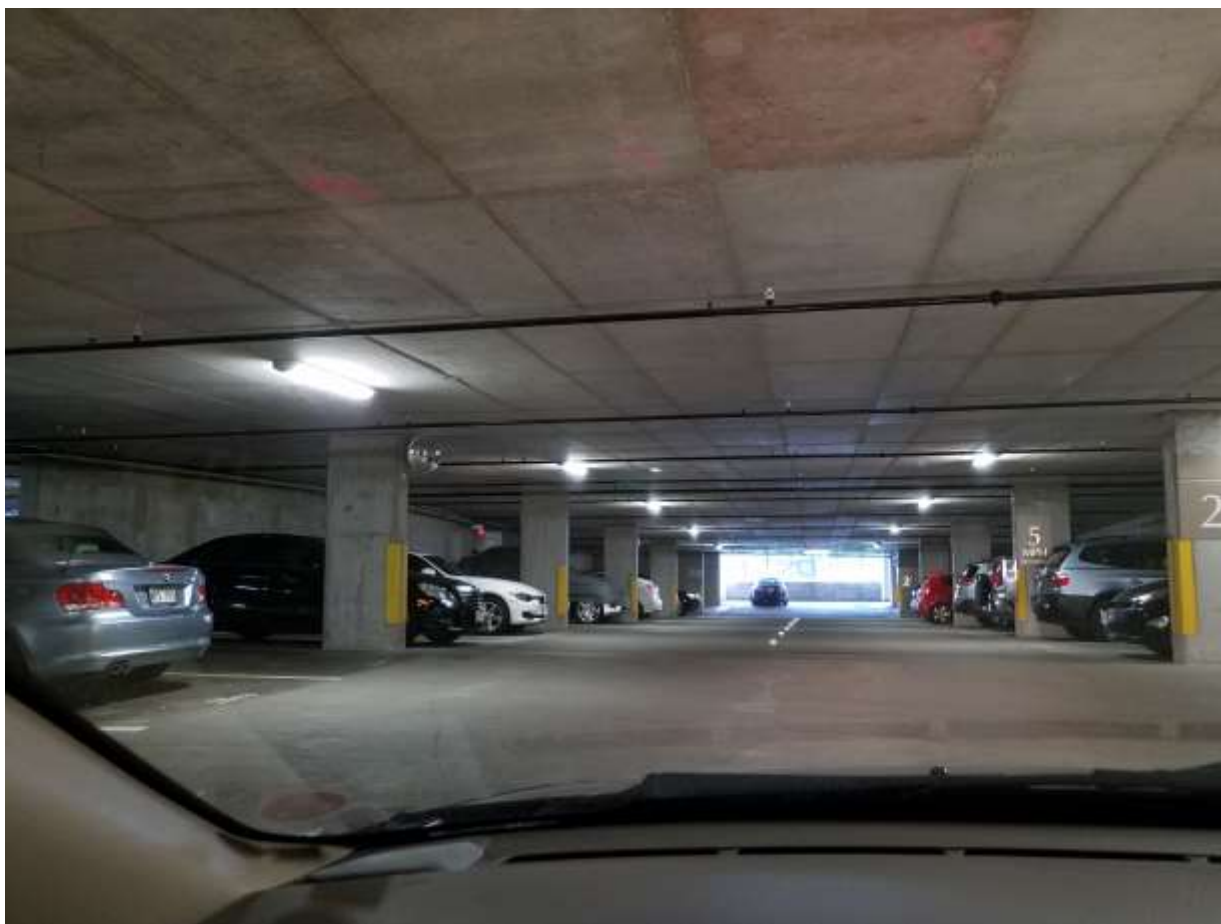
Thus, the only way a driver can see an oncoming car is looking at the garage mirror. The garage lighting and the size of the mirror, does not allow a driver to see an oncoming car if their headlights are not turned on. (See picture on next page)

There have been many occasions when I, and other individuals, have stopped, looked at the mirror, saw no vehicle coming down, thus slowly inched forward, and almost were hit by an oncoming car with their headlight not turned on.
