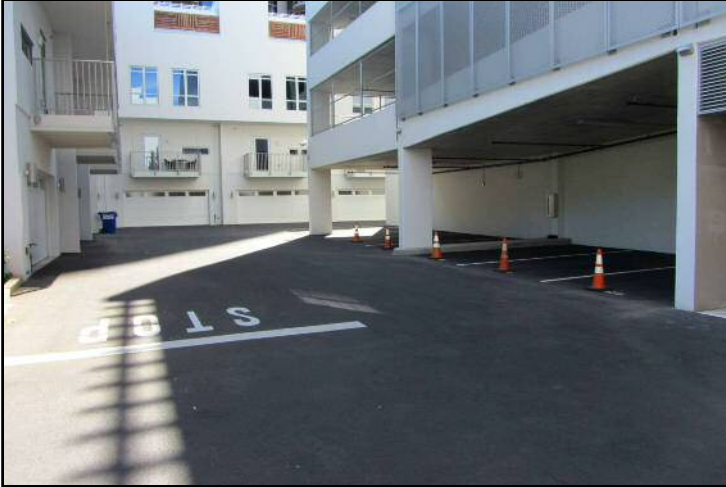
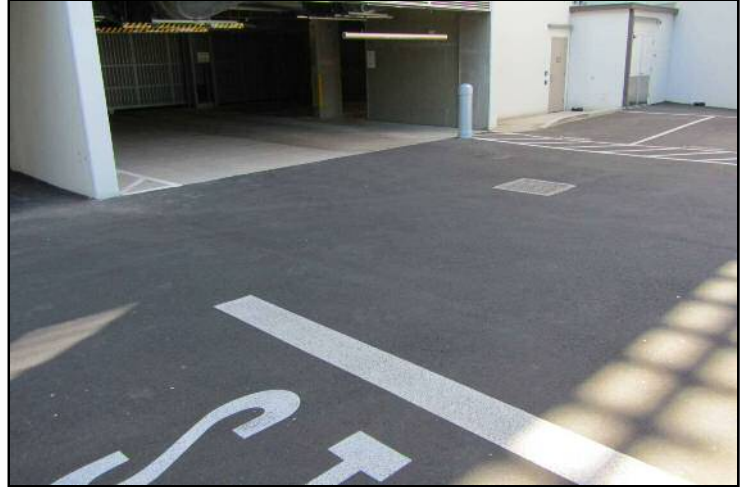
Component: 101 - Asphalt - Replace

Evaluation: Asphalt surfaces are new and in good level condition. Recommend seal coating early to protect surface and extend useful life.

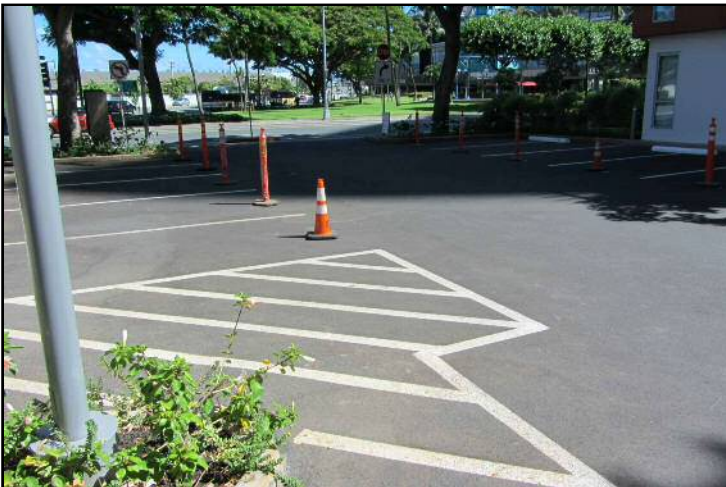
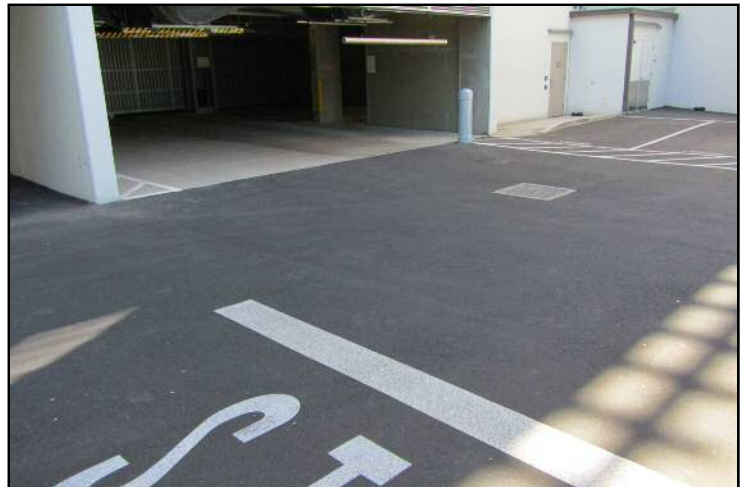
Component: 111 - Asphalt - Seal/Repair

Evaluation: Recommend starting seal coating for extended useful life.

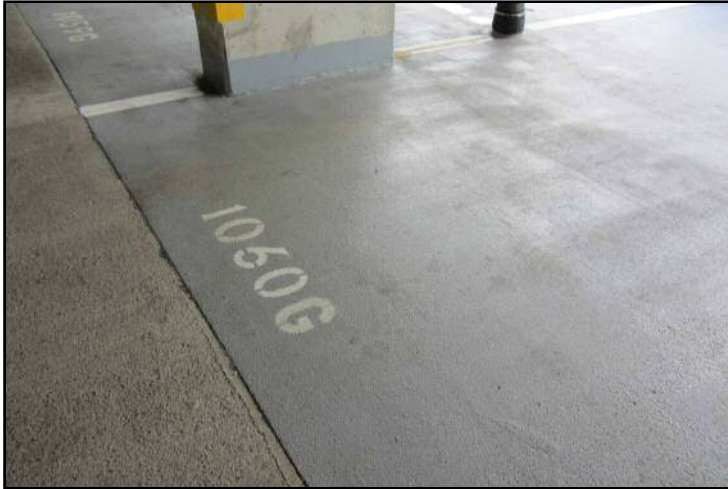
Component: 271 - Parking Deck - Seal/Repair

Evaluation: Exposed areas of parking garage are sealed.

Surface is new and in good condition. Top floor of structure has drainage issues and will have accelerated aging from exposure. Noted issues with water ponding on 7th floor.

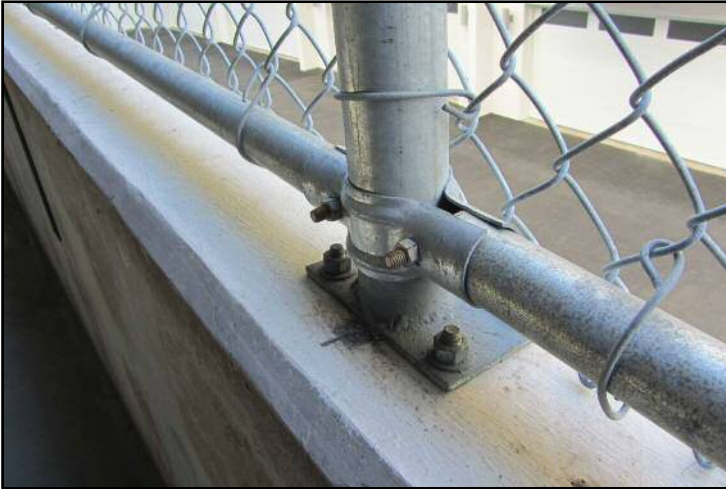
Component: 309 - Chain Link Fencing - Replace
Location: Parking garage
Cost Source:
Best Case:
Worst Case:

Evaluation: Chain link fencing is in good condition. Recommend repair and replacement as needed under the Operating Budget.

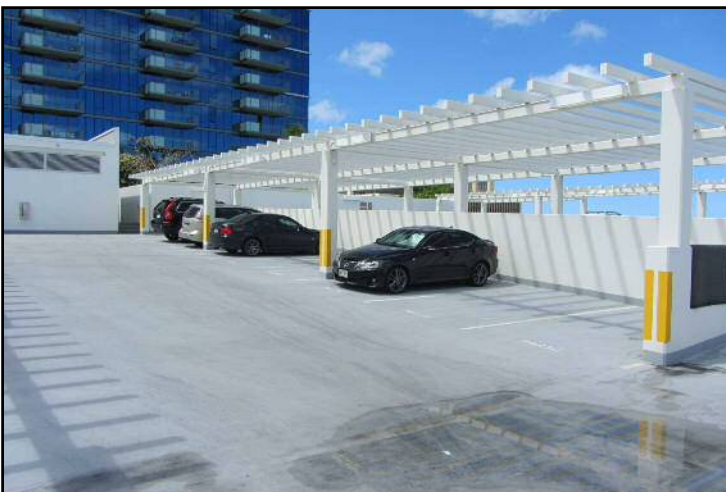
Component: 319 - Metal Trellis - Paint
Location: 7th Parking
Cost Source:
Best Case:
Worst Case:

Evaluation: Painted metal trellis on parking structure is a long life component with frequent painting and eventual section repairs. Ease of access recommend handling painting under the Operating Budget.

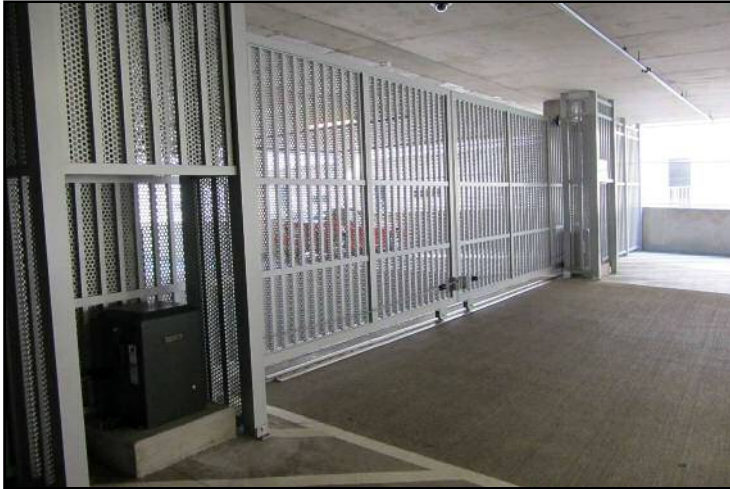
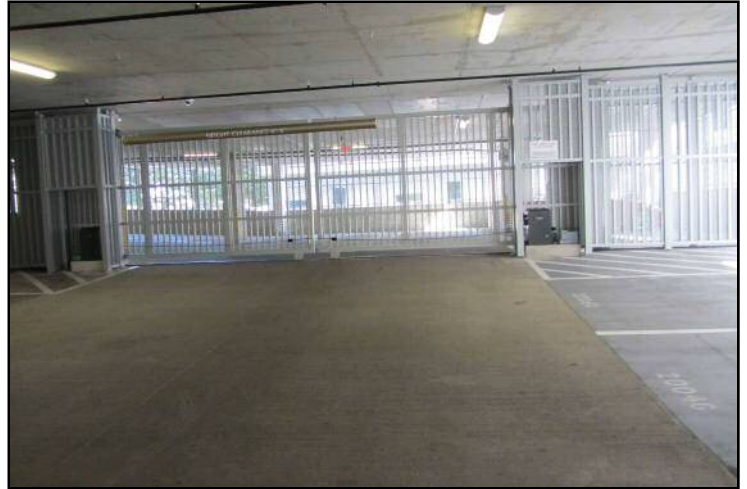
Component: 320 - Metal Gates - Replace
Location: Entrances/Exits parking garage
Cost Source: Akamai Reserves Cost Database
Best Case: \$80,000 \$20,000/gate; Estimate for gate replacement
Worst Case: \$100,000 \$25,000/gate; Higher estimate to replace gate

Evaluation: Slide gates are functional and in good condition.

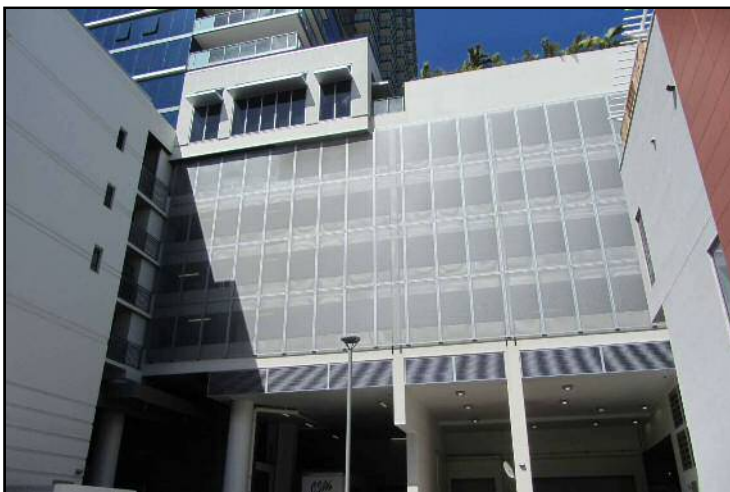
Component: 325 - Metal Panel - Replace
Location: Parking Garage
Cost Source: Budget estimate
Best Case: \$258,750 Estimate to replace panel
Worst Case: \$345,000 Higher estimate

Evaluation: Aluminum panels are in good condition. Estimate for full replacement cost. Recommend maintaining and sectional replacement as needed under the Operating Budget to avoid this expense.

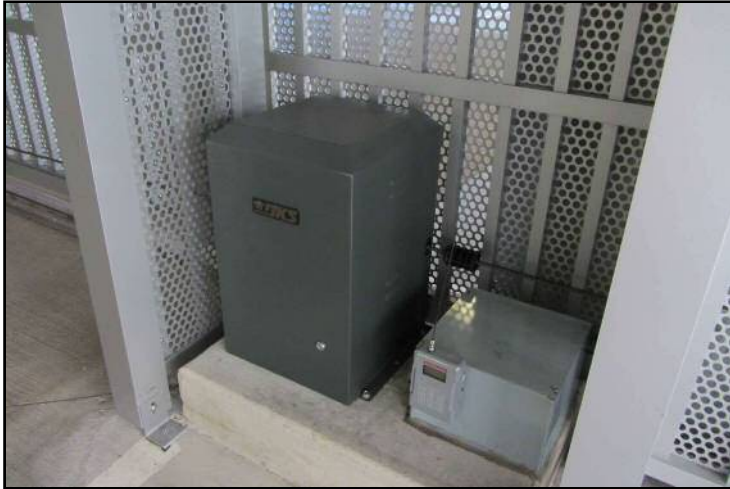
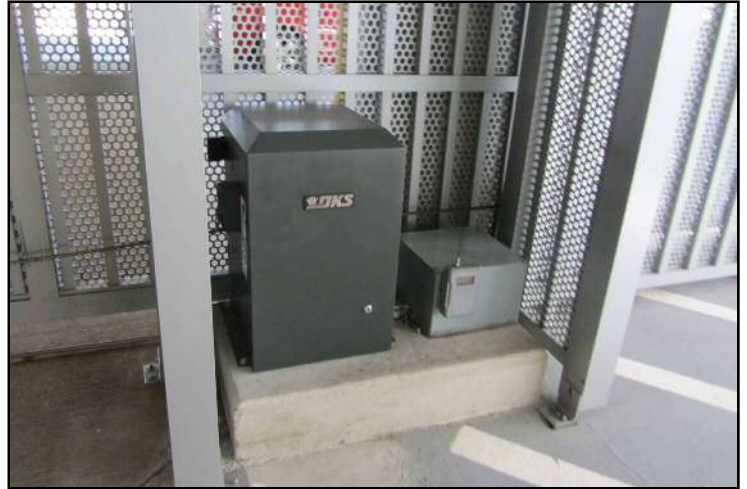
Component: 401 - Gate Operators - Replace

Evaluation: Door king gate operators are in good condition.

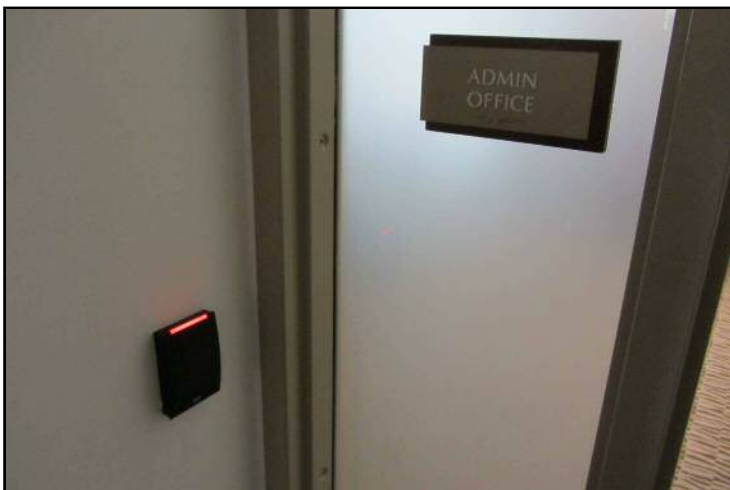
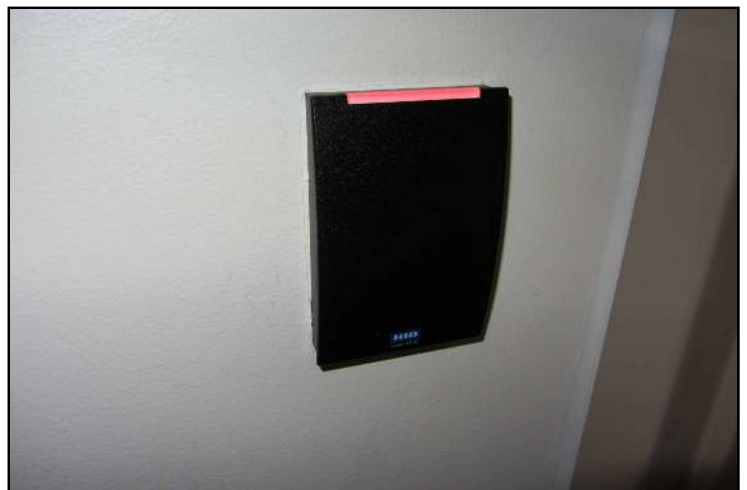
Component: 402 - Fob Entry System - Replace

Evaluation: Fob entry system is in good functional condition.

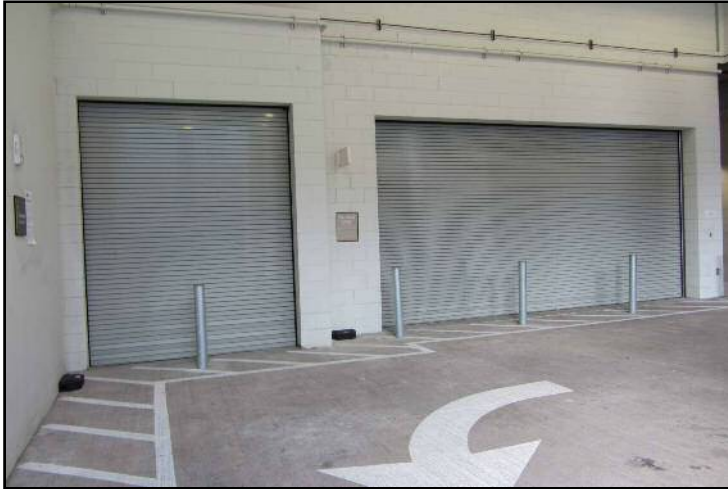
Component: 404 - Roll Up Door - Replace
Location: Lower level parking garage
Cost Source: Akamai Reserves Cost Database
Best Case: \$15,000 Estimate to replace door
Worst Case: \$17,000 Higher estimate

Evaluation: Roll up doors are new and in good condition.

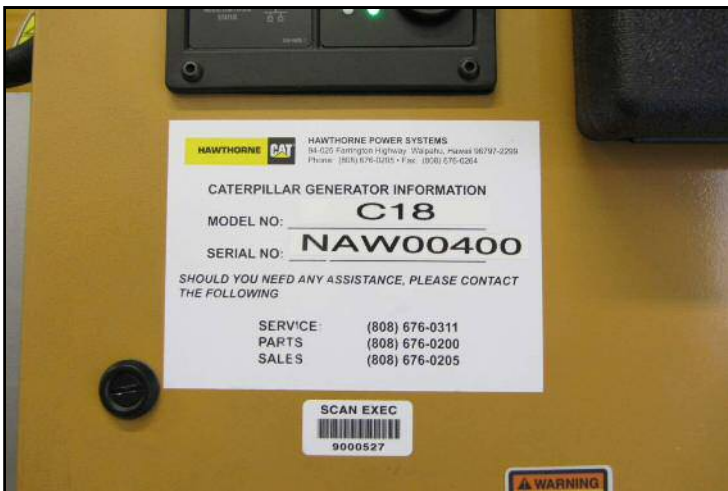
Component: 410 - Generator - Rebuild
Location: Level 1 Generator room
Cost Source: Akamai Reserves Cost Database
Best Case: \$55,000 Estimate to rebuild
Worst Case: \$65,000 Higher estimate

Evaluation: Caterpillar generator is new and in good functional condition.

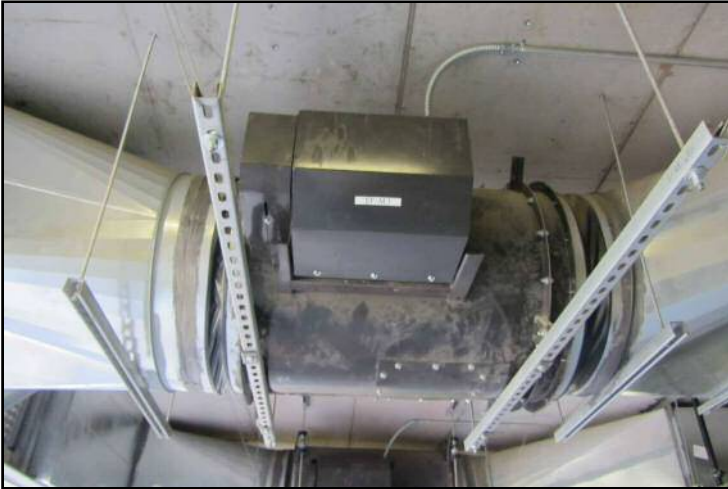
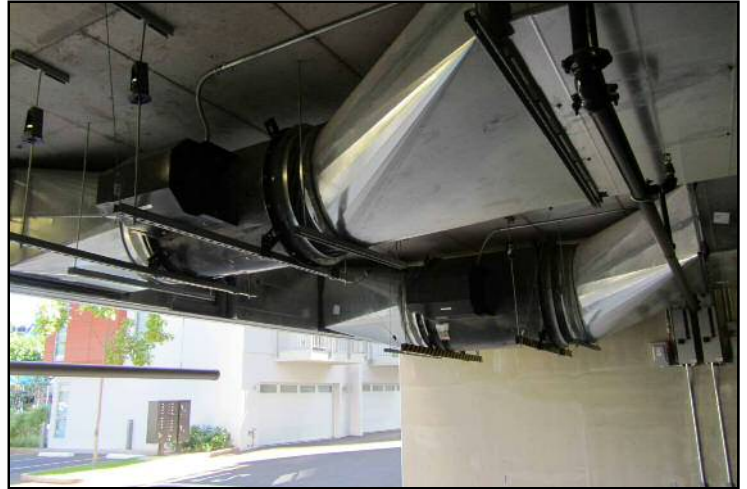
Component: 412 - Exhaust Fan - Replace
Location: Parking garage
Cost Source: Akamai Reserves Cost Database
Best Case: \$9,600 Estimate for large unit replacement
Worst Case: \$12,000 Higher estimate

Evaluation: EF.M1 and EF.M2 are functional and in good condition.

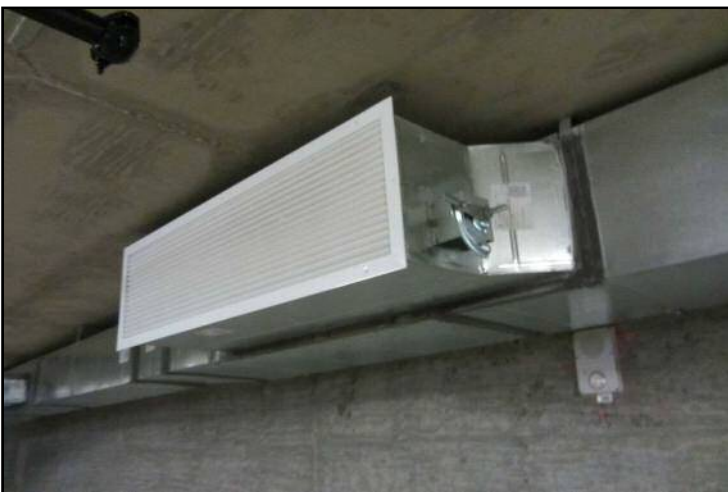
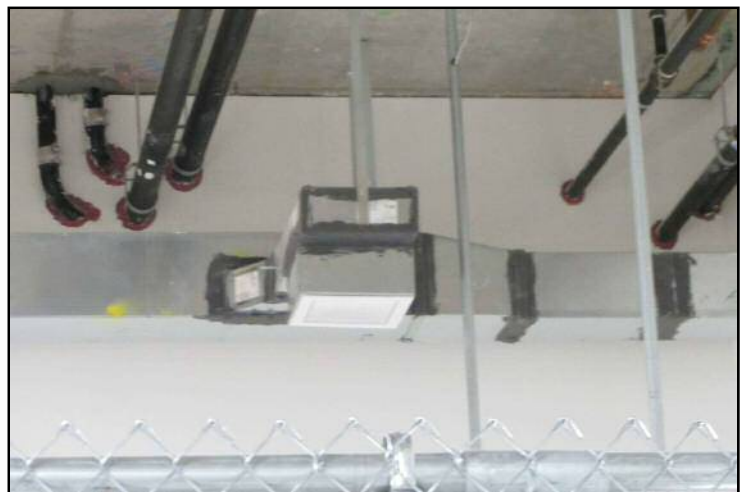
Component: 412 - Exhaust Fan - Replace
Location: Garage and common areas
Cost Source:
Best Case:
Worst Case:

Evaluation: 1/6 to 1-1/2 HP direct drive units. Recommend repair and maintenance as needed under the Operating Budget.

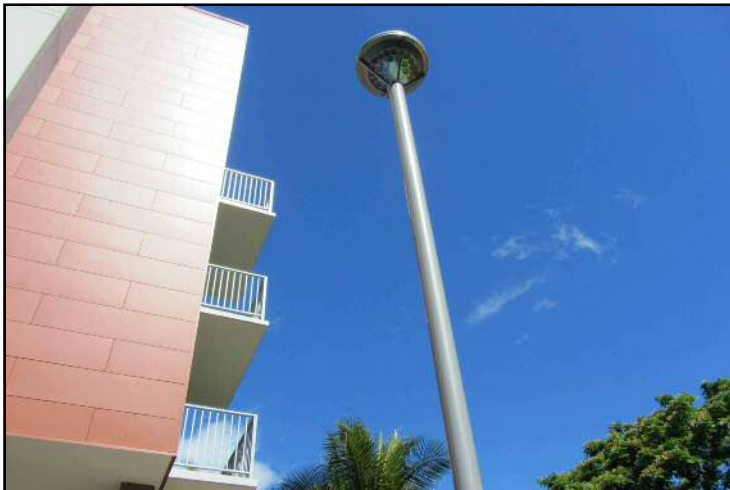
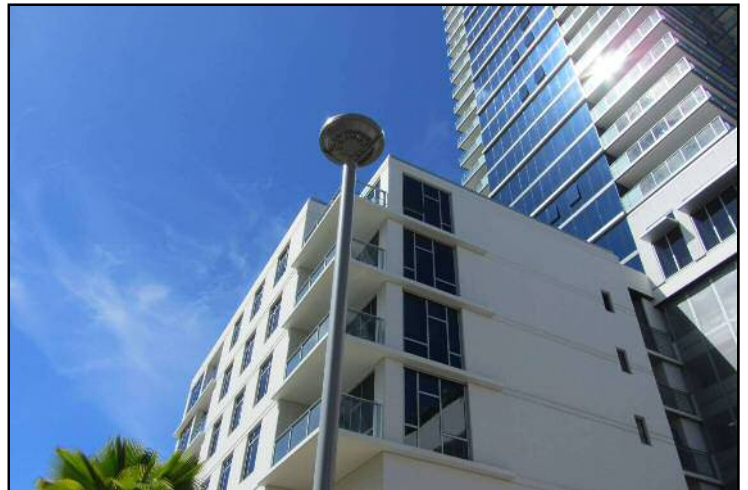
Component: 426 - Pole Lights - Replace

Evaluation: LED lights are in good condition.

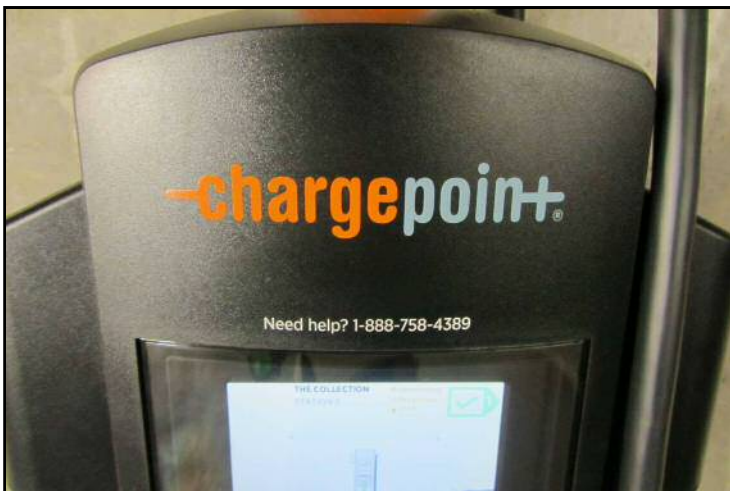
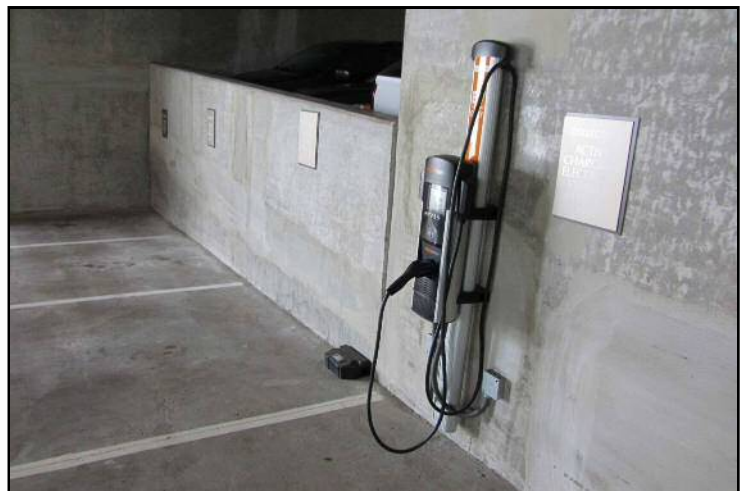
Component: 432 - Electric Vehicle Charging - Repair/Replacement

Evaluation: EV charging stations are in good functional condition.

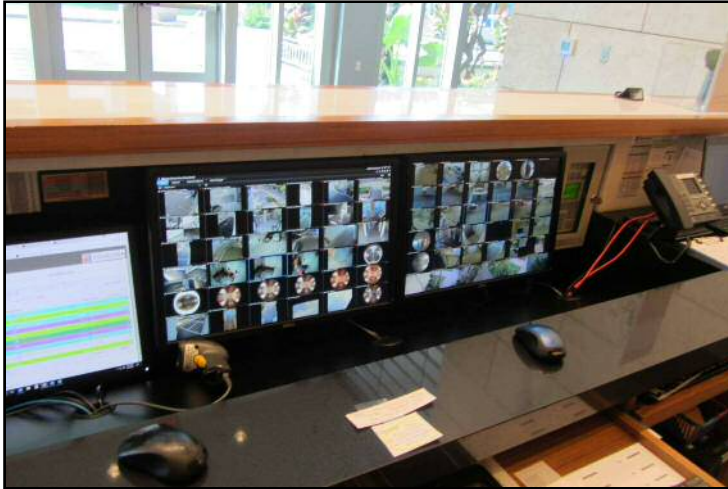
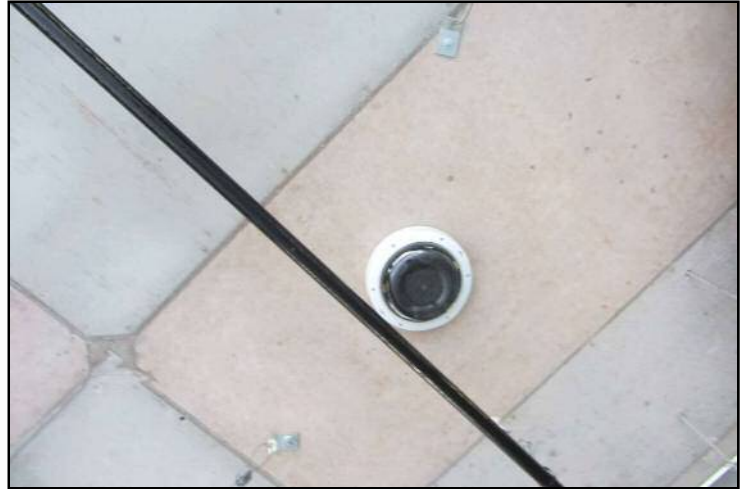
Component: 445 - Security Camera System - Replace/Upgrade

Evaluation: New camera system is functional and in good condition. Recommend replacement of individual cameras as needed under the Operating Budget between cycles.

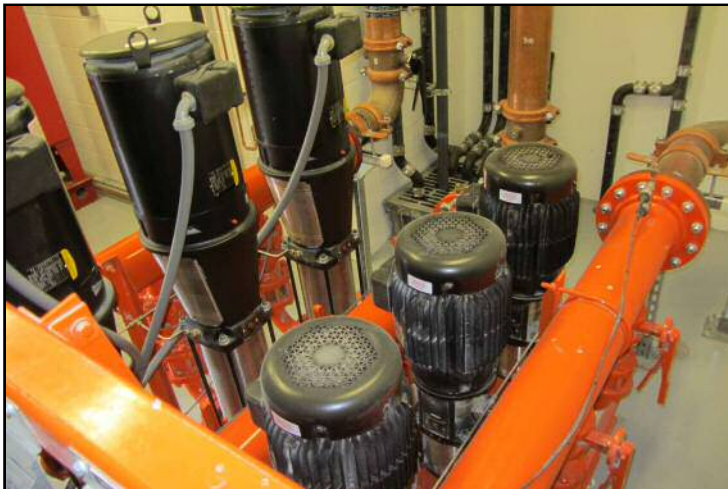
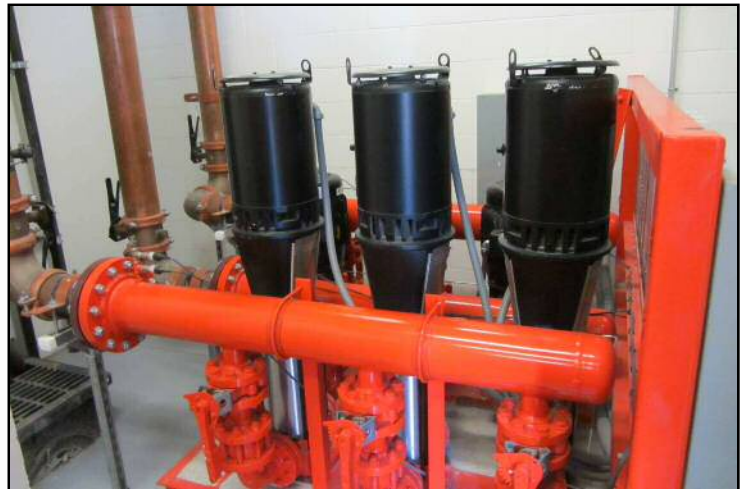
Component: 472 - Dom. Water Booster Pumps -Replace

Evaluation: 25 HP pumps with modules are in good functional condition.

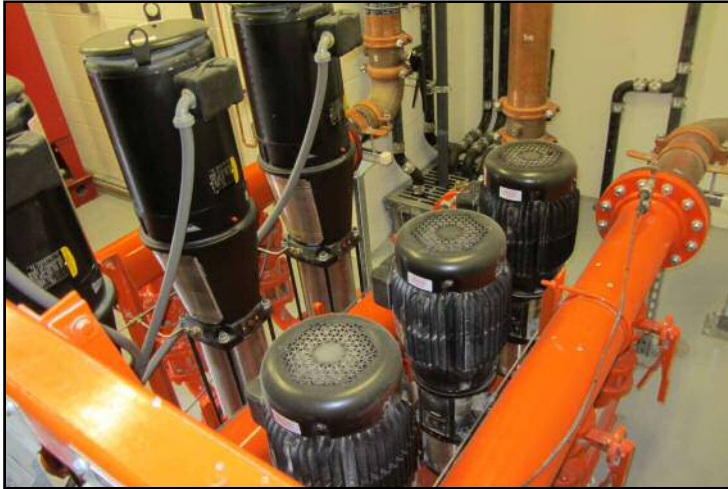
Component: 472 - Dom. Water Booster Pumps -Replace
Location: Tower; Ground floor mechanical room
Cost Source: Akamai Reserves Cost Database
Best Case: \$30,000 7.5 HP Pump; Estimate to replace
Worst Case: \$36,000 7.5 HP Pump; Higher estimate

Evaluation: Smaller 7.5 HP pumps are in good functional condition.

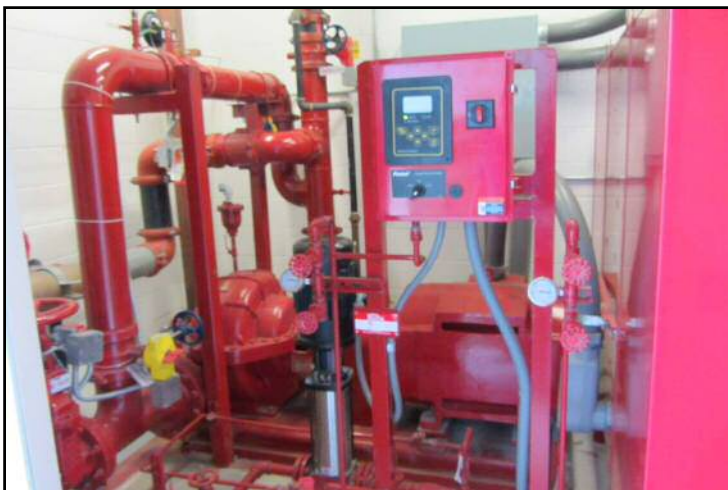
Component: 476 - Fire Pump - Replace
Location: Ground floor of pump room
Cost Source: Akamai Reserves Cost Database
Best Case: \$50,000 Estimate to replace pump
Worst Case: \$60,000 Higher estimate

Evaluation: Fire pump is new and in good condition.

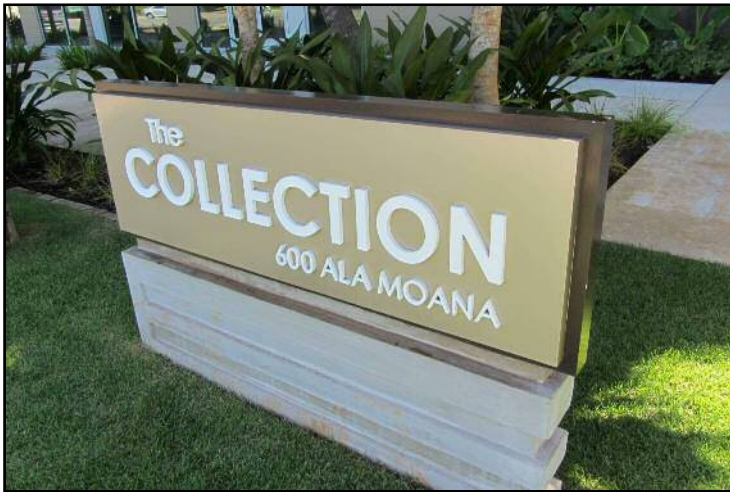
Component: 530 - Front Sign - Repair/Replace
Location: Entrance and intersections
Cost Source:
Best Case:
Worst Case:

Evaluation: Signs are in good attractive condition. Recommend repair and replacement as needed under the Operating Budget.

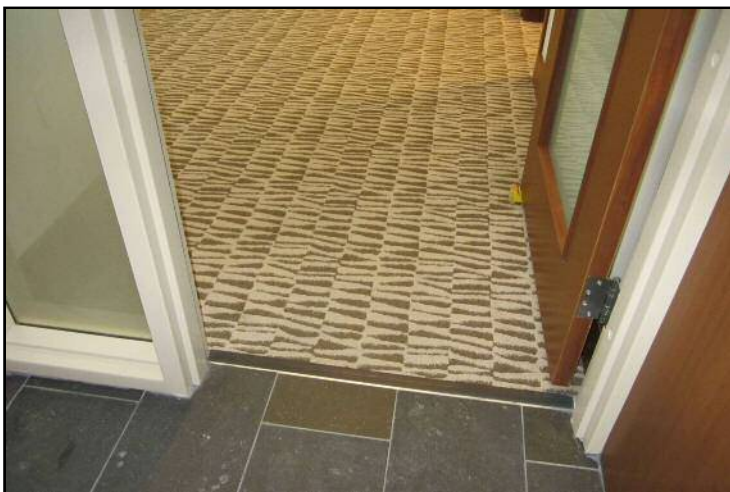
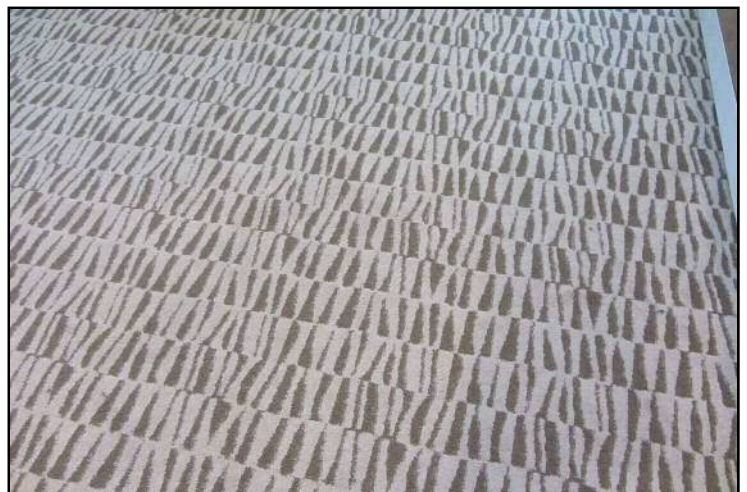
Component: 713 - Office Carpet - Replace
Location: Manager's office
Cost Source:
Best Case:
Worst Case:

Evaluation: Minimal area with light traffic. Recommend replacement as needed under the Operating Budget.

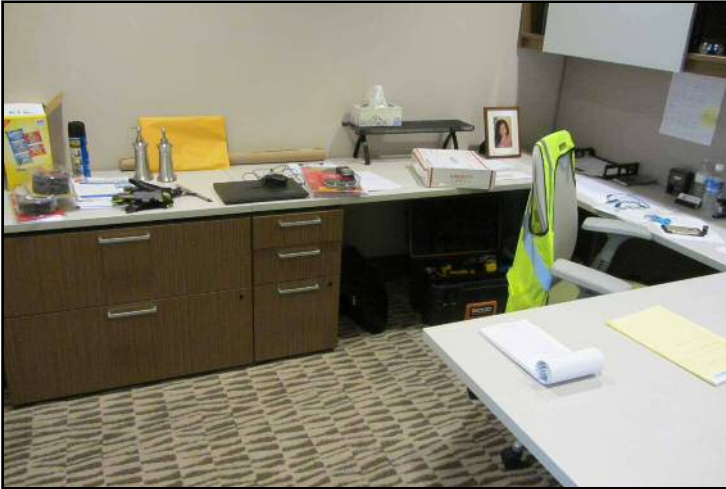
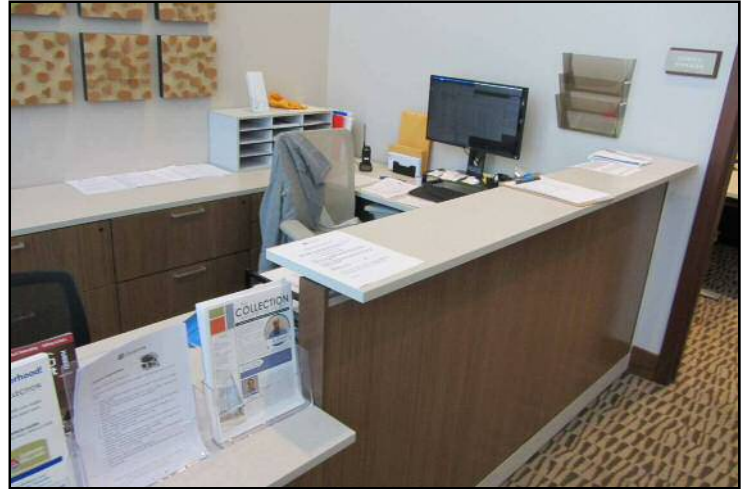
Component: 715 - Office - Remodel
Location: Offices
Cost Source: Budget estimate
Best Case: \$10,000 Estimate to refurbish
Worst Case: \$15,000 Higher estimate

Evaluation: Cabinets, desks, furniture, and lighting are new and in good condition. Budget estimate to remodel rooms and upgrade furniture.

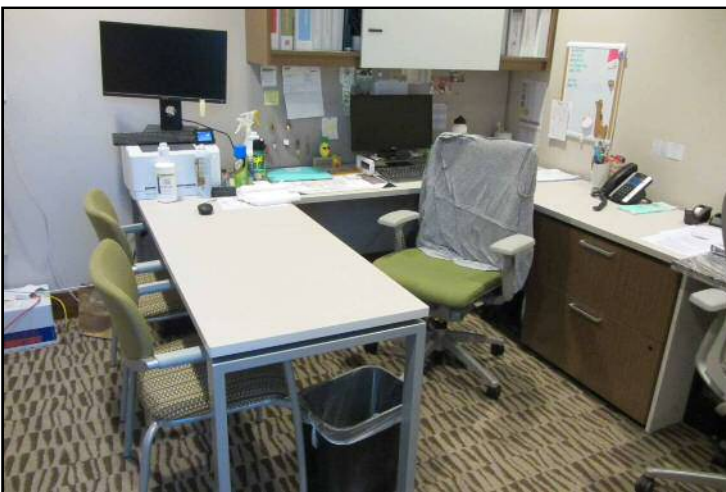
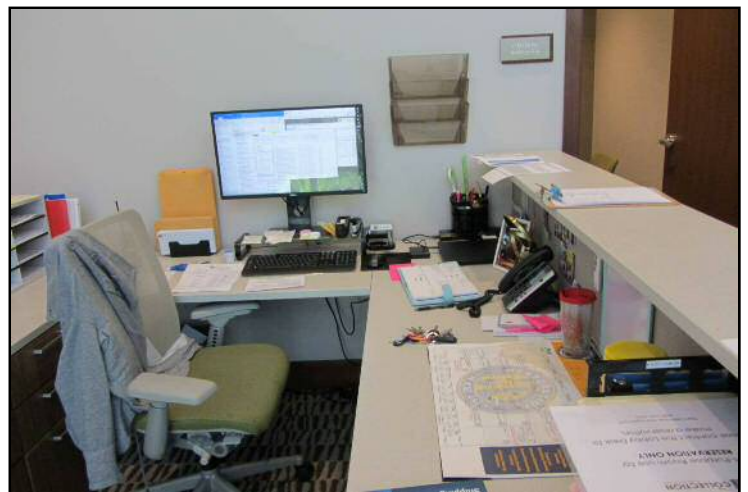
Component: 716 - Office Equipment - Replace/Upgrade
Location: Offices and front desk
Cost Source: Akamai Reserves Cost Database
Best Case: \$12,500 Estimate for replacement equipment
Worst Case: \$17,500 Higher estimate for additional equipment replacement

Evaluation: Several computers and various equipment will require routine upgrades to maintain functional systems. Recommend individual early replacements as needed under the Operating Budget between cycles.

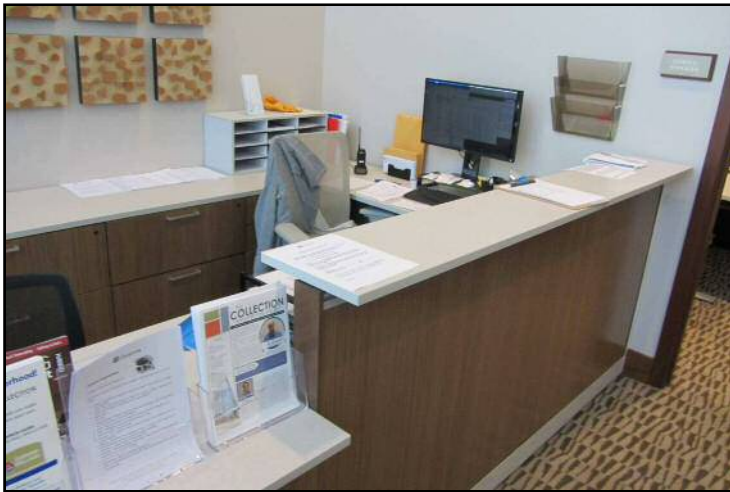
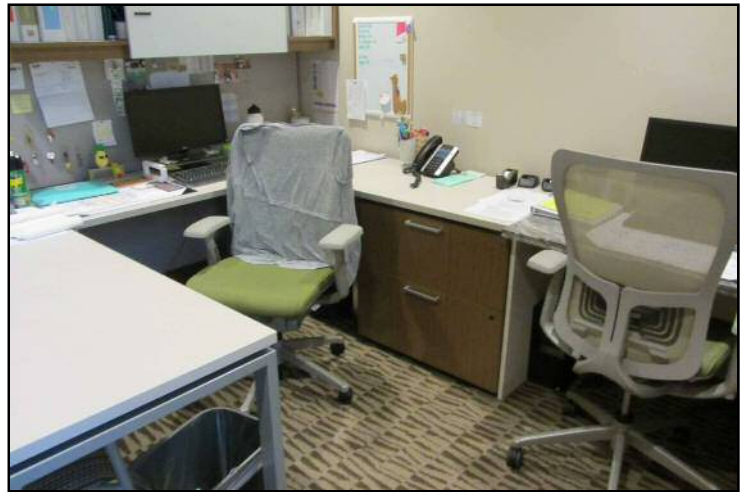
Component: 718 - Office Furniture - Replace

Evaluation: Fabric and cushions handled under the Operating Budget as needed. Furniture is functional and in good attractive condition.

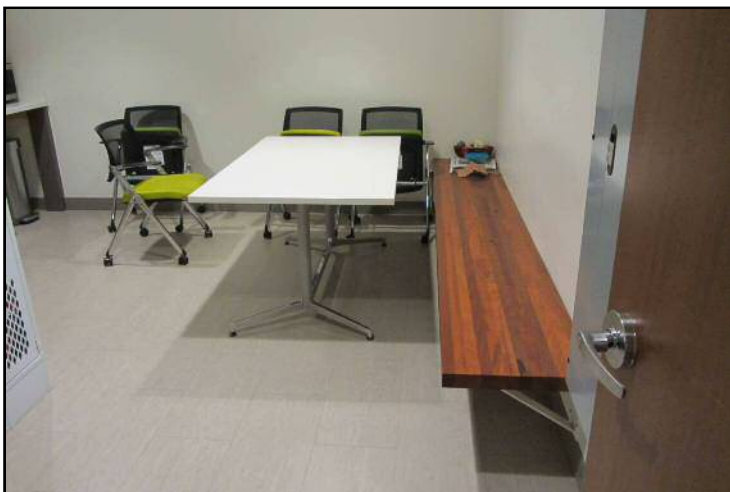
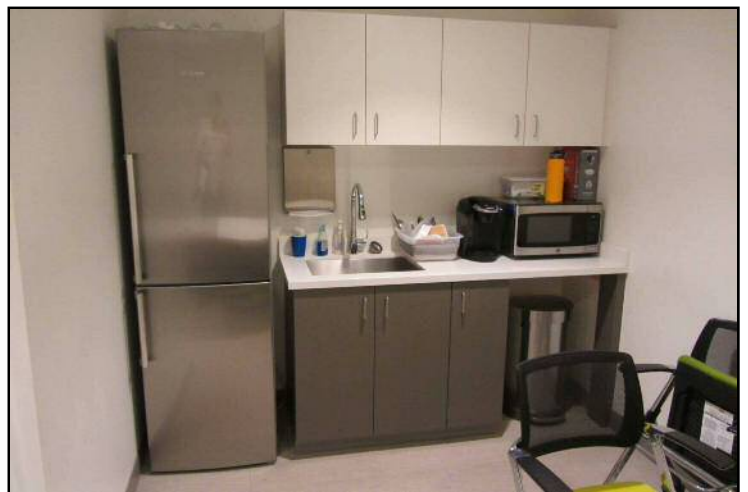
Component: 722 - Employee Break Room - Refurbish

Evaluation: Furniture, kitchen, and appliances may require individual replacement as needed under the Operating Budget. Estimate for full refurbish on this cycle.

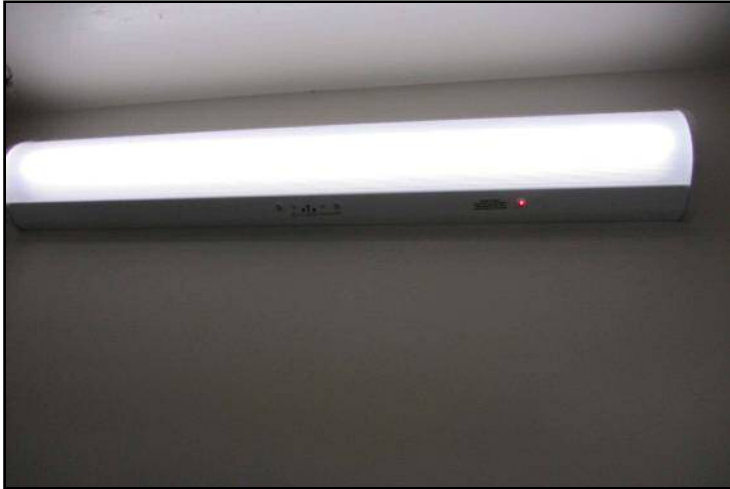
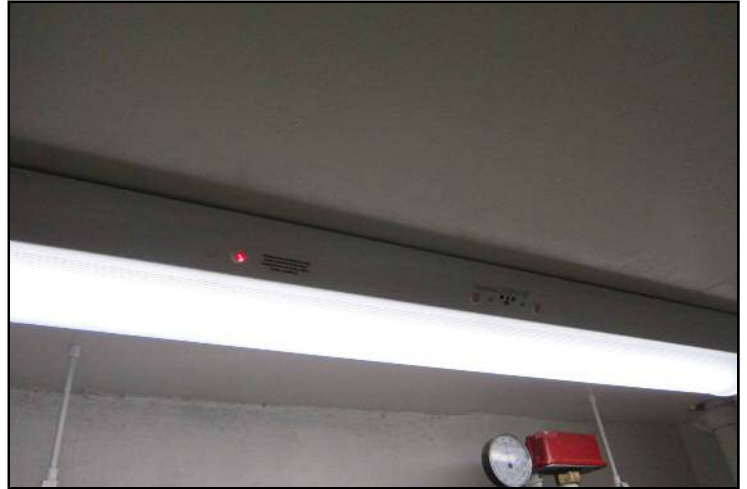
Component: 742 - Emergency Lights - Replace
Location: Stairways, garage, common service areas
Cost Source: Akamai Reserves Cost Database
Best Case: \$16,000 Estimate for replacement
Worst Case: \$18,000 Higher estimate

Evaluation: Motion sensor emergency lighting is in good functional condition. Recommend individual replacement and repair as needed under the Operating Budget to avoid full replacement.

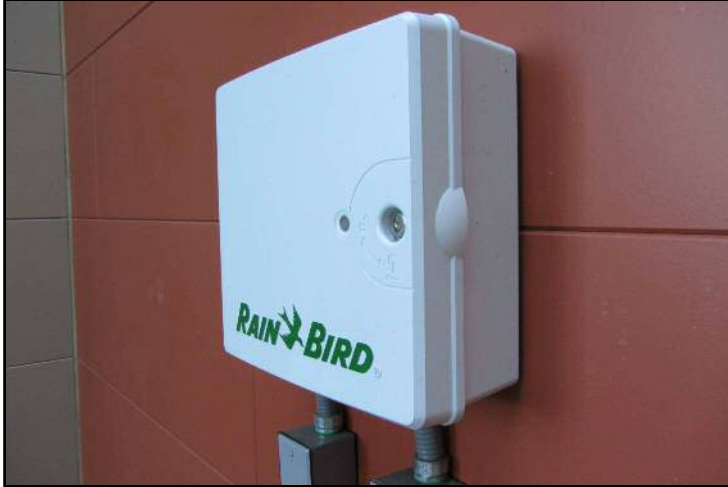
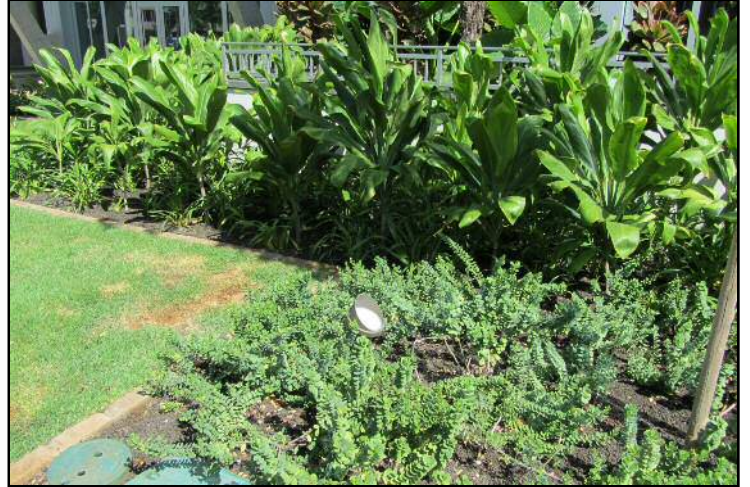
Component: 902 - Irrigation System - Repair/Replace
Location: Throughout property
Cost Source:
Best Case:
Worst Case:

Evaluation: Irrigation system is maintained as needed under the Operating Budget.

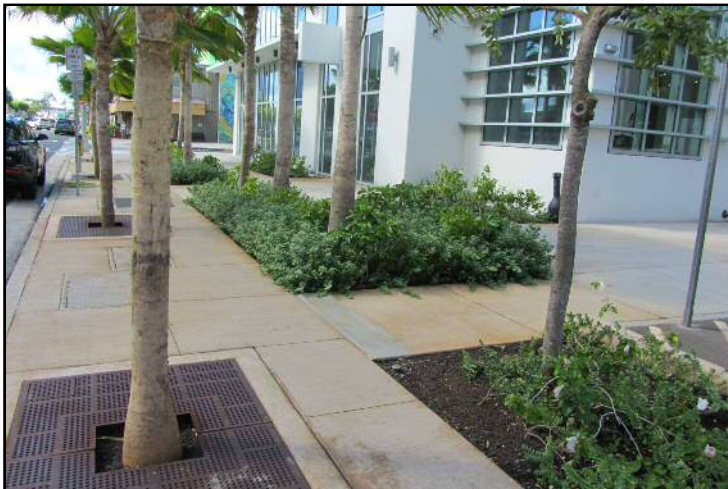
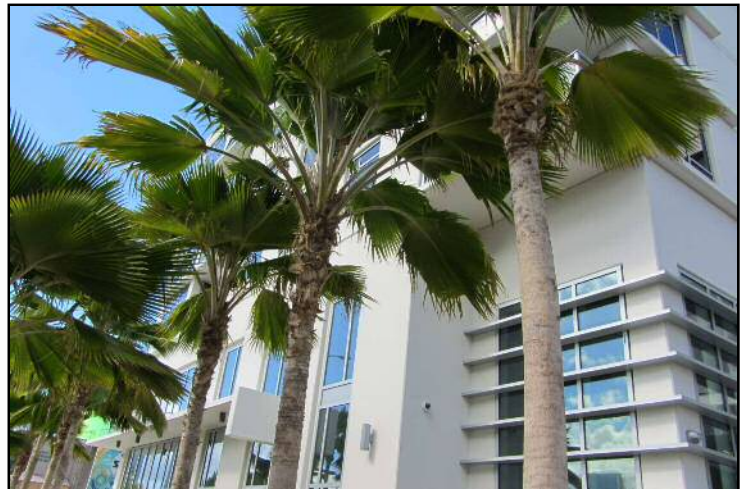
Component: 910 - Landscaping - Restoration
Location: Throughout common areas
Cost Source: Akamai Reserves Cost Database
Best Case: \$75,000 Estimate for restoration
Worst Case: \$100,000 Higher estimate for additional restoration

Evaluation: Major landscaping restoration is recommended on this cycle to replace trees and upgrade aging appearance.

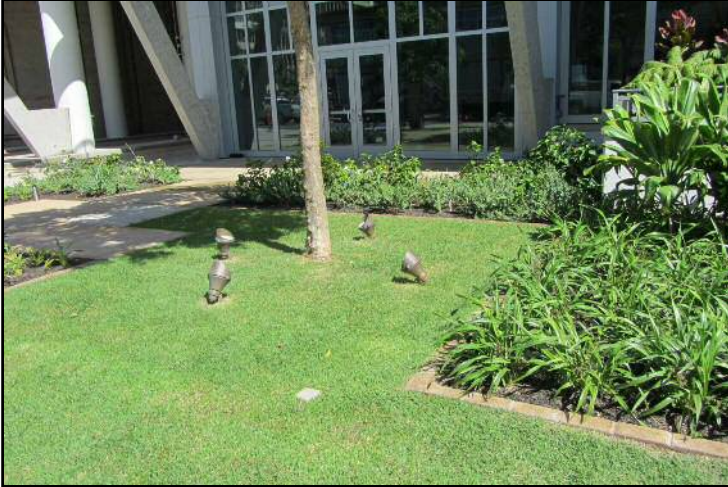
Component: 911 - Landscape Lights - Replace
Location: Throughout common area landscaping
Cost Source:
Best Case:
Worst Case:

Evaluation: Landscaping lights are maintained as needed under the Operating Budget.

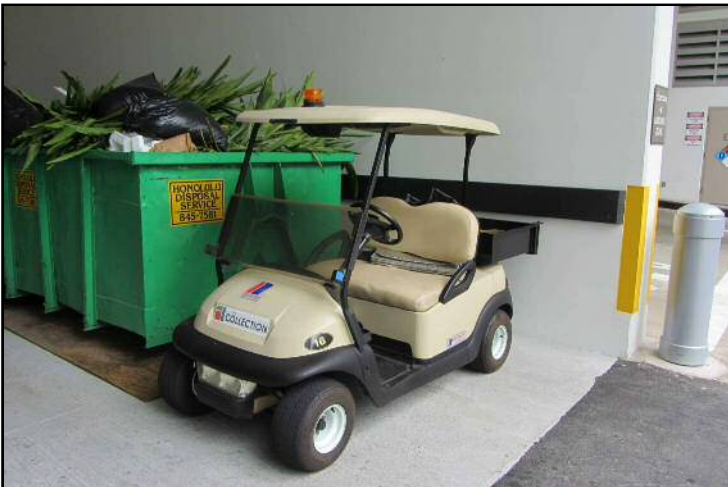
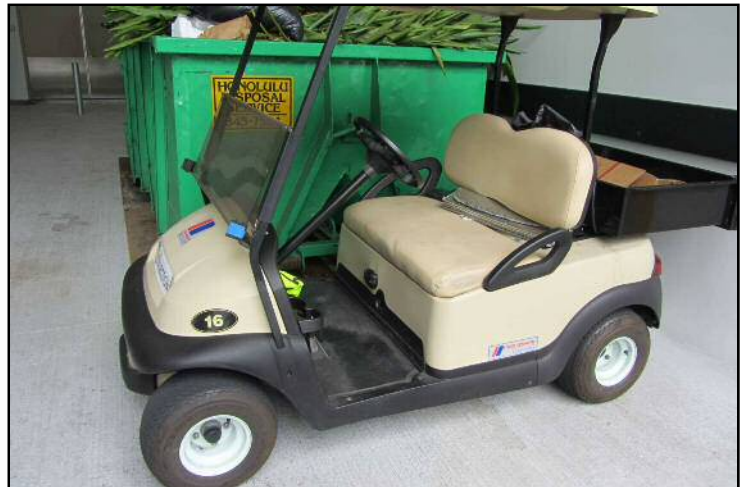
Component: 919 - Utility Vehicle - Replace
Location: Throughout property
Cost Source:
Best Case:
Worst Case:

Evaluation: Minimal replacement expense. Recommend handling under the Operating Budget.

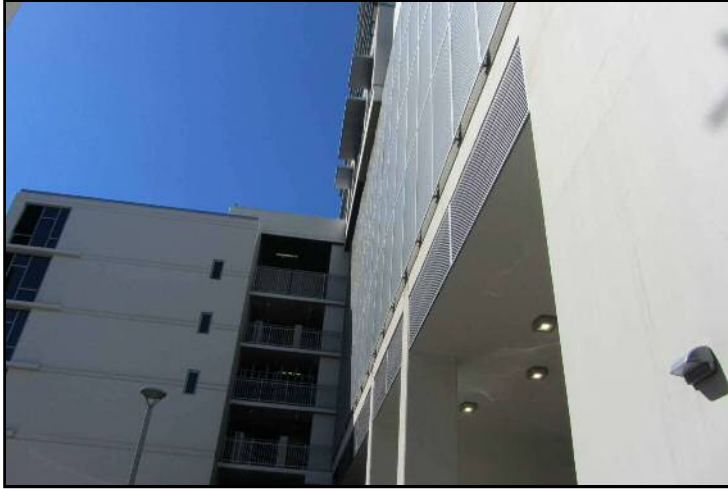
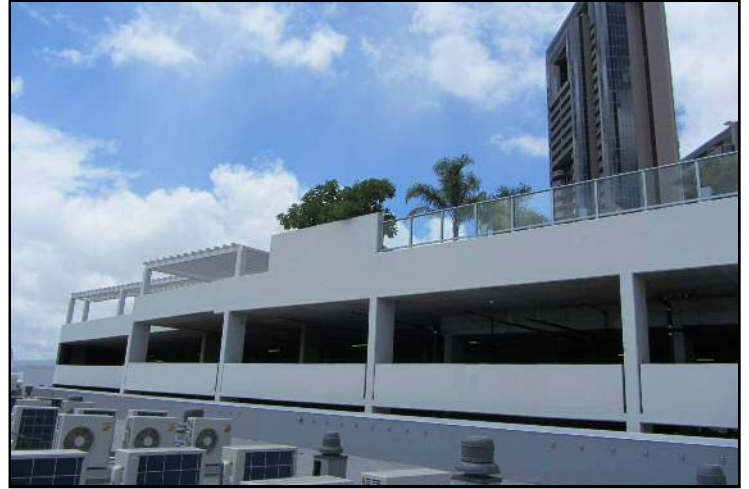
Component: 1002 - Exterior Concrete - Paint
Location: Exterior concrete surfaces of building
Cost Source: Akamai Reserves Cost Database
Best Case: \$1,100,000 Estimate to paint
Worst Case: \$1,400,000 Higher estimate to paint

Evaluation: Parking garage and service areas are in good attractive condition.

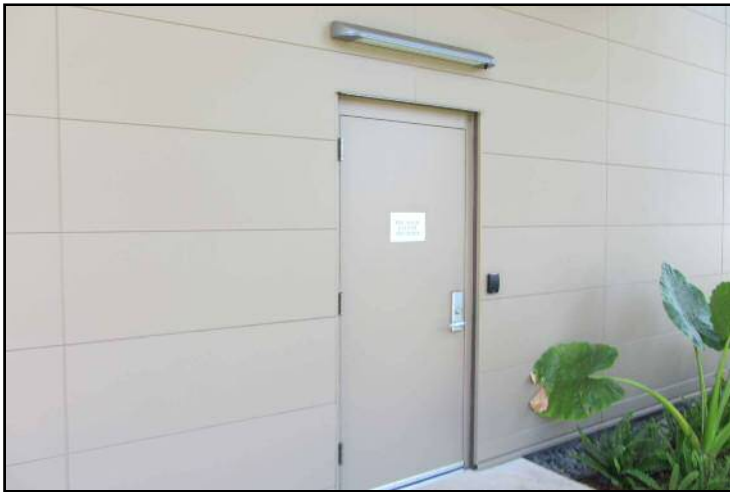
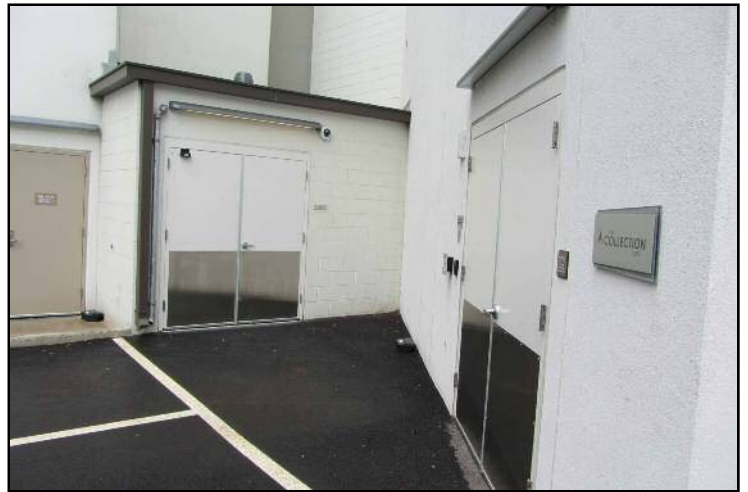
Component: 730 - Utility Doors - Replace

Evaluation: Metal doors are new and in good condition. Recommend replacement as needed as a small expense.

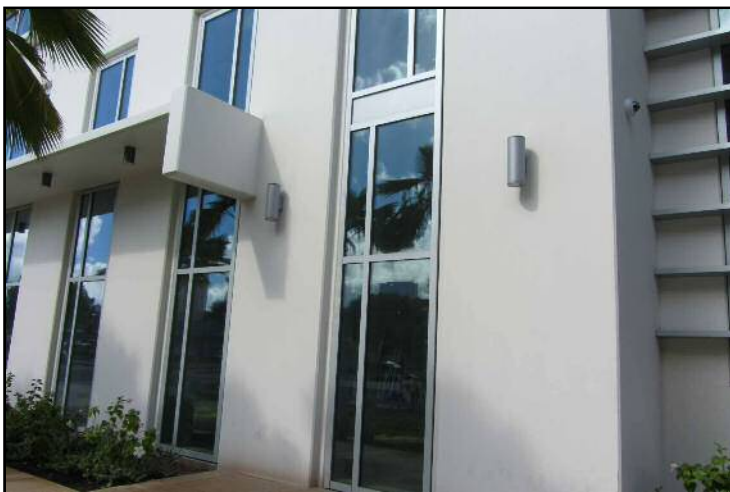
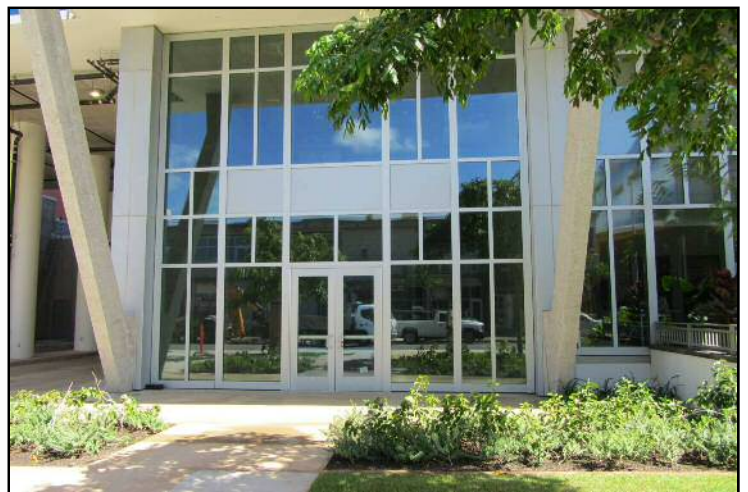
Component: 1025 - Window Seal - Test/Repair

Evaluation: Windows and doors are in good condition.

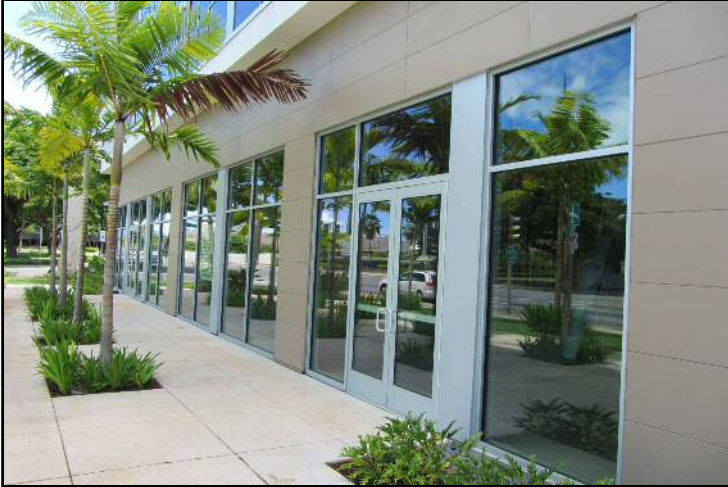
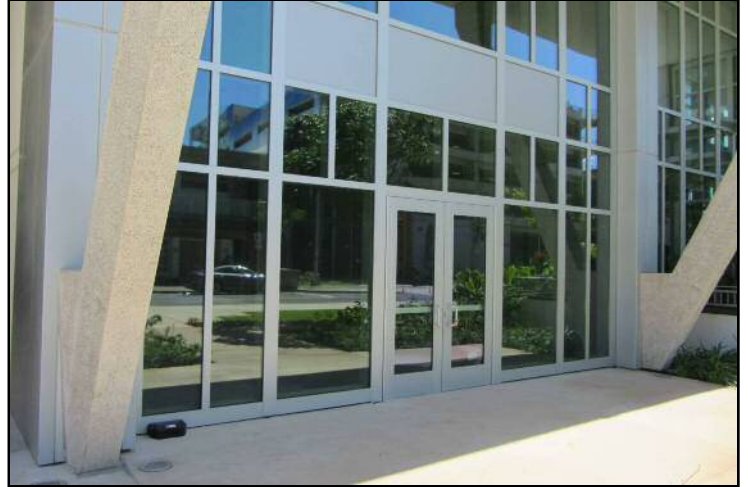
Component: 1026 - Window Seal - Replace
Location: Commerical unit windows/doors
Cost Source: Estimate provided by client
Best Case: \$35,895 Estimate to replace caulking
Worst Case: \$39,596 Higher estimate for additional labor

Evaluation: Windows and doors are in good condition.
