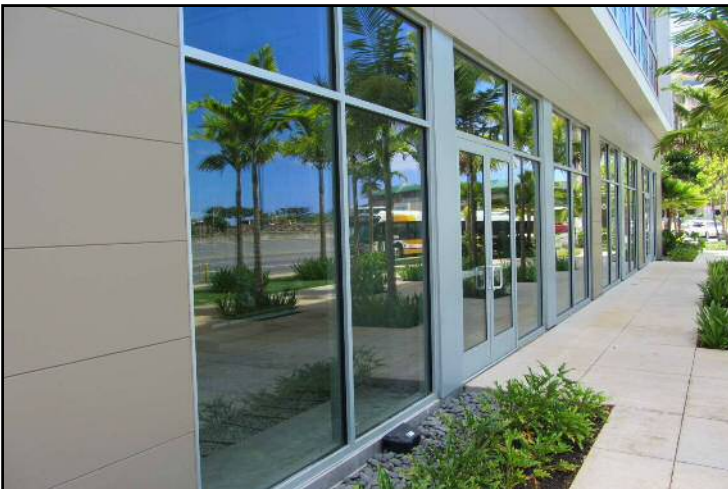
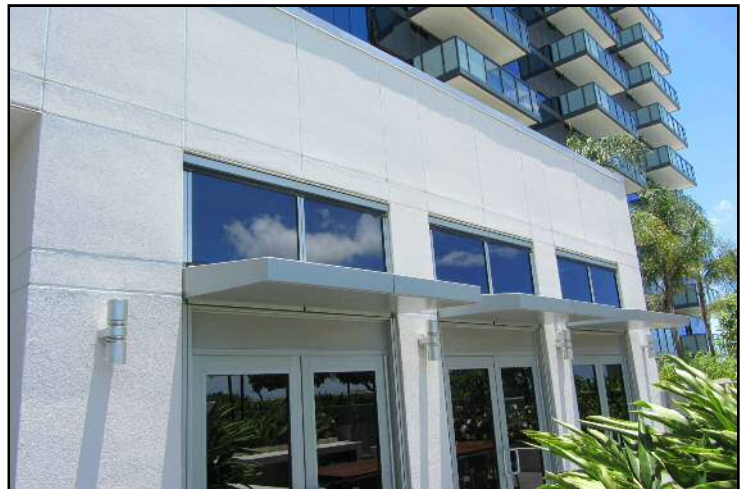
Component: 1070 - Glass Doors and Windows - Replace
Location: Unit entries
Cost Source: Budget estimate
Best Case: \$100,000 Estimate to replace
Worst Case: \$150,000 Higher estimate

Evaluation: Storefront doors and windows are in good condition.

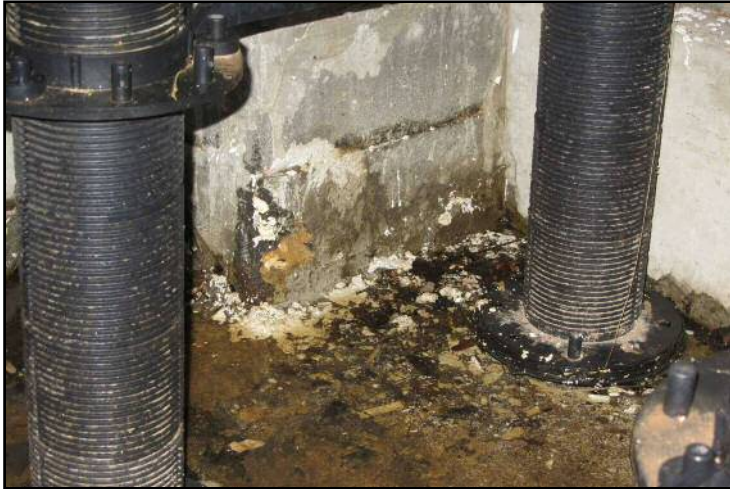
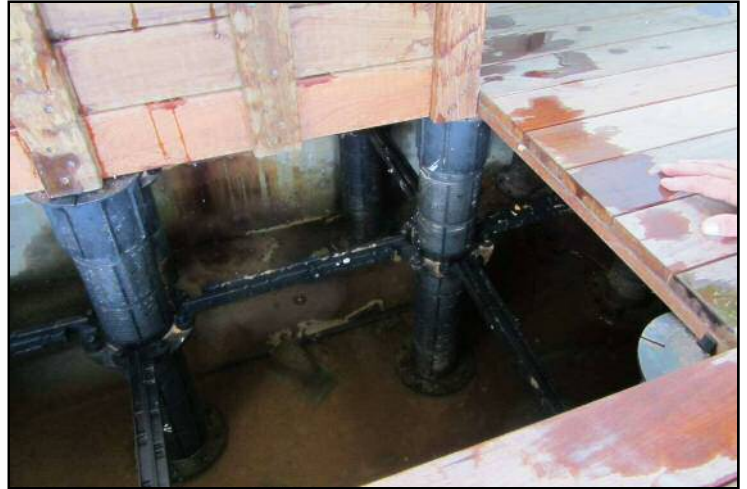
Component: 206 - Concrete Topping Slab - Replace/Repair
Location: 7th floor recreation deck
Cost Source:
Best Case:
Worst Case:

Evaluation: Topping slab under pool deck and stone pavers will be monitored for ponding and drainage by in-house staff.

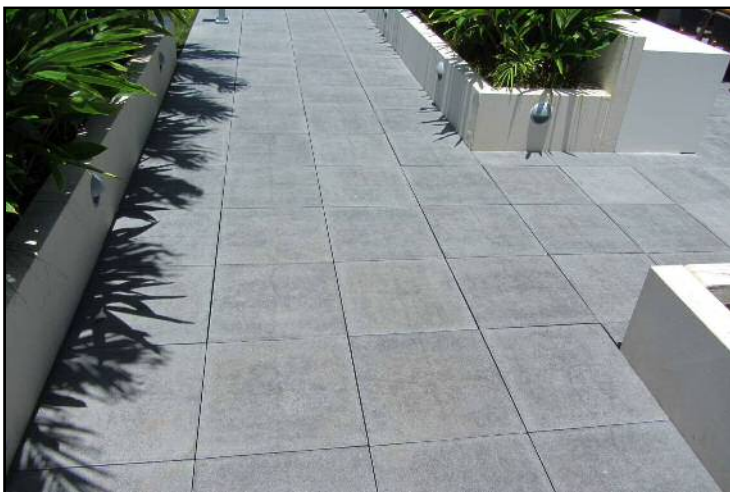
Component: 280 - 7th Floor Pavers - Replace
Location: 7th floor recreation deck
Cost Source: Akamai Reserves Cost Database
Best Case: \$111,250 Estimate to repair
Worst Case: \$133,500 Higher estimate for subsurface repairs

Evaluation: Tiles are new and in good condition. Recommend replacing broken tiles as needed under the Operating Budget as needed between full replacement.

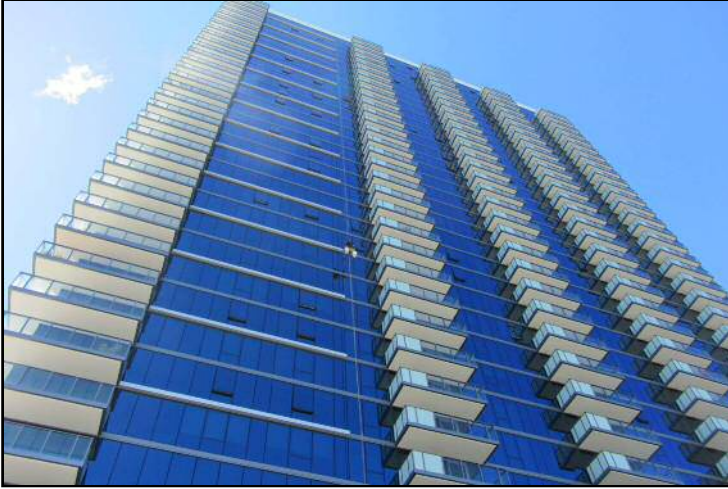
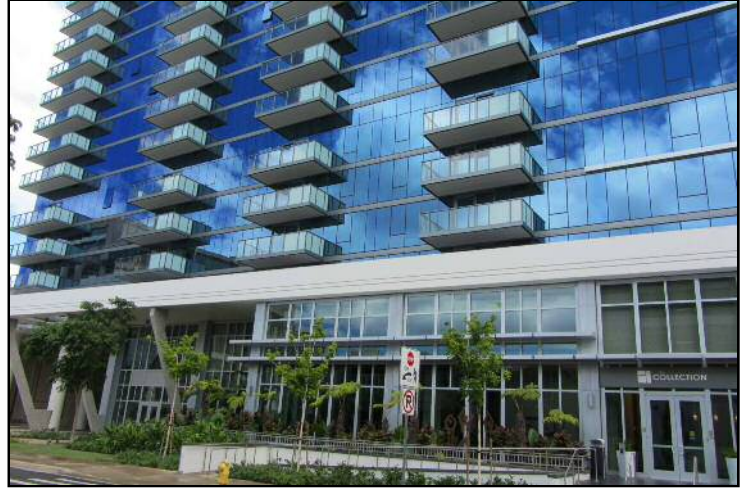
Component: 312 - Aluminum/Glass Handrail - Replace

Evaluation: Hand rails are new and in good condition. No issues reported.

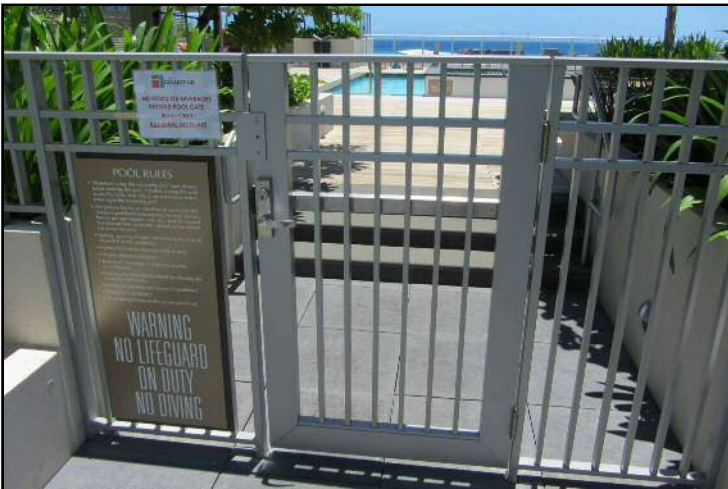
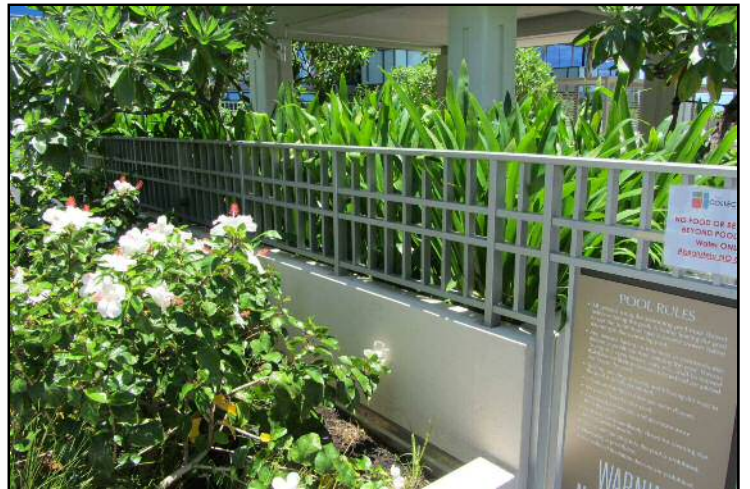
Component: 312 - Pool Handrail - Replace

Evaluation: Metal railing is new and in good functional condition.

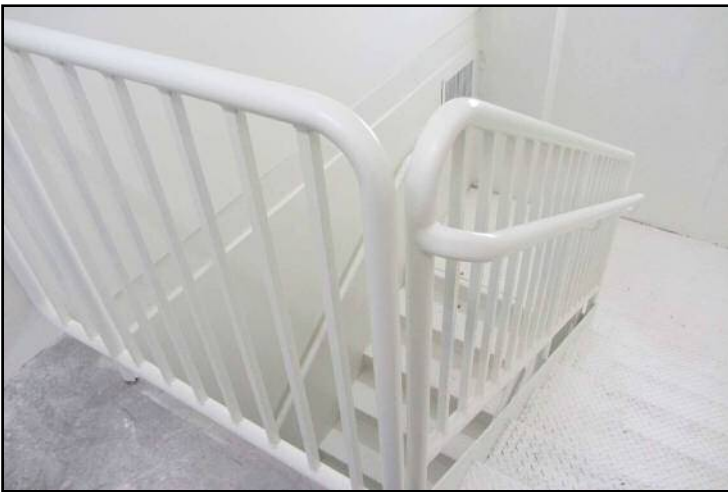
Component: 322 - Metal Hand Rail - Replace
Location: Building stairs
Cost Source:
Best Case:
Worst Case:

Evaluation: With painting and small repairs performed in-house these components are long life with no expectation for full replacement.

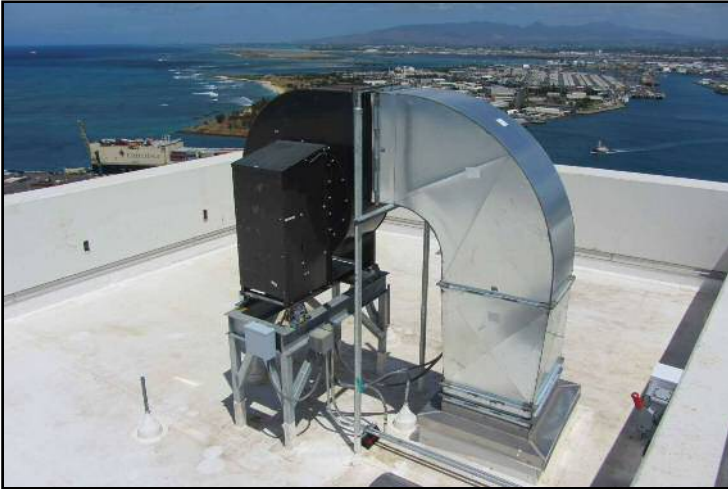
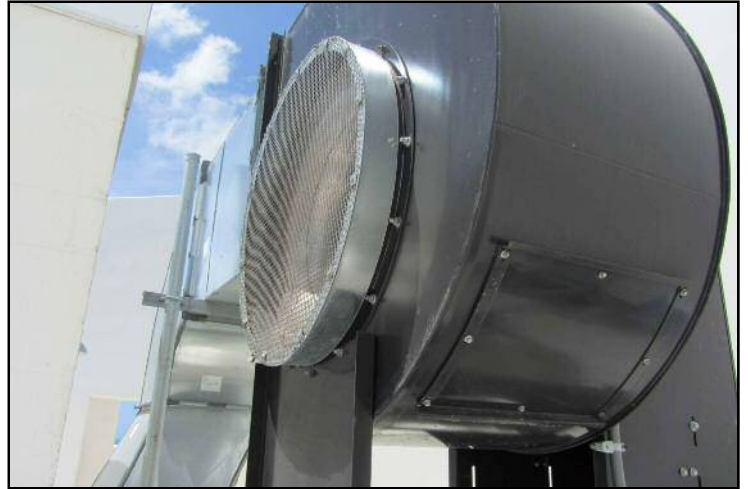
Component: 414 - Pressure Fan - Replace
Location: Tower roof top
Cost Source: Akamai Reserves Cost Database
Best Case: \$60,000 Estimate to replace fan and intake
Worst Case: \$75,000 Higher estimate

Evaluation: SPF units are in good functioning condition. Inspection and maintenance is handled under the Operating Budget.

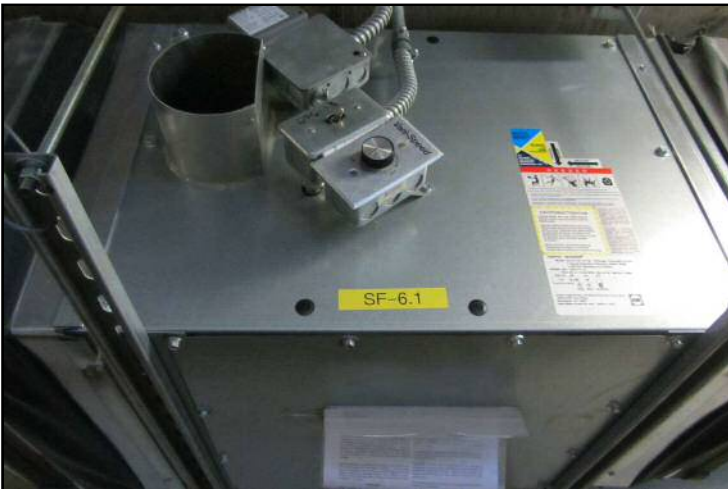
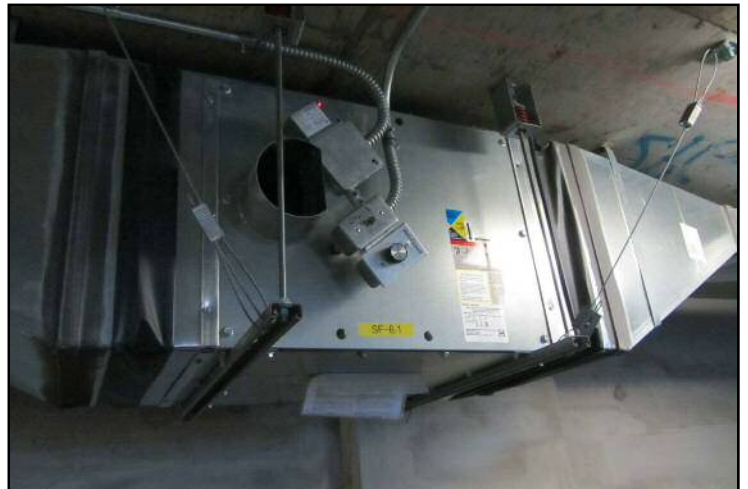
Component: 414 - Supply Fan - Replace
Location: Parking garage and 8th floor storage
Cost Source: Akamai Reserves Cost Database
Best Case: \$20,000 Estimate to replace fan and intake
Worst Case: \$40,000 Higher estimate

Evaluation: Supply fan units are in good functioning condition. Inspection and maintenance is handled under the Operating Budget.

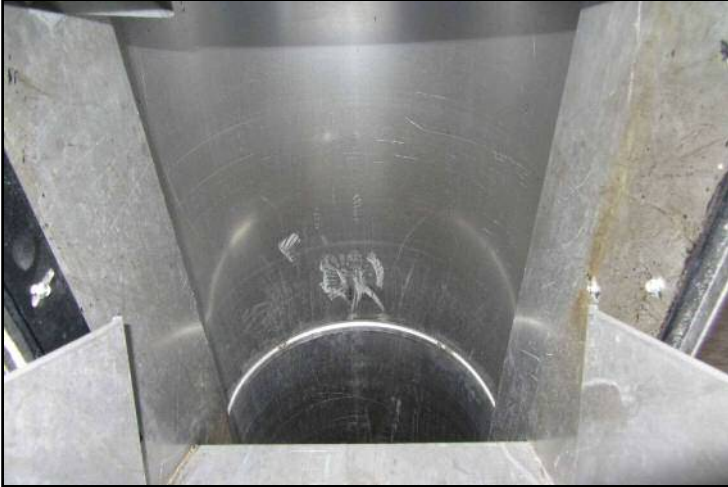
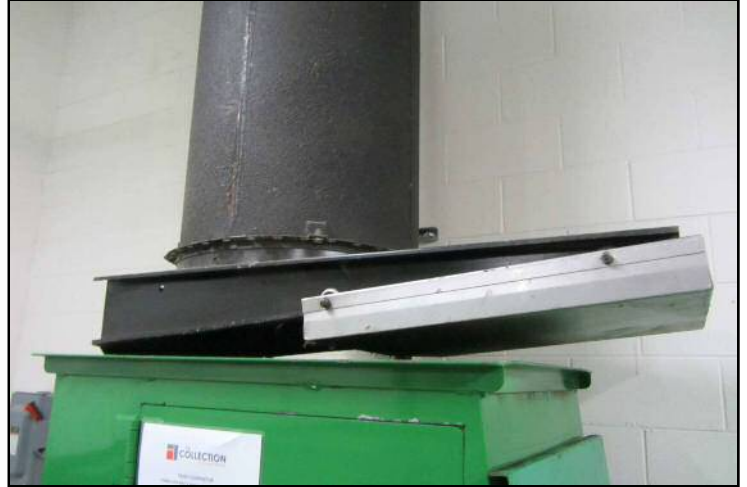
Component: 416 - Trash Chute - Partial Replace

Evaluation: Trash chute is new and in good condition.

Recommend planning for partial replacement of heavy used lower sections. Cleaning and maintenance under the Operating Budget.

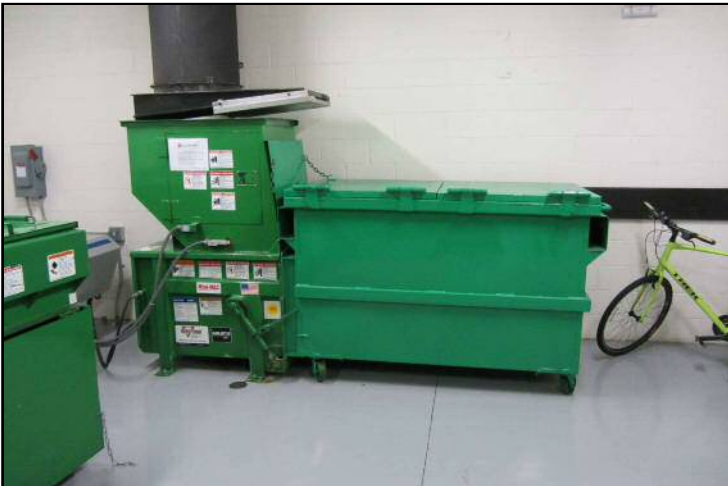
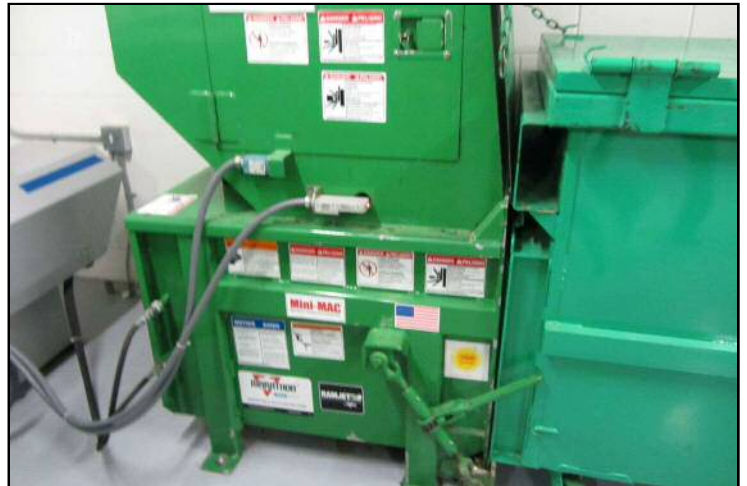
Component: 417 - Trash Compactor - Replace

Evaluation: Marathon compactor was manufactured in 2016. System reported to be functional and in good condition.

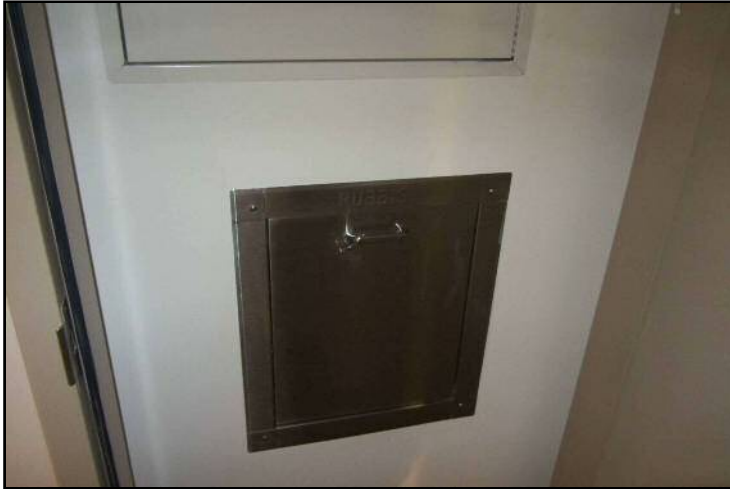
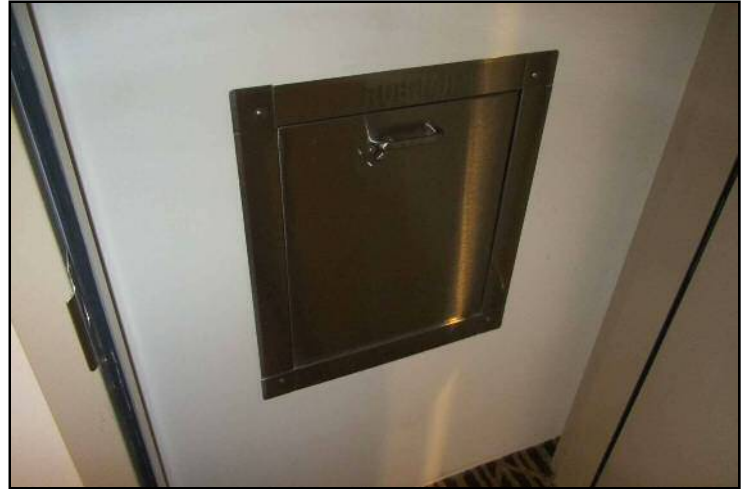
Component: 418 - Trash Doors - Partial Replace
Location: 43rd to 3rd floors
Cost Source:
Best Case:
Worst Case:

Evaluation: Doors are new and in good functional condition. Recommend partial replacement as needed under the Operating Budget.

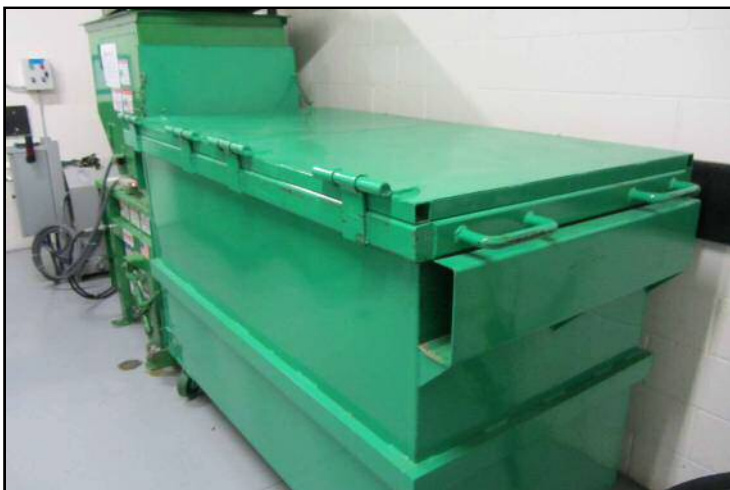
Component: 419 - Trash Compactor Bins - Replace
Location: Level 1 trash room
Cost Source: Estimate provided by client
Best Case: \$12,900 Estimate to replace unit
Worst Case: \$15,000 Higher estimate

Evaluation: Compactor bins are reported to be functional and in good condition.

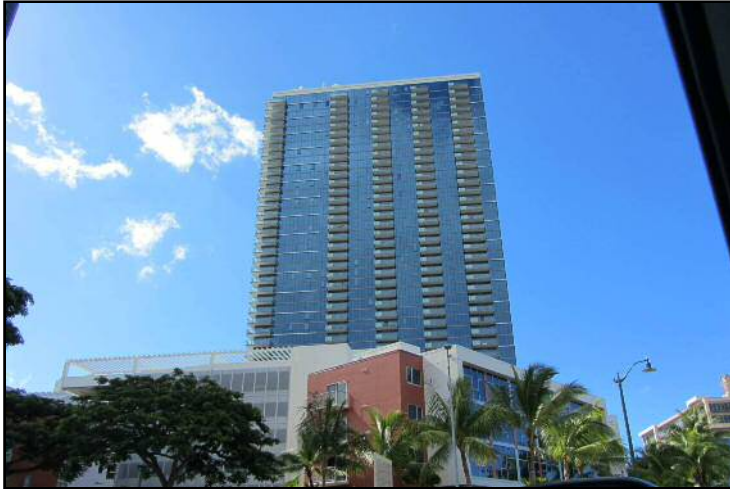
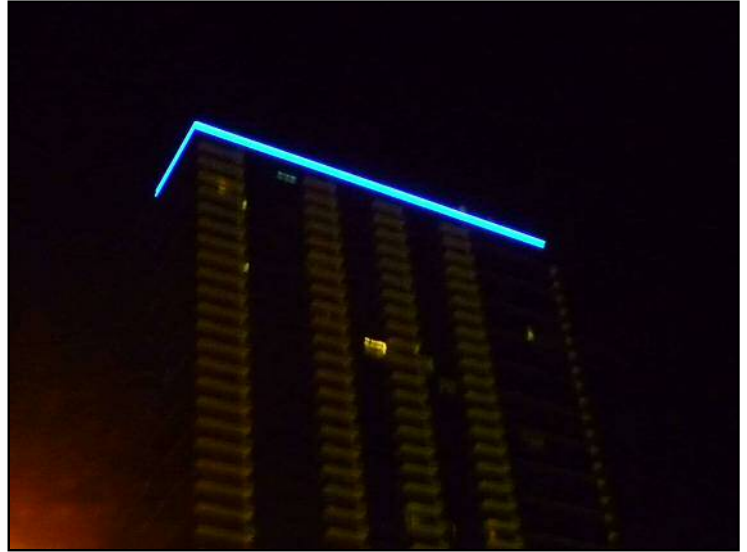
Component: 425 - Crown Lighting - Replace

Evaluation: LED lighting system on crown is new and reported to be in good functional condition.

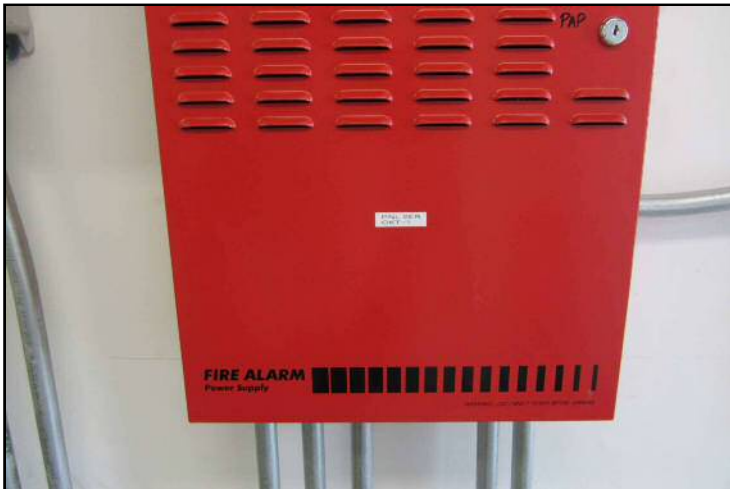
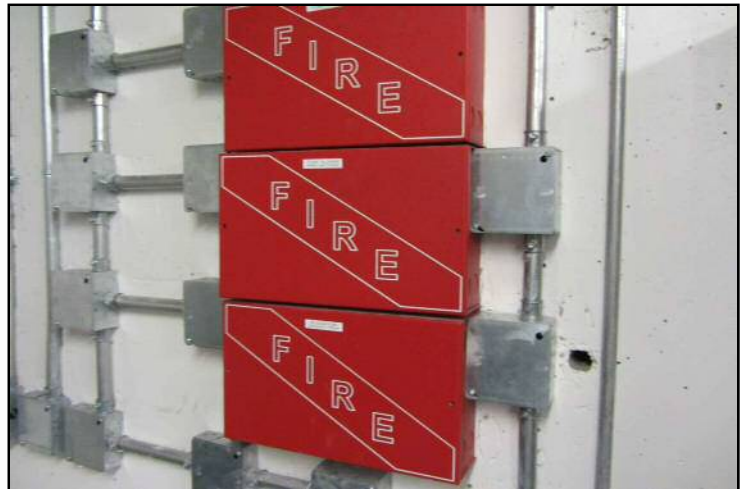
Component: 430 - Fire Alarm System - Replace/Upgrade

Evaluation: Recently installed modern system is report in good functional condition. Routine inspection and maintenance handled under the Operating Budget. System upgrade costs are undetermined at this time.

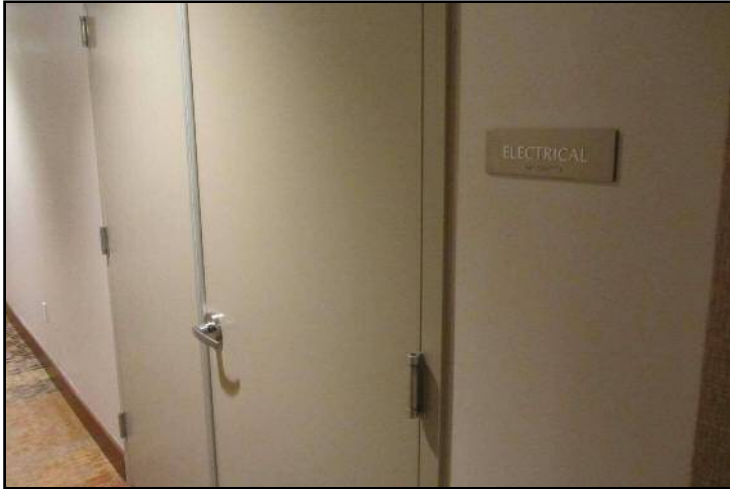
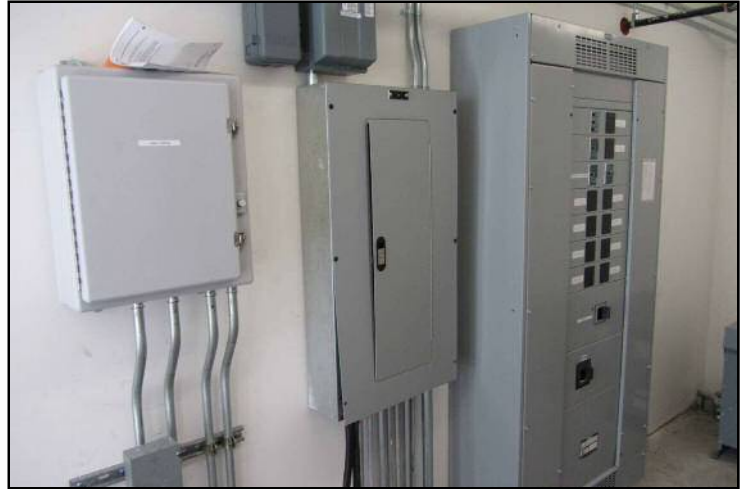
Component: 431 - Electrical Panels - Inspect/Repair
Location: All Tower common electrical switches and panels
Cost Source: Budget estimate
Best Case: \$9,000 Estimate to inspect and repair
Worst Case: \$11,000 Higher estimate for more repairs

Evaluation: Electrical panels are heat scanned on this cycle. Eventual full electrical system upgrade may be required. Inspection and routine testing will help develop upgrade plan as system ages.

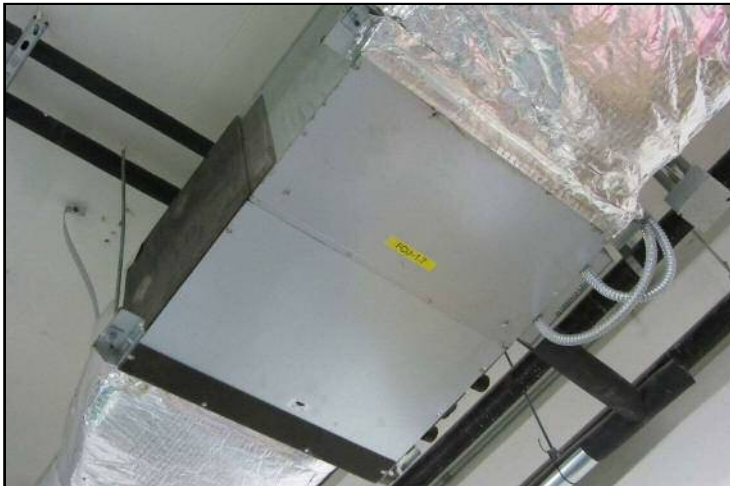
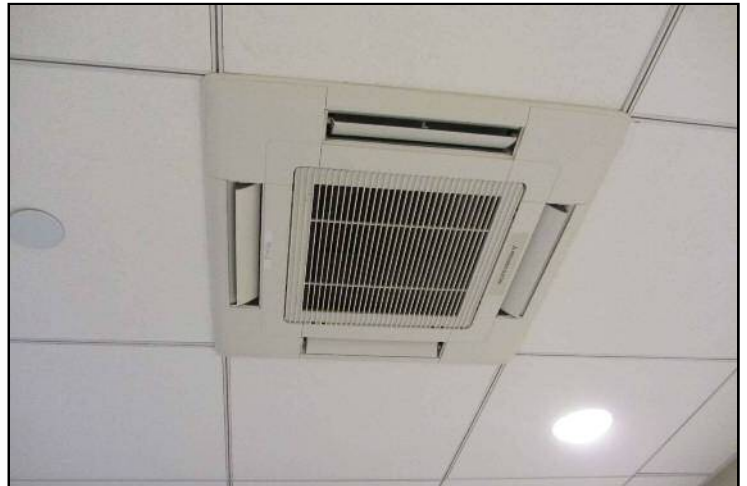
Component: 436 - Fan Coil - Replace
Location: Units are located inside building
Cost Source: Akamai Reserves Cost Database
Best Case: \$33,000 Estimate for similar unit
Worst Case: \$35,200 Higher estimate

Evaluation: Fan coils are in good functional condition.

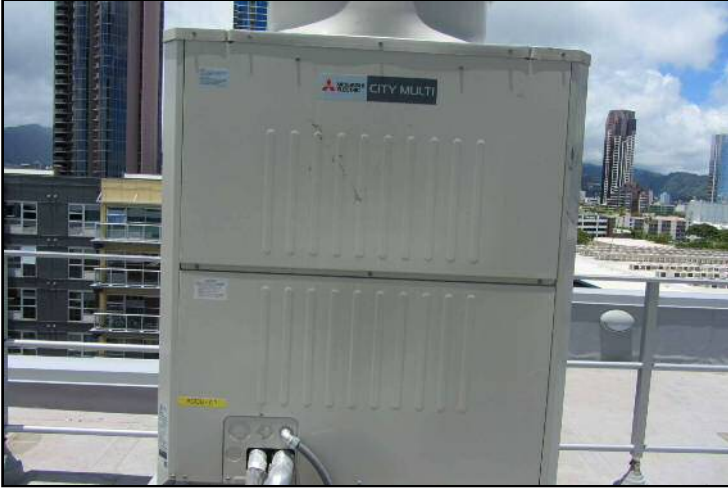
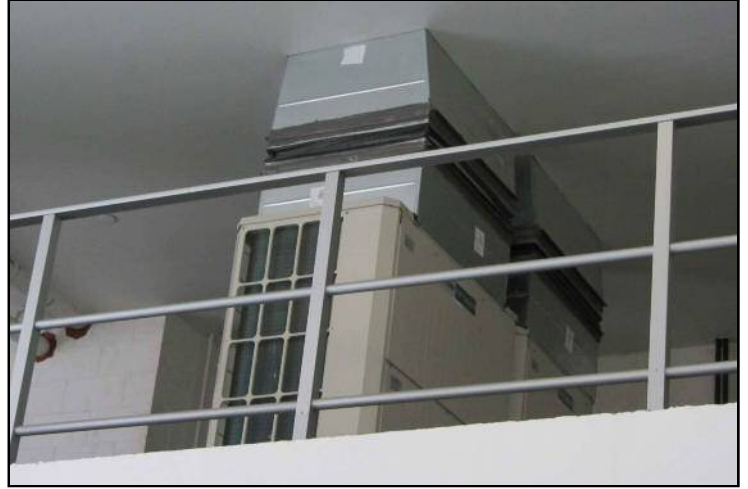
Component: 437 - Condenser - Replace
Location: Annex roof and mechanical area
Cost Source: Akamai Reserves Cost Database
Best Case: \$10,000 Estimate to replace
Worst Case: \$16,000 Higher estimate

Evaluation: Condensers are in good functional condition.

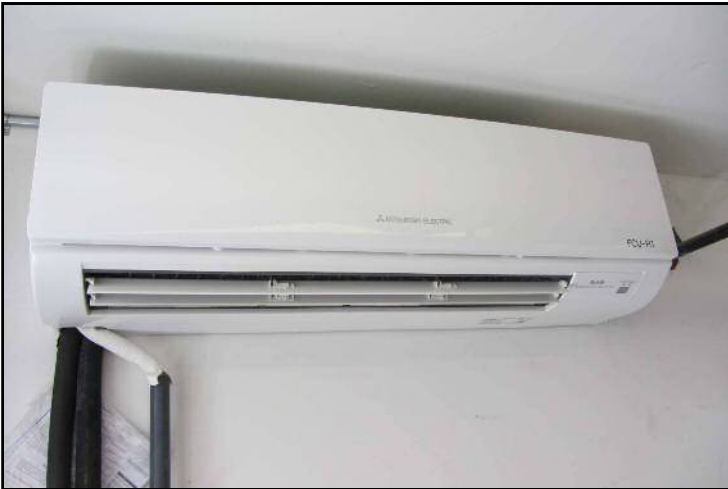
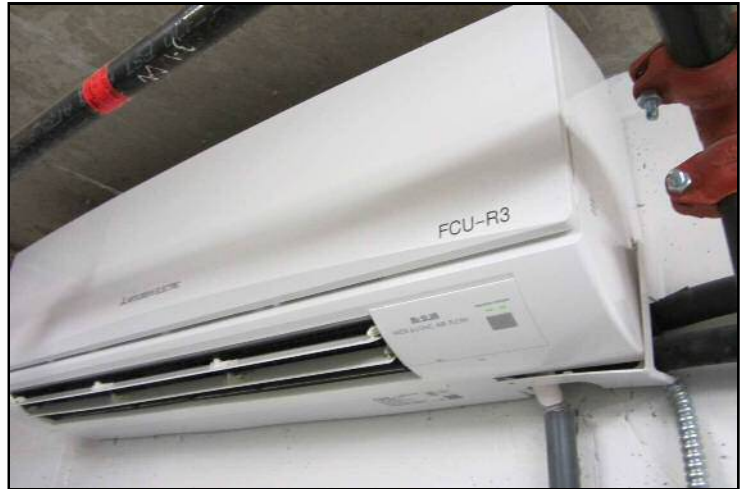
Component: 438 - Split System Fan - Replace
Location: Mechanical rooms
Cost Source: Akamai Reserves Cost Database
Best Case: \$12,000 Estimate to replace
Worst Case: \$13,400 Higher estimate

Evaluation: AC units are in good functional condition.

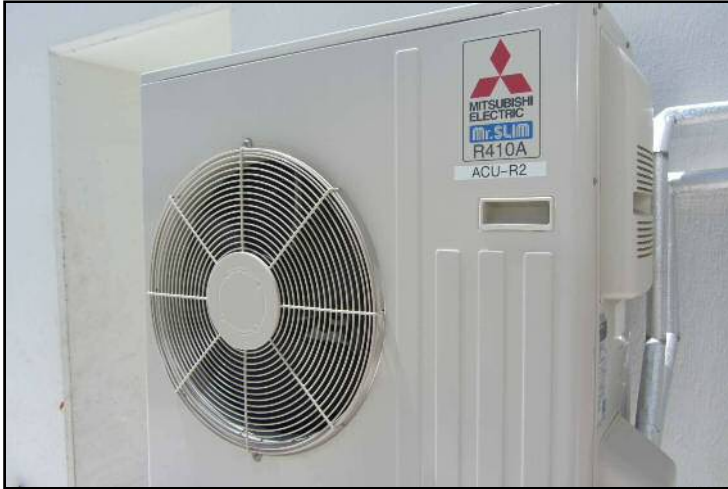
Component: 439 - Spit System Condenser - Replace
Location: Mechanical rooms
Cost Source: Akamai Reserves Cost Database
Best Case: \$12,000 Estimate to replace
Worst Case: \$13,400 Higher estimate

Evaluation: AC units are in good functional condition.

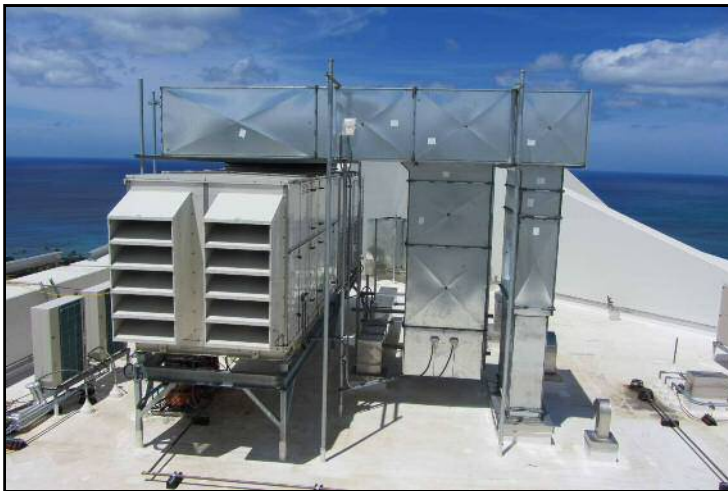
Component: 441 - Outdoor Air Handler - Replace
Location: Building Roof
Cost Source: Budget estimate
Best Case: \$750,000 Estimate to replace
Worst Case: \$1,000,000 Higher estimate

Evaluation: Unit is Quarterly and Monthly inspected and repairs are performed as needed under the Operating Budget. Additional information for future replacement needed.

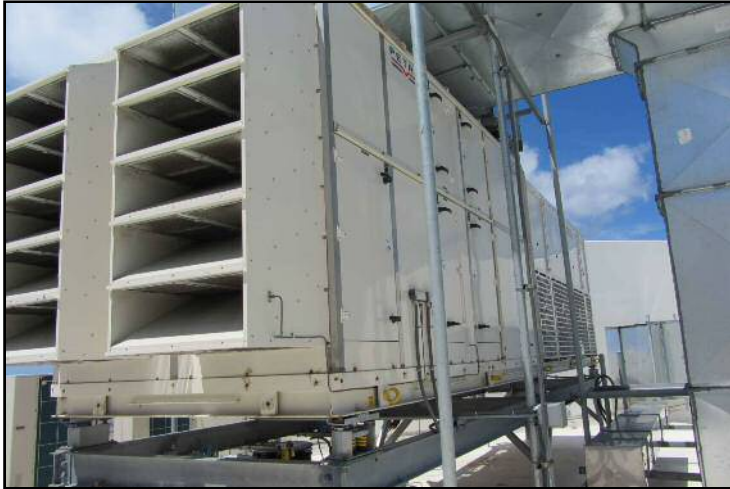
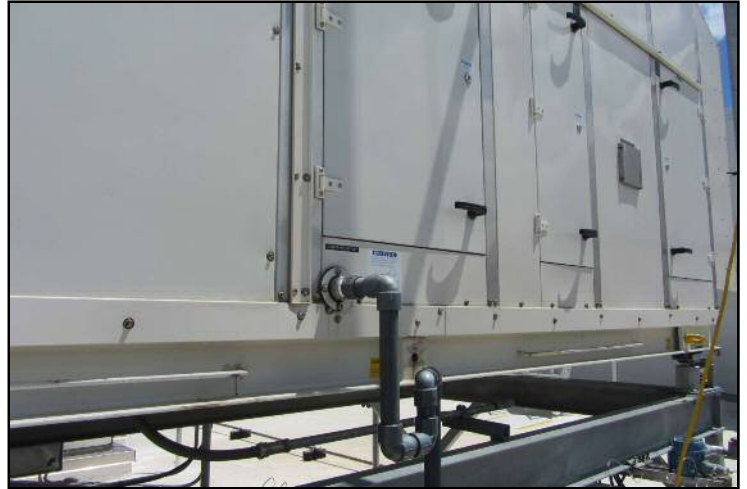
Component: 442 - Compressor - Replace
Location: Inside rooftop unit
Cost Source: Akamai Reserves Cost Database
Best Case: \$14,000 Estimate to replace
Worst Case: \$15,000 Higher estimate

Evaluation: Compressors are reported in good functional condition.

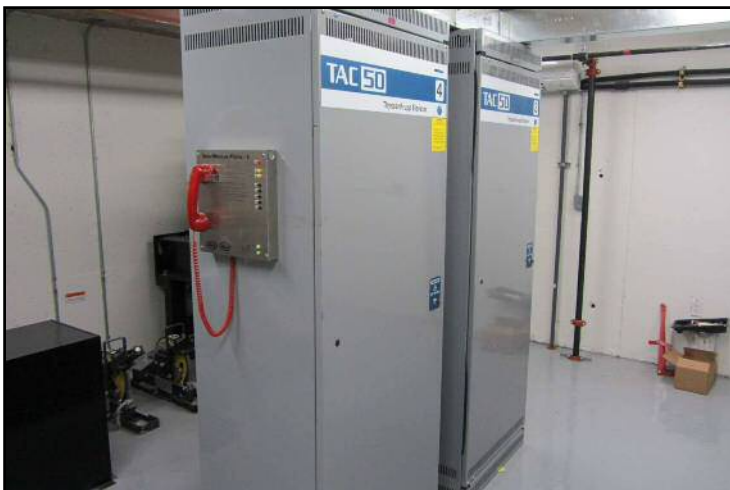
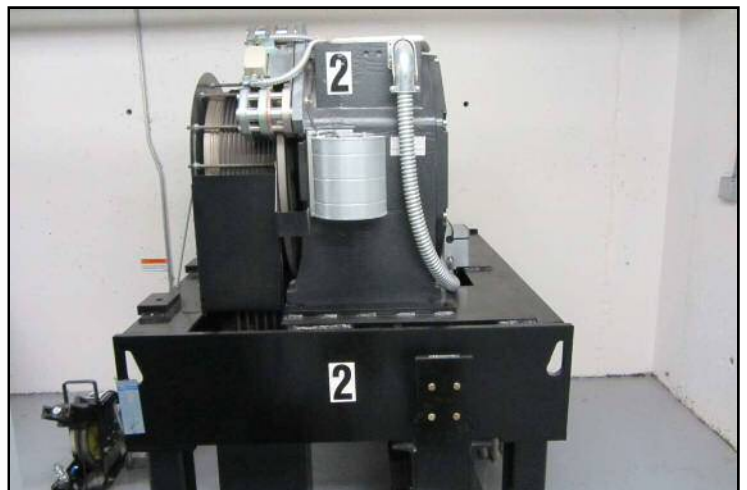
Component: 450 - Elevator - Modernize
Location: Center of Tower
Cost Source: Research with local contractor/vendor
Best Case: \$1,400,000 \$350,000/Elevator; Estimate for modernization
Worst Case: \$1,500,000 \$375,000/Elevator; Higher estimate

Evaluation: New TAC50 ThyssenKrupp elevators are in good condition.

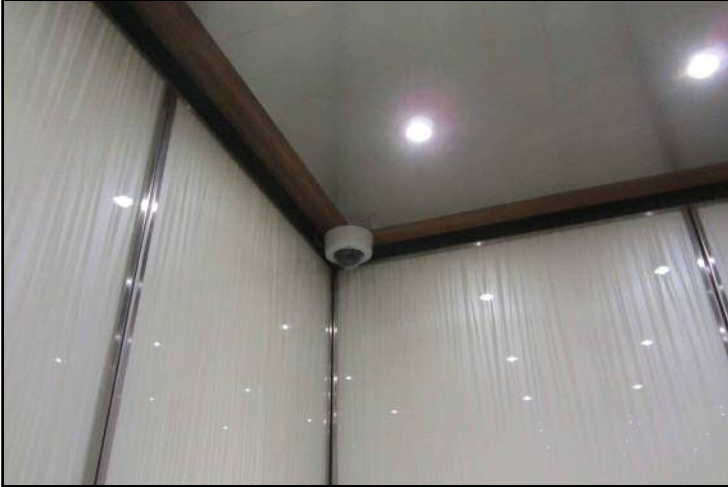
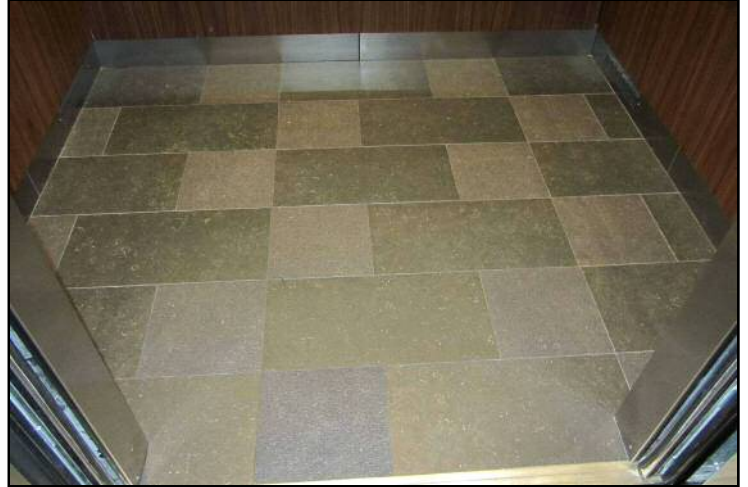
Component: 451 - Elevator Cab - Remodel

Evaluation: Interiors are new and in good condition.

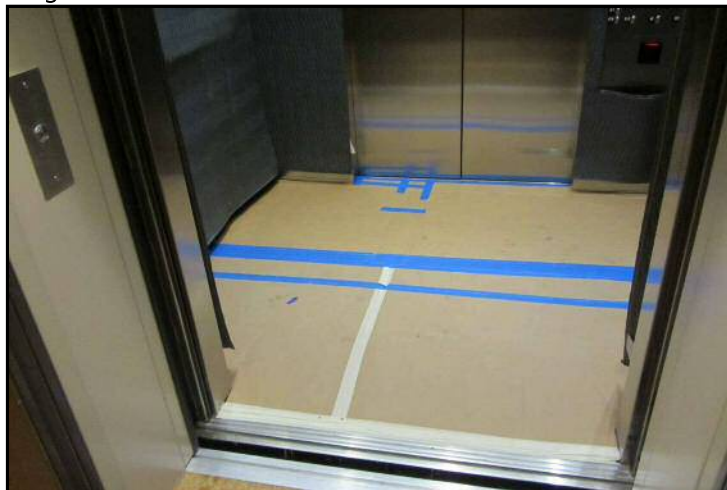
Component: 452 - Elevator - Realign/Leveling

Evaluation: Reported the elevators require routine floor scan and realigning/re-leveling of landing vanes as concrete compresses.

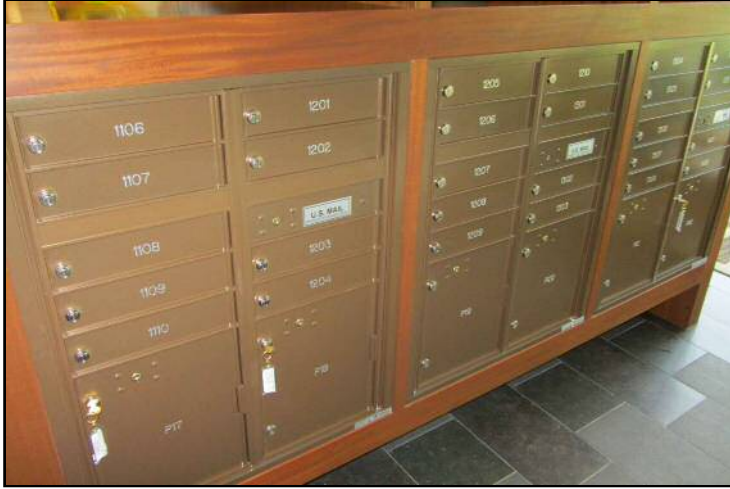
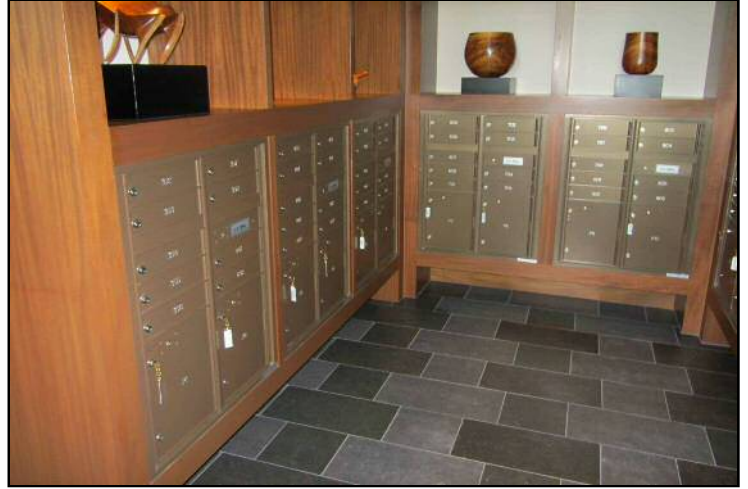
Component: 501 - Mailboxes - Replace
Location: Lobby
Cost Source: Akamai Reserves Cost Database
Best Case: \$75,000 Estimate to replace kiosks
Worst Case: \$105,000 Higher estimate

Evaluation: Mailboxes are not exposed outdoors and will have an extended Useful life. Units are new and in good condition.

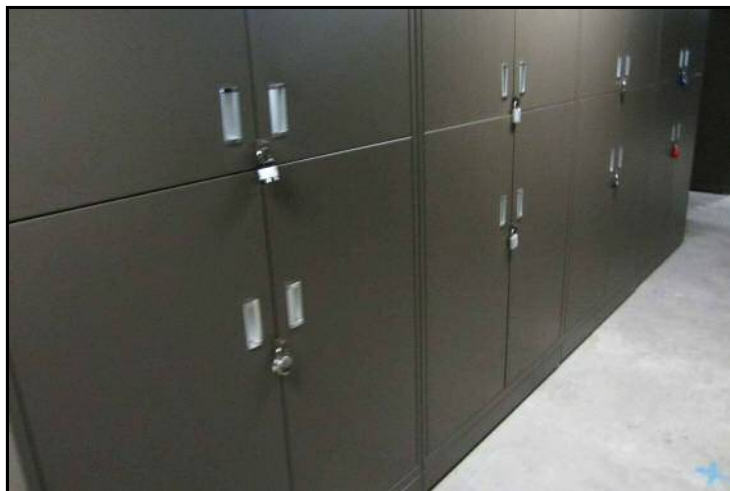
Component: 514 - Storage Lockers - Replace
Location: Storage Areas
Cost Source:
Best Case:
Worst Case:

Evaluation: Lockers are in good functional condition. Maintenance and replacement under the Operating Budget as needed.

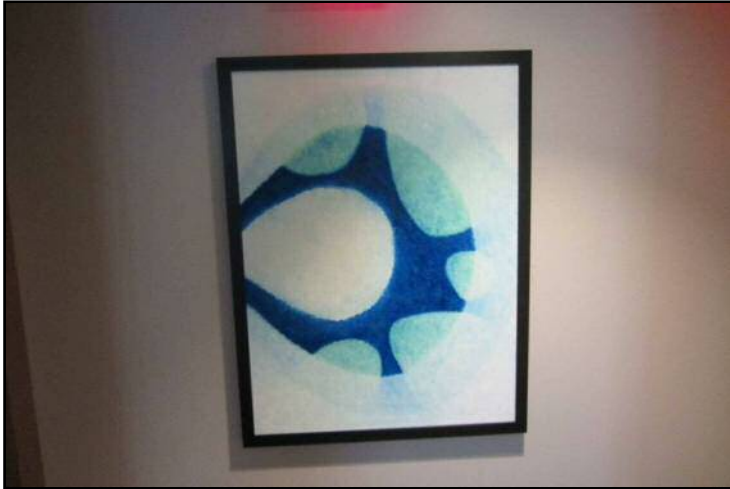
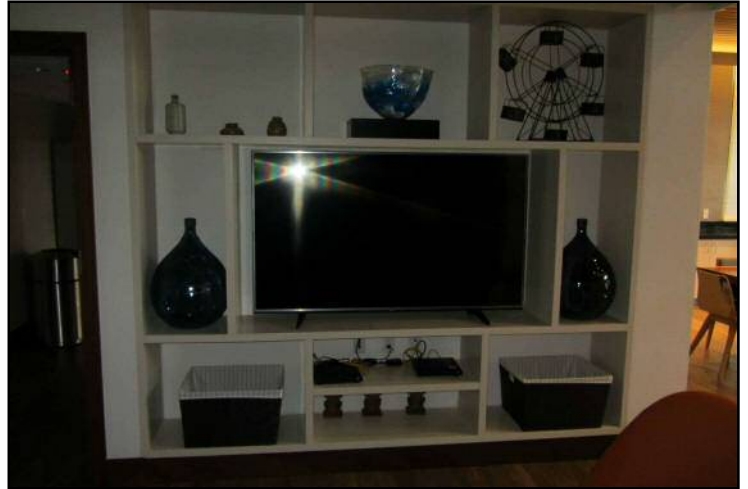
Component: 515 - Artwork - Replace
Location: Throughout building
Cost Source: Client Cost History
Best Case: \$200,000 Estimate to replace
Worst Case: \$220,000 Higher estimate

Evaluation: Artwork allowance for future replacement based on invoice.

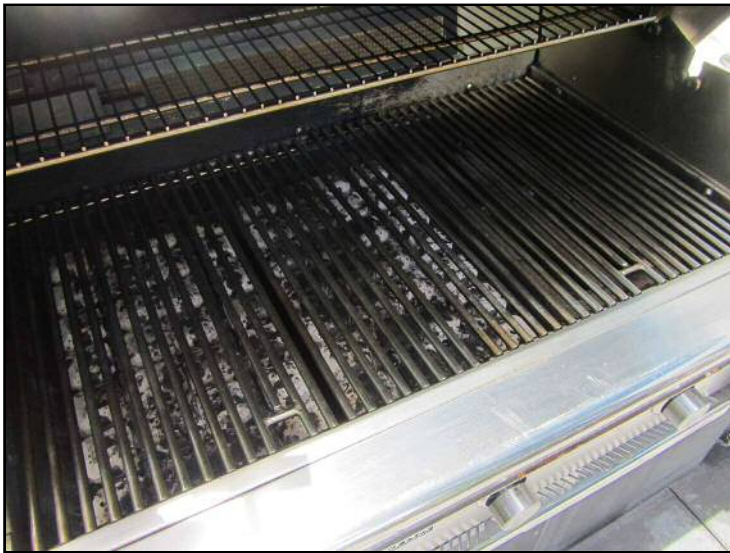
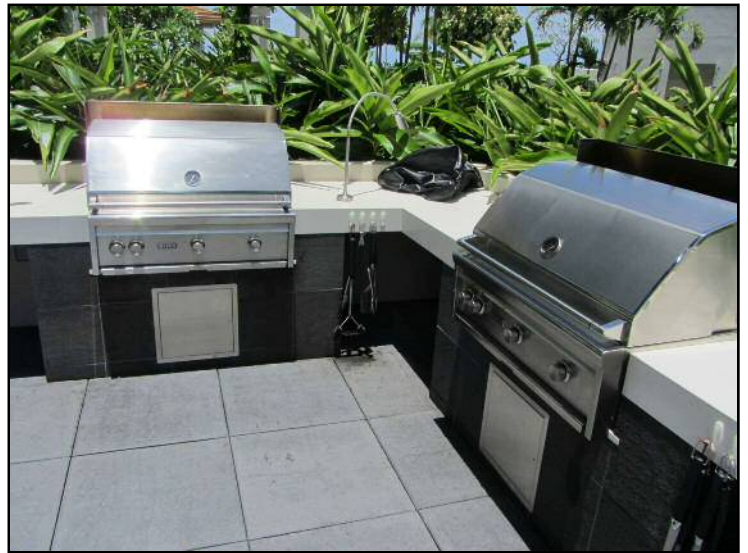
Component: 541 - BBQ - Replace
Location: 7th floor recreation area
Cost Source:
Best Case:
Worst Case:

Evaluation: BBQs are maintained by in-house staff under the Operating Budget.

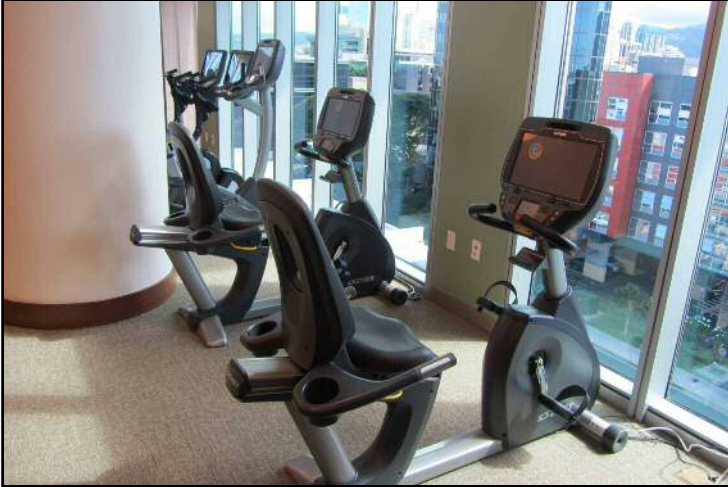
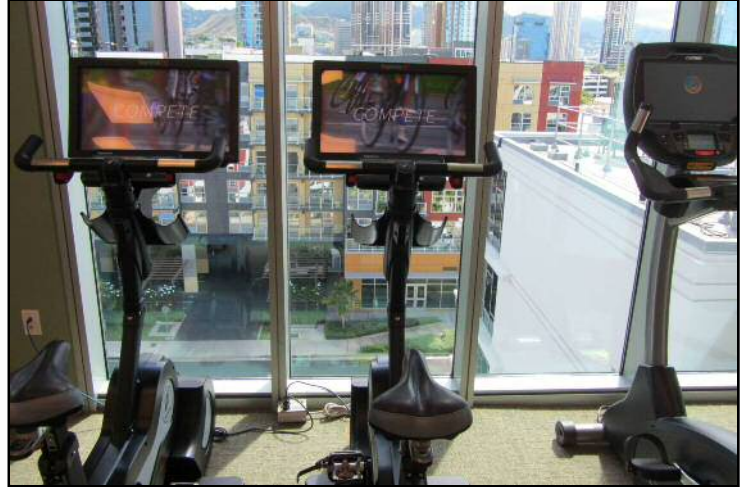
Component: 542 - Exercise Equipment - Replace
Location: Exercise room
Cost Source: Research with local contractor/vendor
Best Case: \$210,805 Estimate to replace
Worst Case: \$237,500 Higher estimate

Evaluation: Exercise equipment is in good functional condition. Cost based on full replacement.

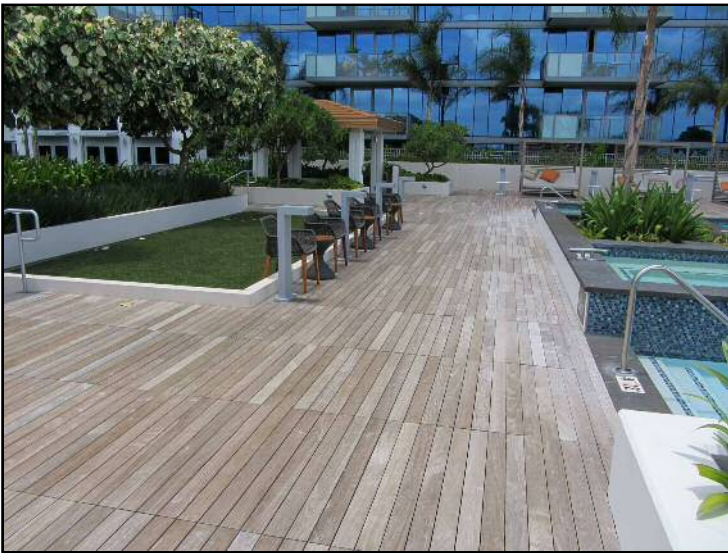
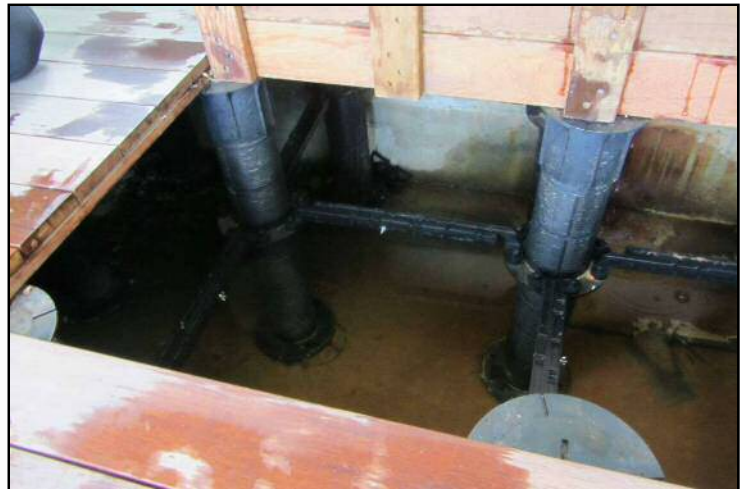
Component: 552 - Pool Teak Deck - Replace
Location: Pool deck
Cost Source: Akamai Reserves Cost Database
Best Case: \$73,000 Estimate to replace teak
Worst Case: \$127,750 Higher estimate

Evaluation: Teak decking is in good attractive condition.

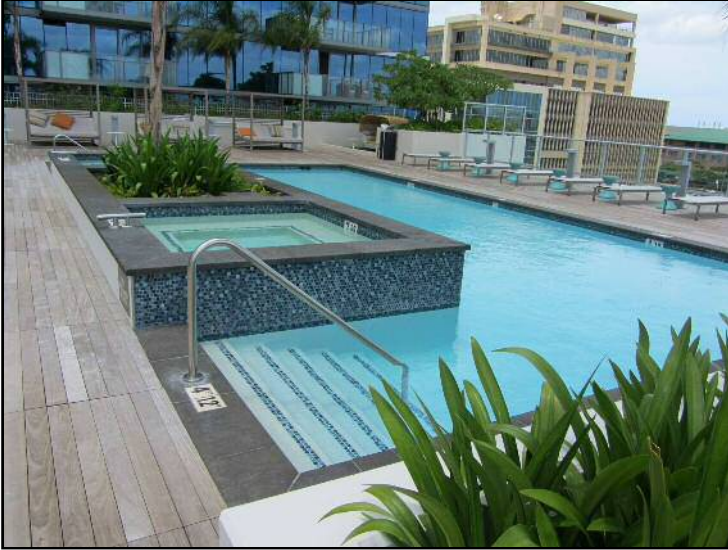
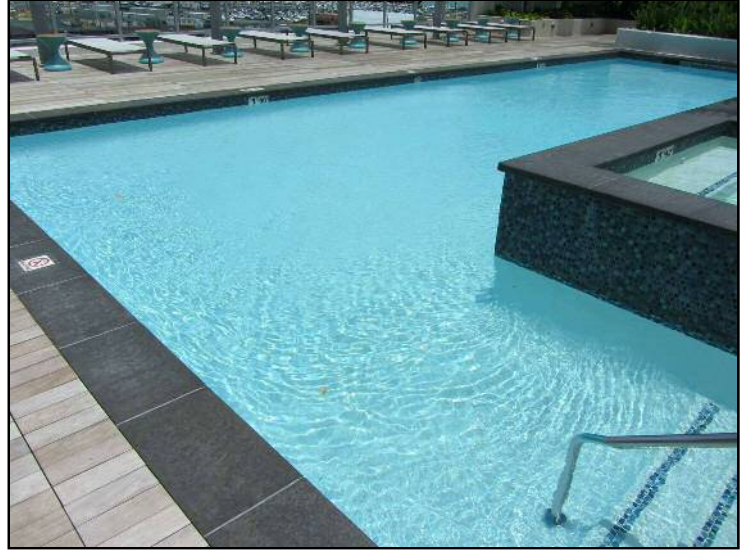
Component: 555 - Pool - Resurface
Location: Pool area; 7th floor
Cost Source: Akamai Reserves Cost Database
Best Case: \$30,000 Estimate to resurface
Worst Case: \$35,000 Higher estimate

Evaluation: Pool surface is new and in good condition.

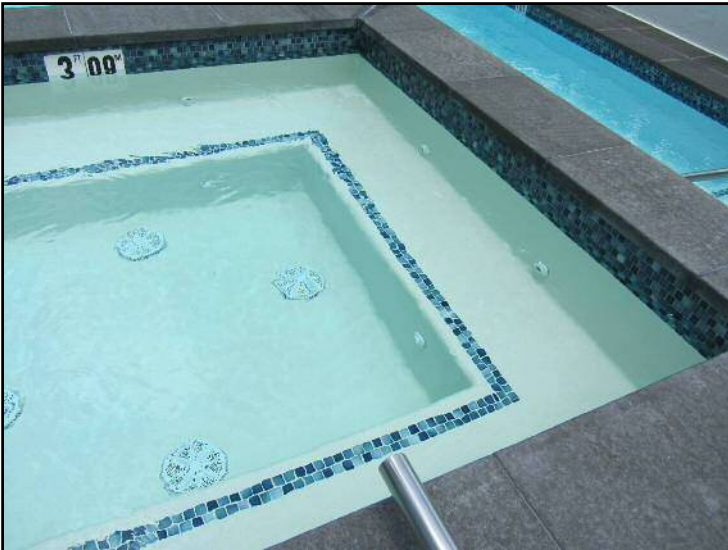
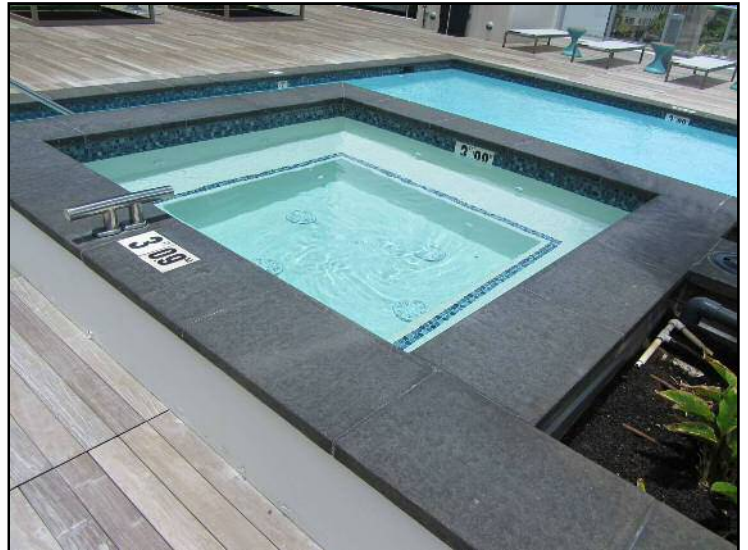
Evaluation: Spas are new and in good condition.
