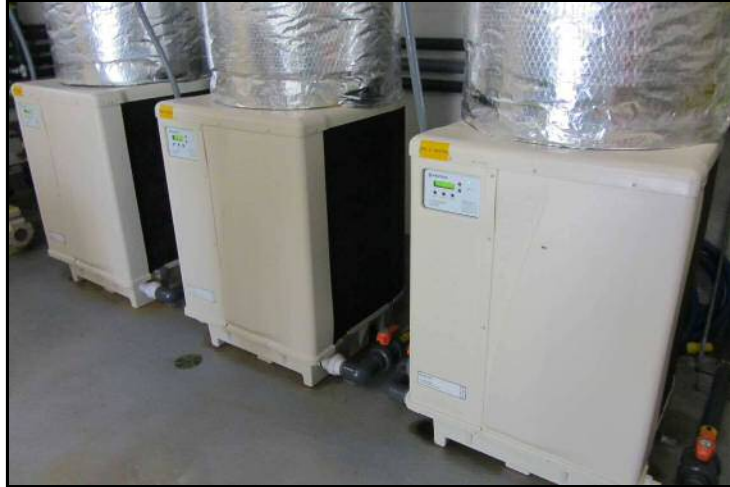
Component: 562 - Pool Heater - Gas - Replace

Evaluation: Electric heaters planned for replacement with gas heaters in 2017.

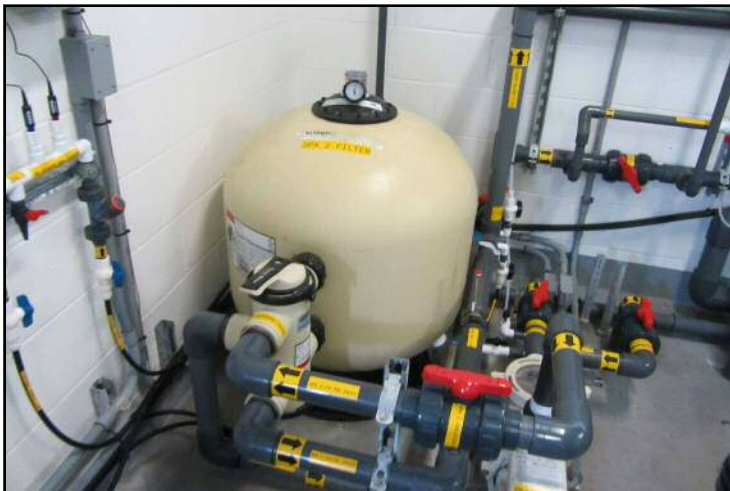
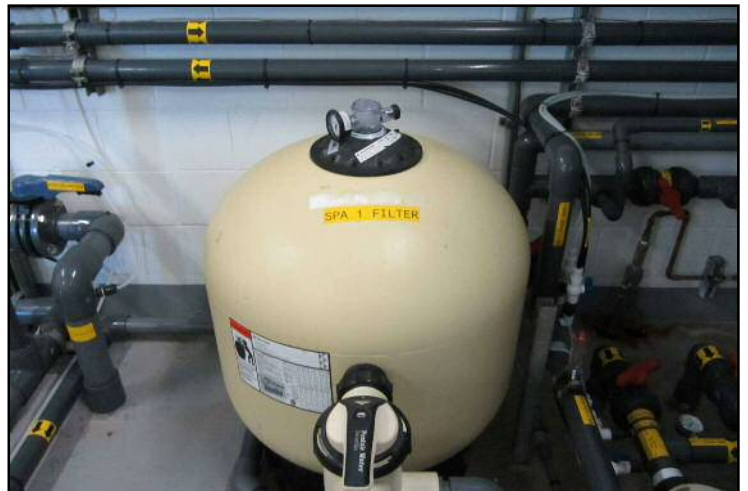
Component: 563 - Pool/Spa Filter - Replace

Evaluation: Filters are in good functional condition.

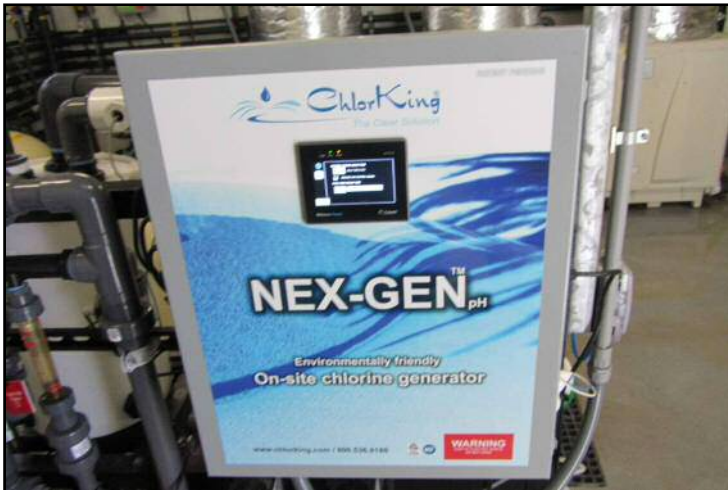
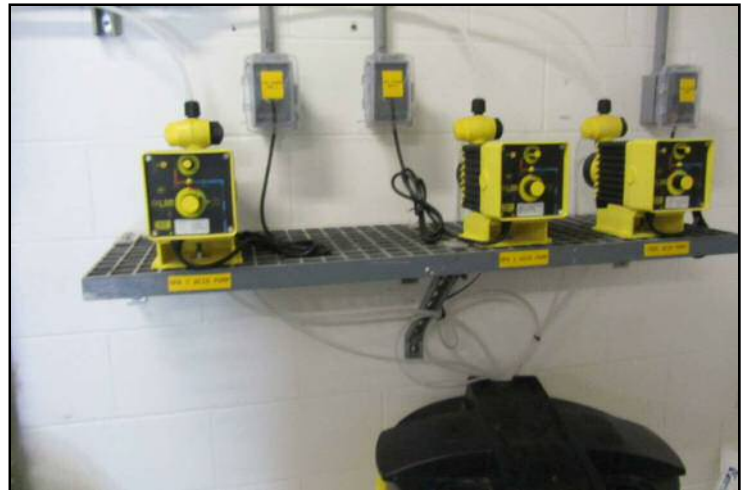
Component: 564 - Pool Ph & Cl Control - Replace
Location: Pool equipment room, 7th floor
Cost Source: Akamai Reserves Cost Database
Best Case: \$12,500 Estimate to replace
Worst Case: \$17,500 Higher estimate

Evaluation: Chemical control system is functional and in good condition.

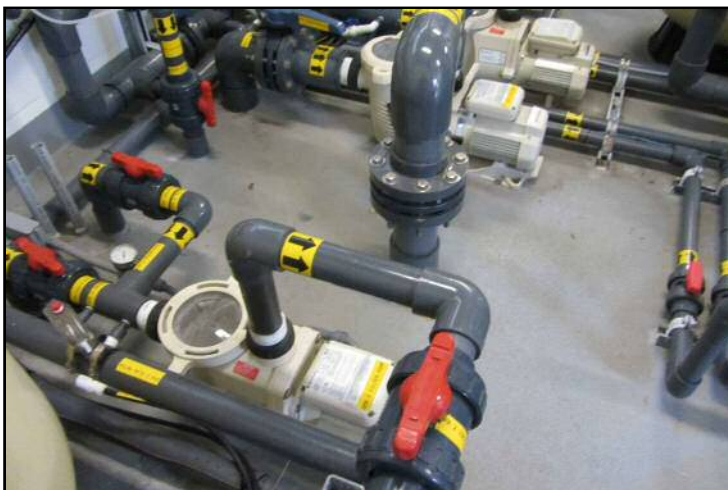
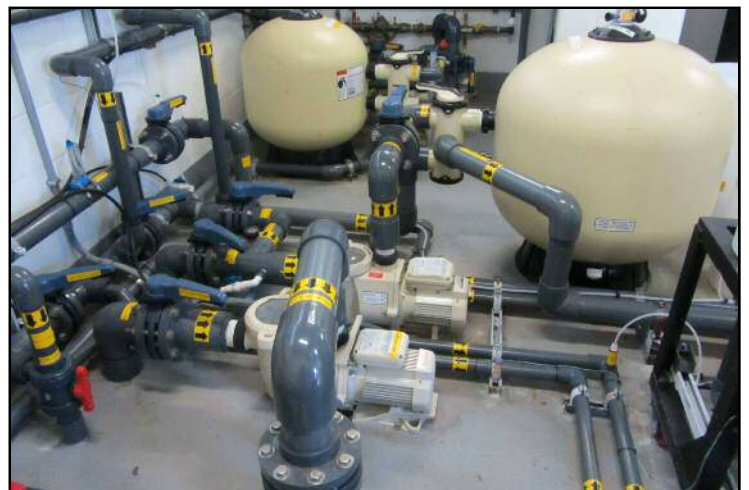
Component: 565 - Pool Pump - Replace
Location: Pool equipment room
Cost Source: Akamai Reserves Cost Database
Best Case: \$8,000 Estimate to replace, installed
Worst Case: \$10,000 Higher estimate

Evaluation: Pumps are in good functional condition.

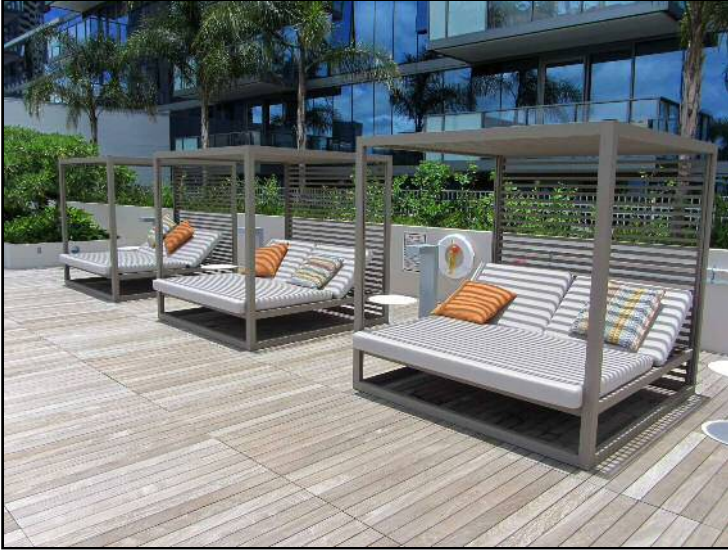
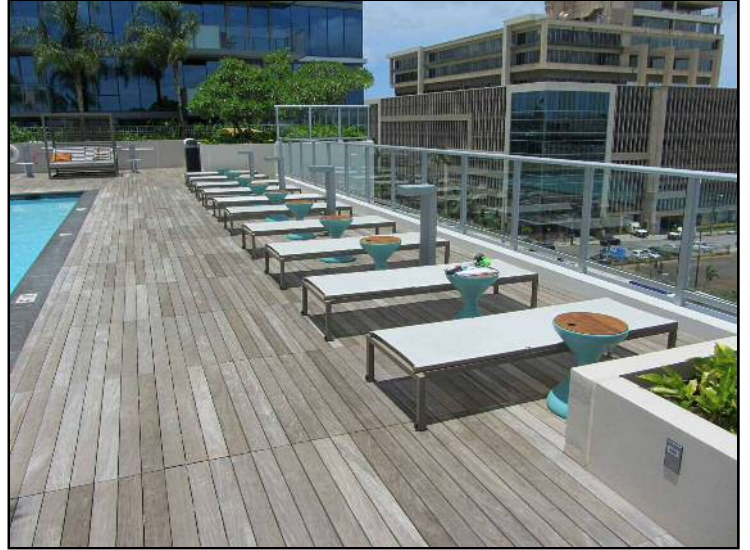
Component: 570 - Pool Metal Furniture - Replace
Location: Pool deck and cabanas
Cost Source: Research with local contractor/vendor
Best Case: \$95,000 Estimate for replacement pieces
Worst Case: \$105,000 Higher estimate

Evaluation: Lounges and other metal furniture is in good condition. Useful life depending on exposure and usage. Cushions and pillows are included in Soft Goods component(#726).

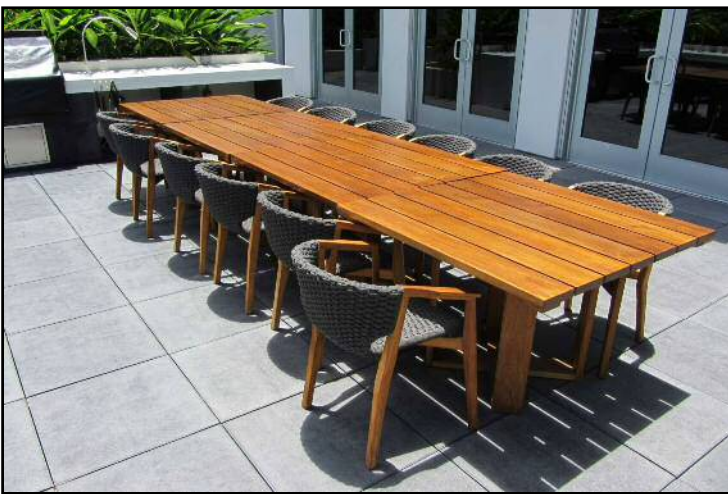
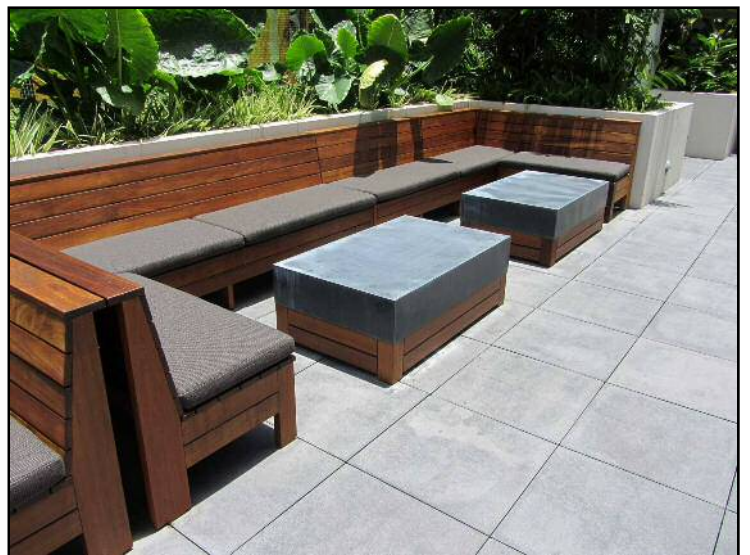
Component: 570 - Pool Wood Furniture - Replace
Location: Pool deck and cabanas
Cost Source: Research with local contractor/vendor
Best Case: \$175,000 Estimate for replacement pieces
Worst Case: \$185,000 Higher estimate

Evaluation: Teak furniture requires routine maintenance and refinishing under the Operating Budget. Useful life depending on exposure and refinishing.

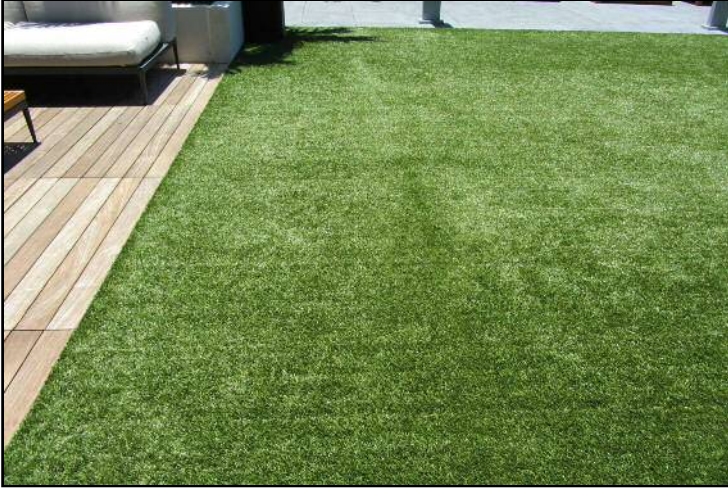
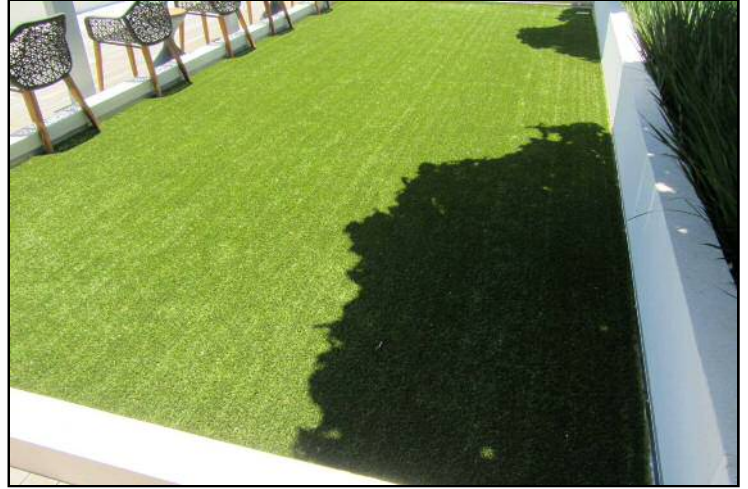
Component: 587 - Artificial Green Turf - Replace

Evaluation: Artificial turf is new and in good condition.

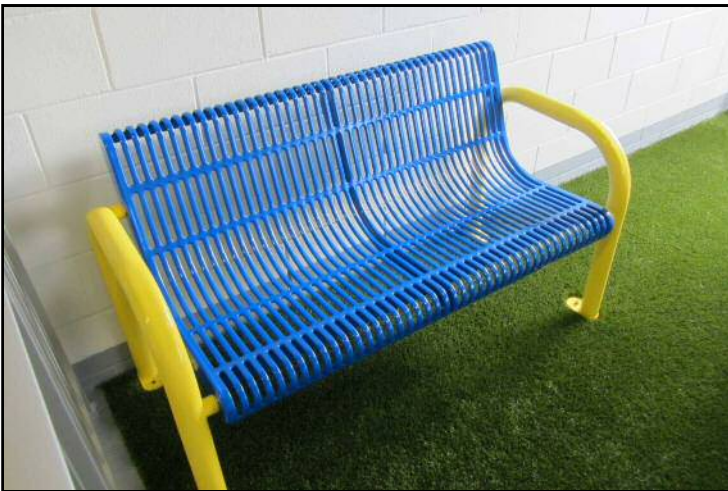
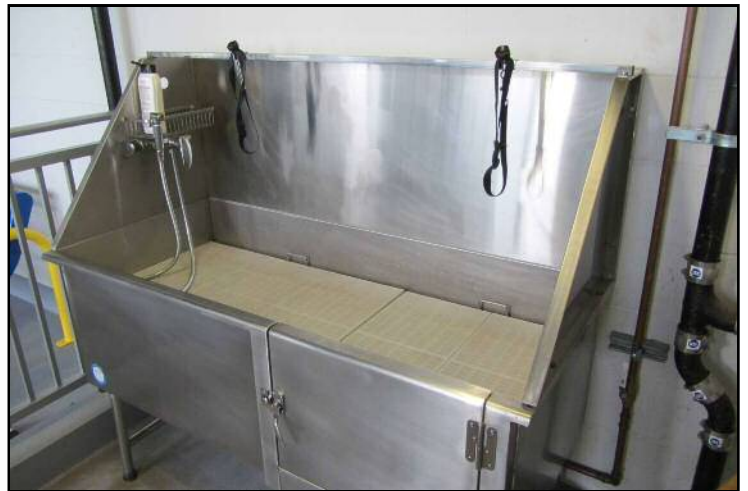
Component: 588 - Dog Park Furniture - Replace

Evaluation: Stainless steel wash station and benches are new and in good condition.

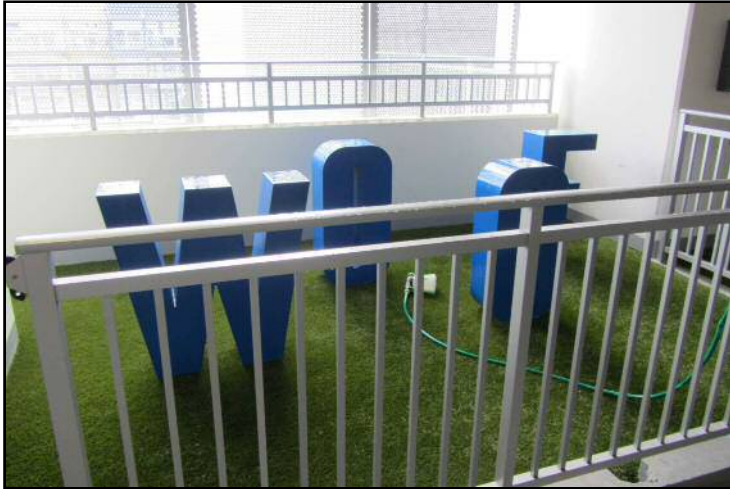
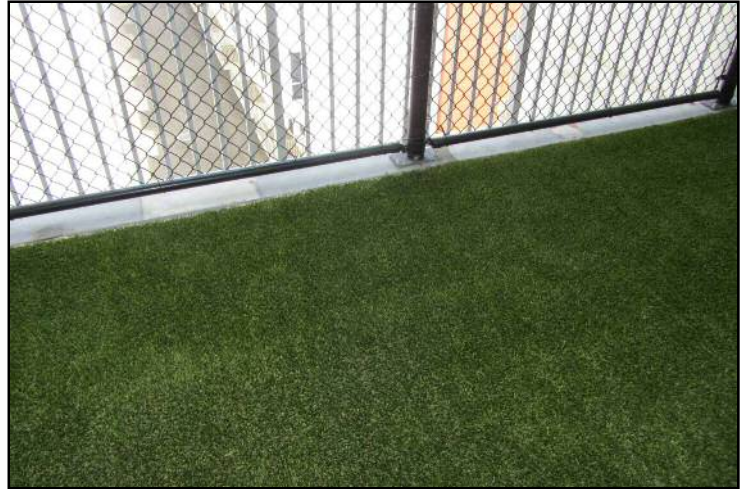
Component: 588 - Dog Park Turf - Replace

Evaluation: Turf is new and in good condition. Turf was being washed during site visit to maintain clean surface.

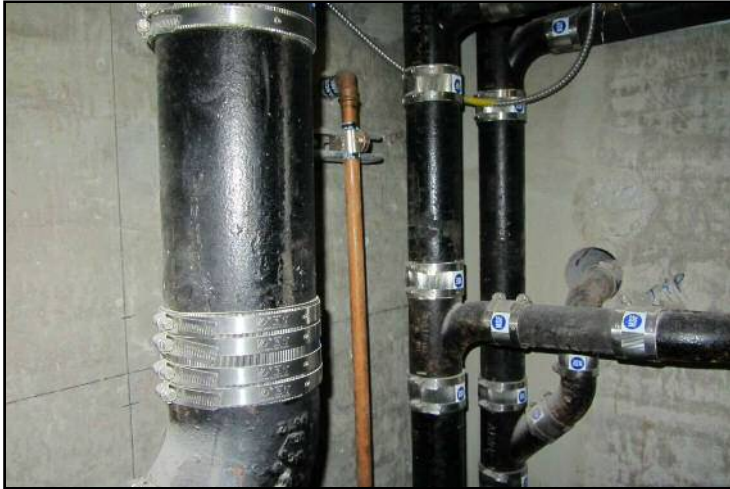
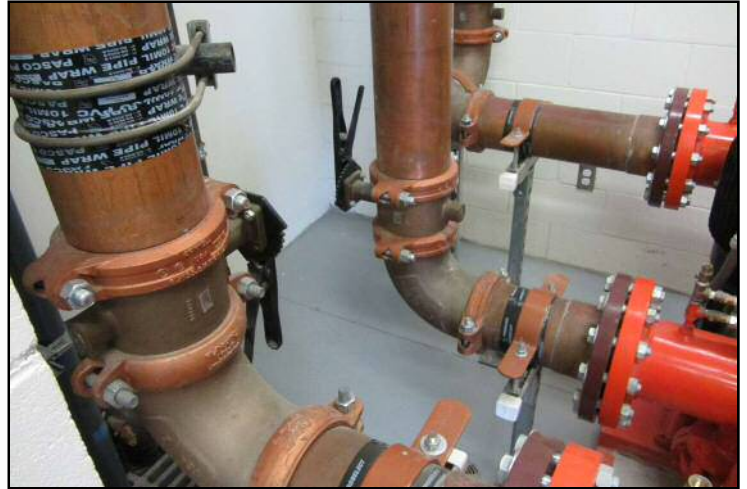
Component: 608 - Plumbing - Repair/Replace

Evaluation: Currently small plumbing repairs are performed under the Operating Budget by in-house staff. Eventual large repair projects will be required as building ages.

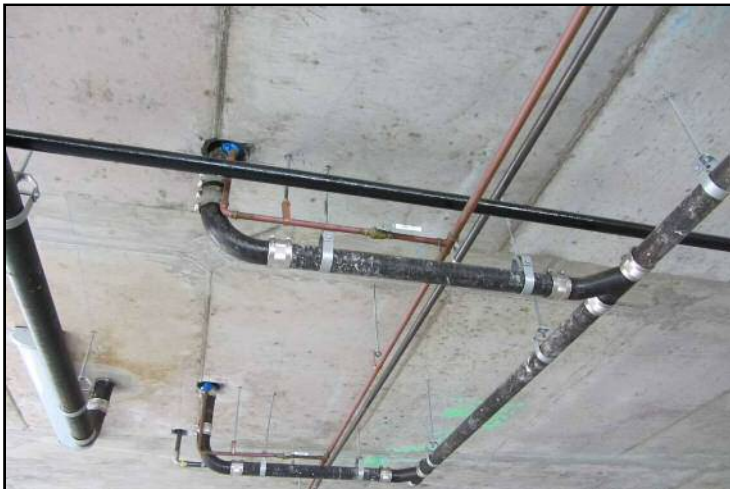
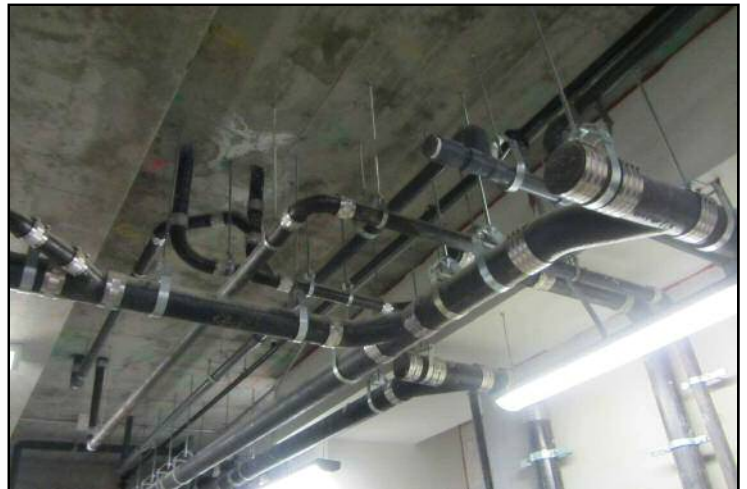
Component: 621 - Plumbing Drain/Stacks - Major Replacement

Evaluation: Horizontal lines in the parking garage are new and in good condition. Recommend routine inspection and evaluation of all common lines under the Operating Budget.

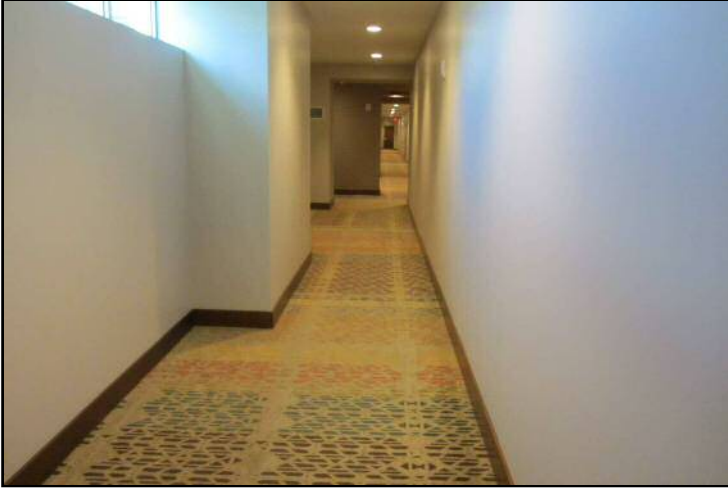
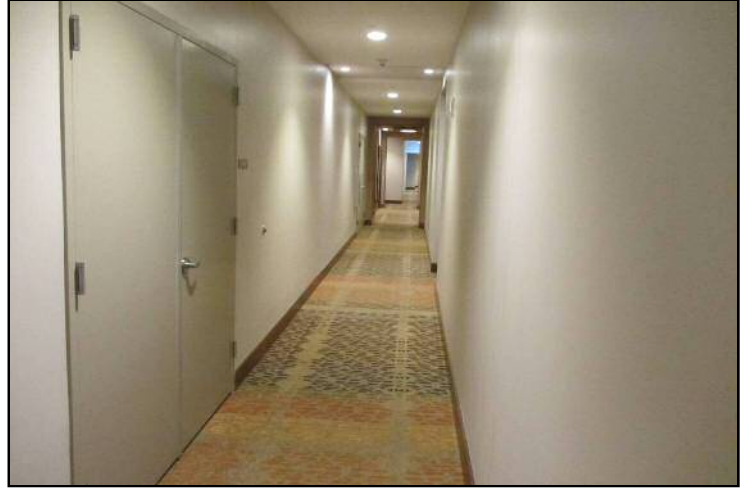
Component: 701 - Interior Surfaces - Paint
Location: Interior common areas
Cost Source:
Best Case:
Worst Case:

Evaluation: Tower interior painted surfaces are maintained under the Operating Budget by in-house staff.

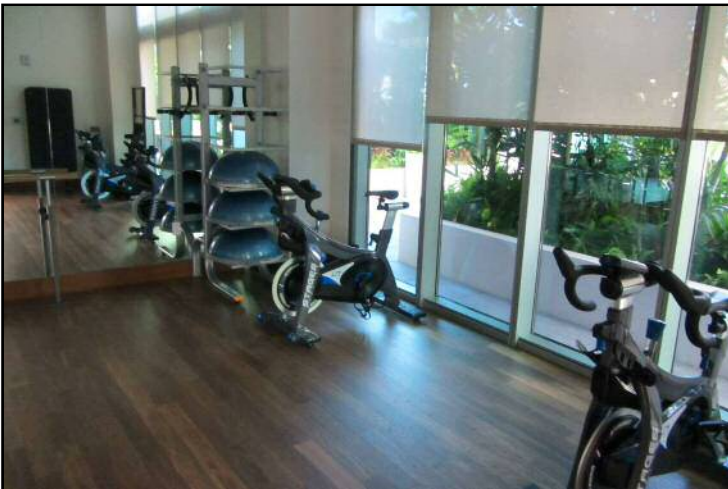
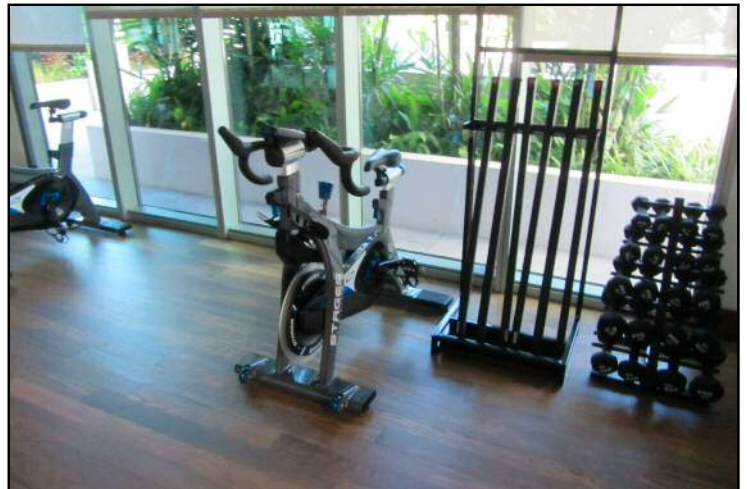
Component: 709 - Window Treatment - Replace
Location: Yoga room, Fitness room, and Waiting room
Cost Source: Research with local contractor/vendor
Best Case: \$15,000 Estimate to replace treatment
Worst Case: \$16,500 Higher estimate

Evaluation: Shades are functional and in good condition.

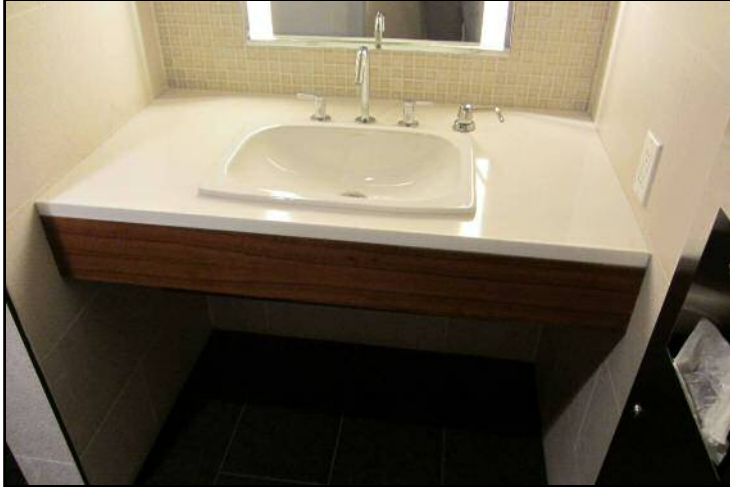
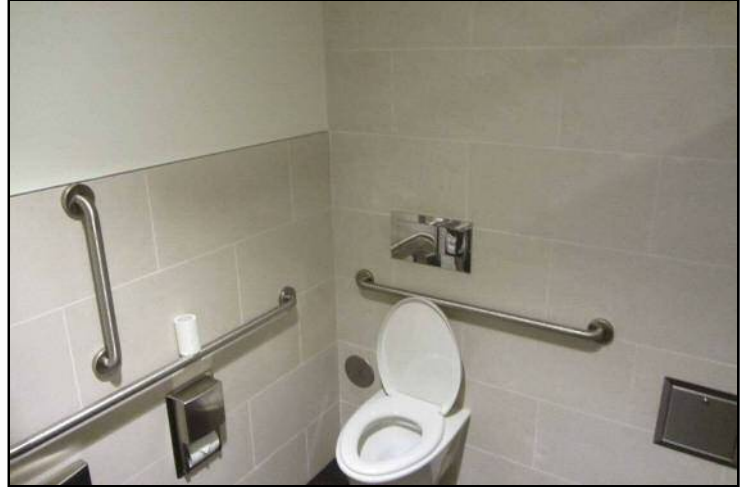
Component: 710 - Restrooms - Remodel
Location: 7th Floor Restrooms & Lobby Restroom
Cost Source: Akamai Reserves Cost Database
Best Case: \$22,500 Estimate to refurbish restrooms
Worst Case: \$35,000 Higher estimate to refurbish

Evaluation: Restrooms are in good condition.

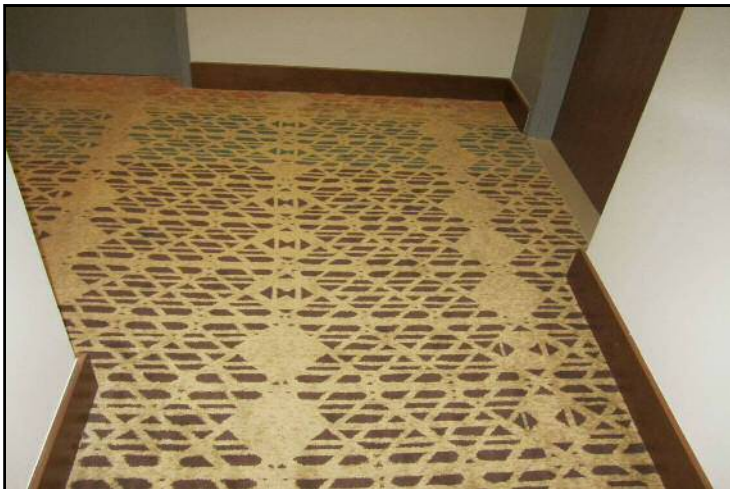
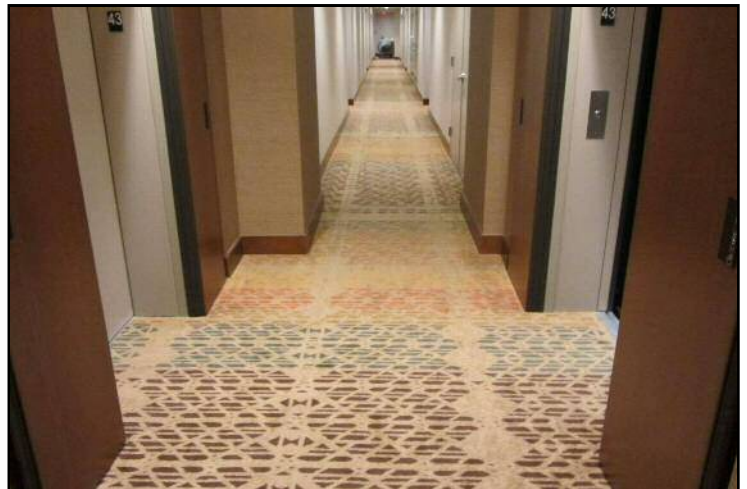
Component: 713 - Tower Hallway Carpet - Replace
Location: Resident hallways; floors 2-43
Cost Source: Akamai Reserves Cost Database
Best Case: \$362,600 Estimate to replace carpet
Worst Case: \$392,000 Higher estimate

Evaluation: Carpets are new and in good condition.

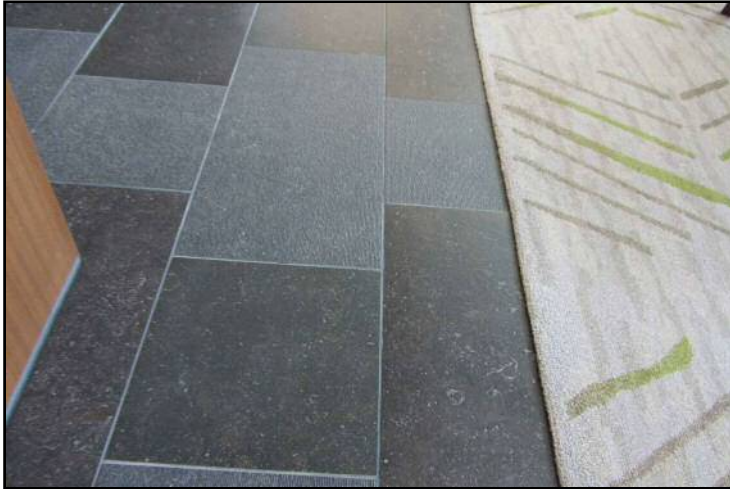
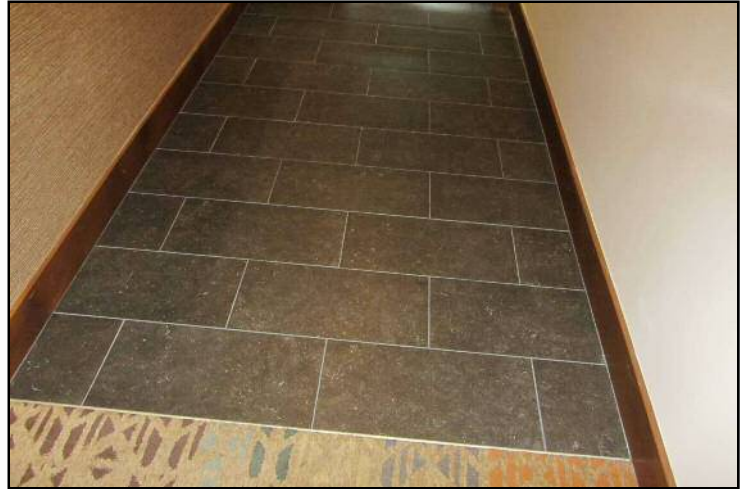
Component: 714 - Tile Floor - Replace
Location: 1st floor lobby, elevator lobbies, and front entry
Cost Source: Akamai Reserves Cost Database
Best Case: \$135,000 \$25/GSF; Estimate to replace tile
Worst Case: \$189,000 \$35/GSF; Higher estimate

Evaluation: Tile flooring is in good condition.

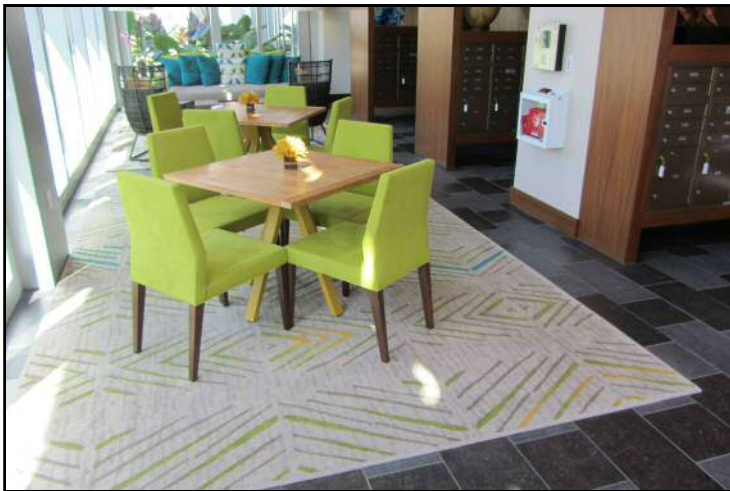
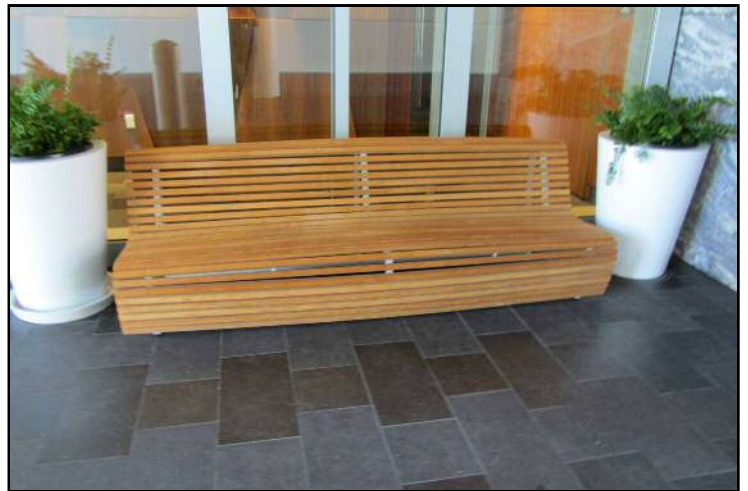
Component: 718 - Lobby & Club Furniture - Replace
Location: 1st floor lobby, Club room, lobby lanai, E-lounge
Cost Source: Research with local contractor/vendor
Best Case: \$147,000 Estimate for replacement pieces
Worst Case: \$157,500 Higher estimate

Evaluation: Furniture is in good condition.

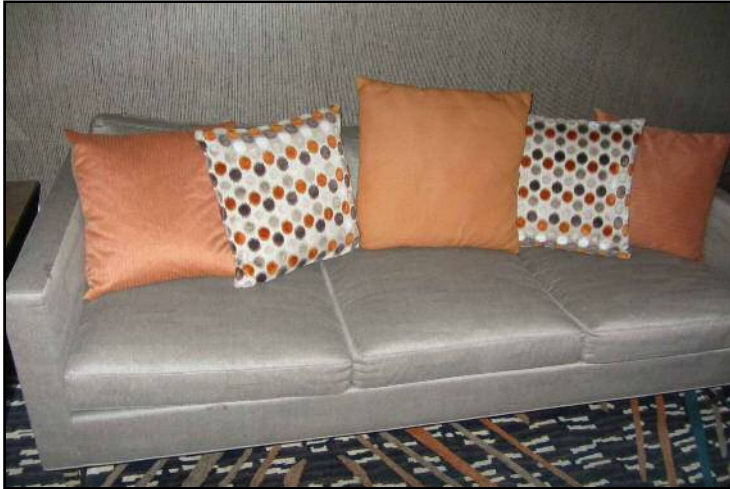
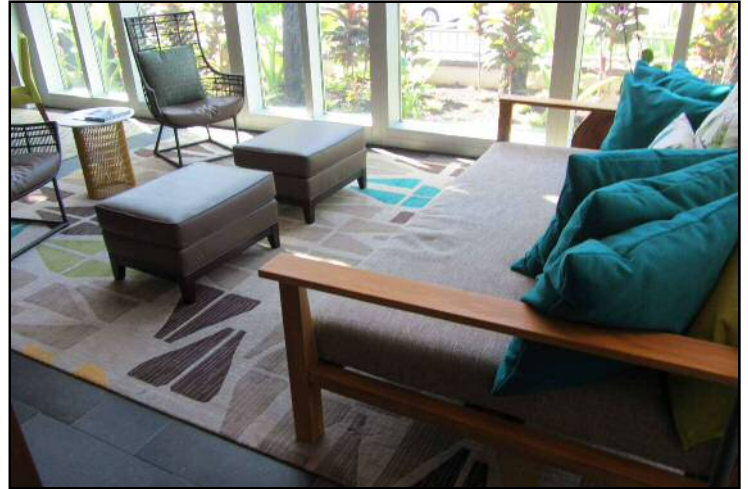
Component: 726 - Soft Goods - Lobby & 7th
Location: 1st floor & 7th floor
Cost Source: Research with local contractor/vendor
Best Case: \$90,000 Estimate to replace
Worst Case: \$100,000 Higher estimate

Evaluation: Soft goods are in good condition. Recommend individual replacement as needed under the Operating Budget.

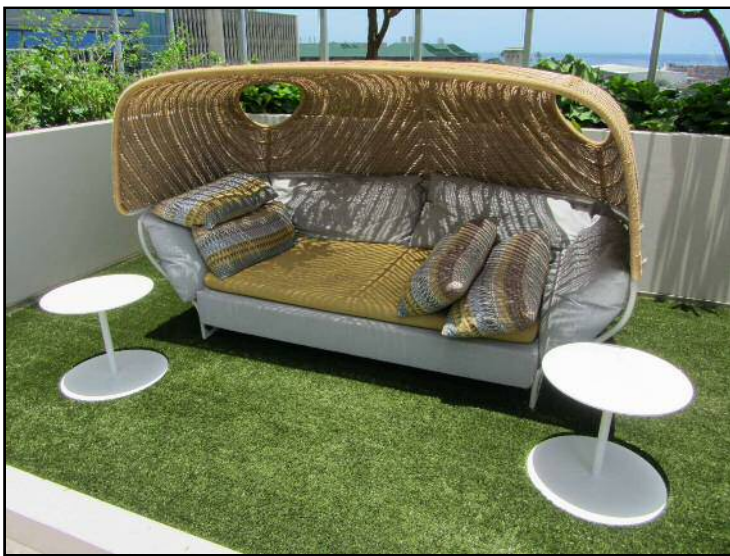
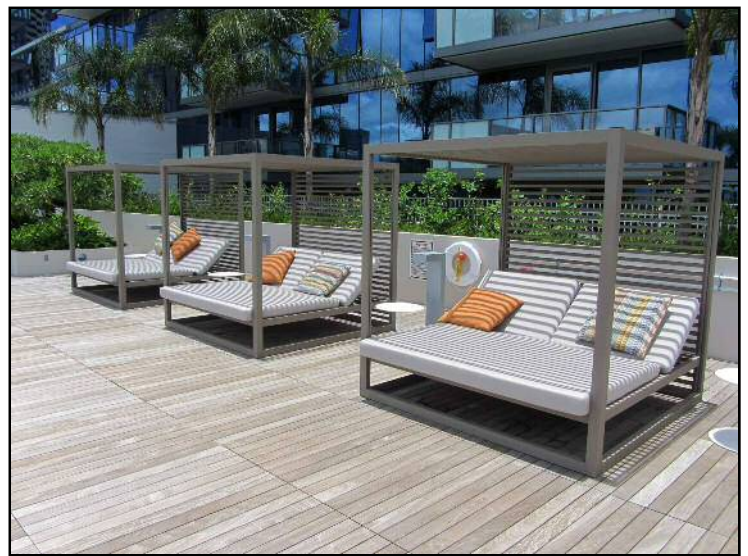
Component: 726 - Soft Goods - Pool Deck
Location: 7th floor Pool Deck
Cost Source: Research with local contractor/vendor
Best Case: \$30,625 Estimate to replace cushions and fabric
Worst Case: \$32,375 Higher estimate

Evaluation: Cushions, pillows, and fabric goods will require frequent replacement to maintain appearance.

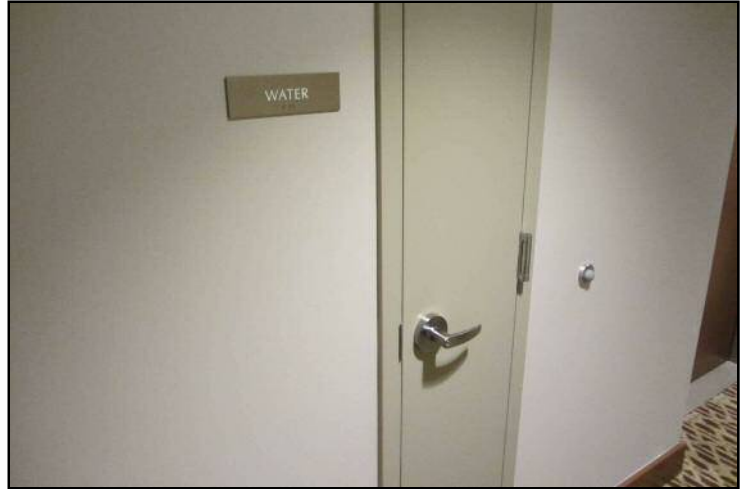
Component: 730 - Utility Doors - Partial Replace

Evaluation: Recommend planning for partial replacement of 30 doors every 5 years beginning in 10 years.

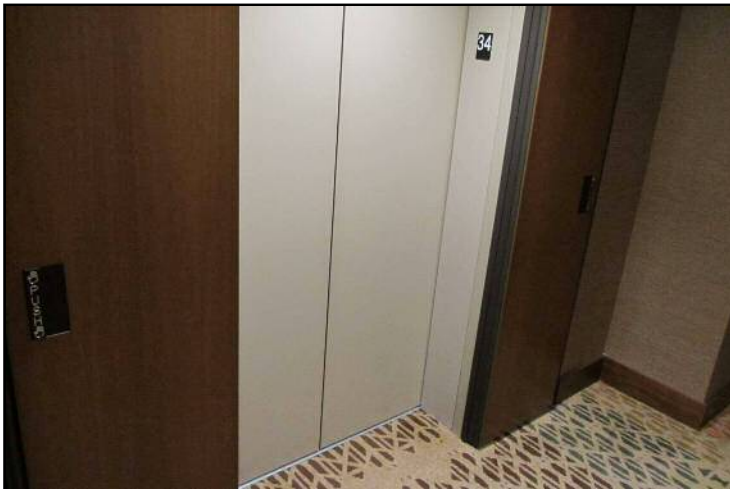
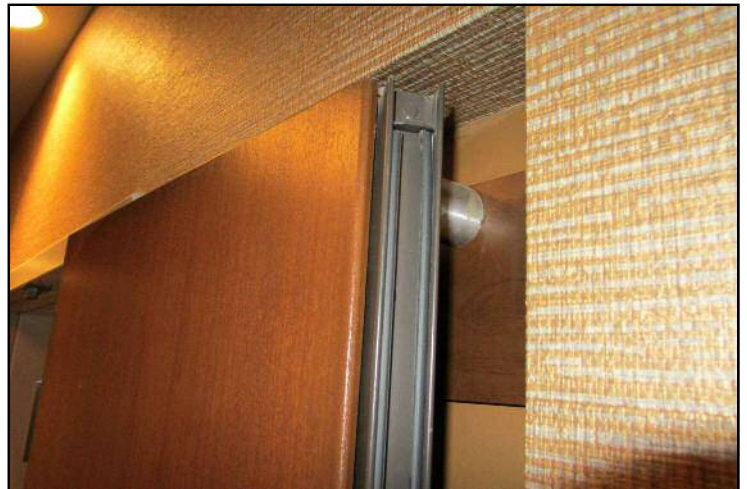
Component: 731 - Elevator Fire Doors - Replace

Evaluation: Doors are new and in good condition.

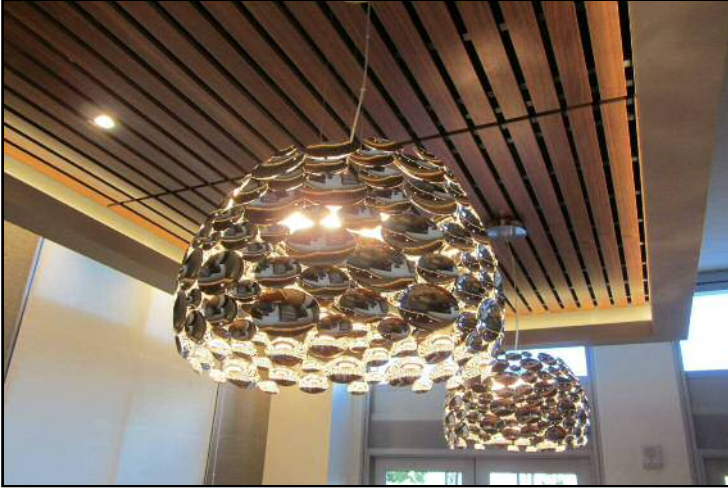
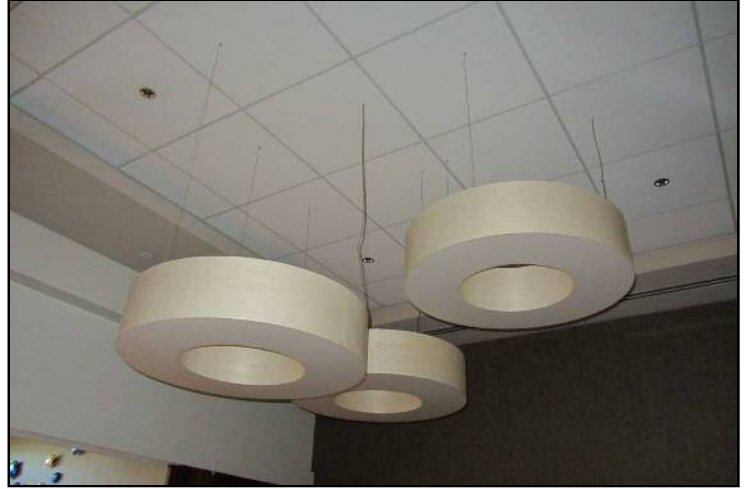
Component: 740 - Ceiling Lights - Replace
Location: Lobby, E-Lounge, and Club Room
Cost Source: Research with local contractor/vendor
Best Case: \$38,000 Estimate to replace
Worst Case: \$42,000 Higher estimate

Evaluation: Interior lights are maintained and replaced as needed under the Operating Budget.

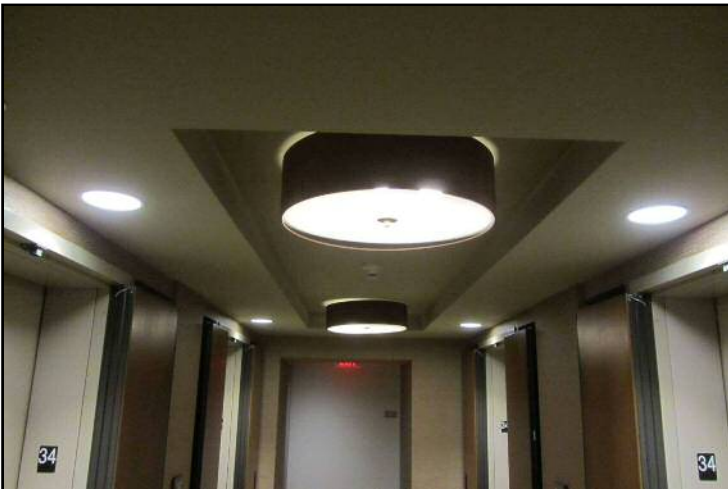
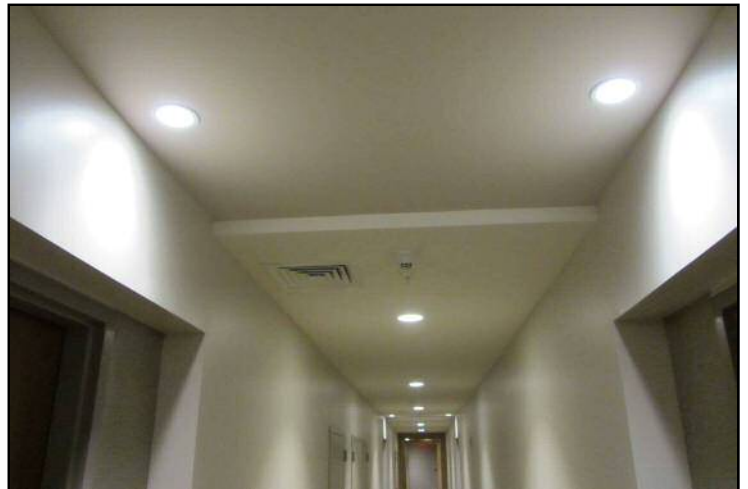
Component: 740 - Elevator Lobby Lighting - Replace
Location: Throughout building common hallways and lobby
Cost Source: Research with local contractor/vendor
Best Case: \$34,944 Estimate to replace
Worst Case: \$50,400 Higher estimate

Evaluation: Large elevator lights are in good condition. Small interior lights are maintained and replaced as needed under the Operating Budget.

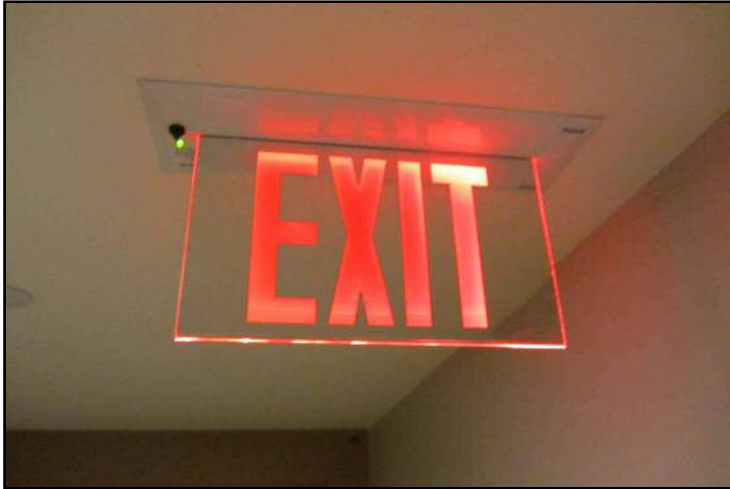
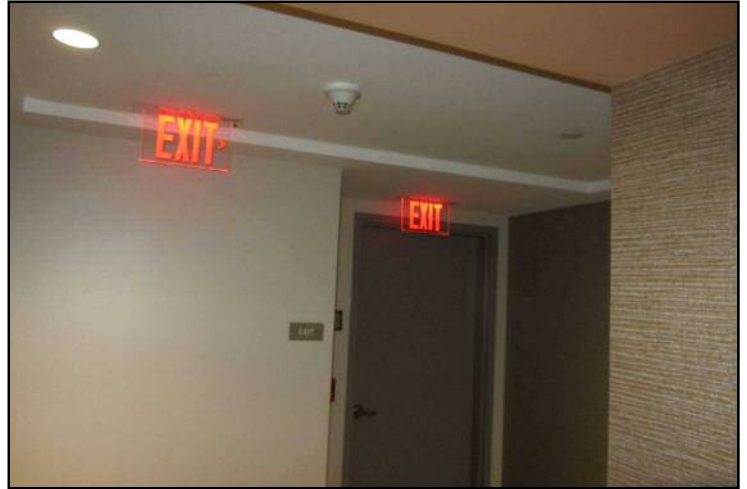
Component: 741 - Exit Lights - Replace

Evaluation: Exit lights are new and in good functional condition.

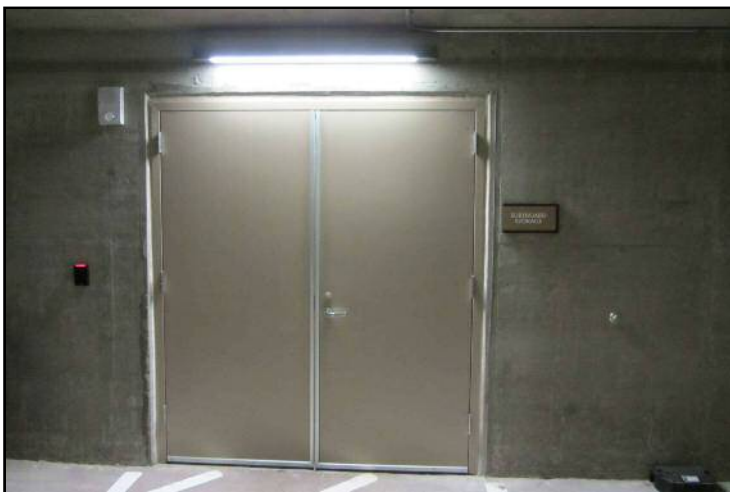
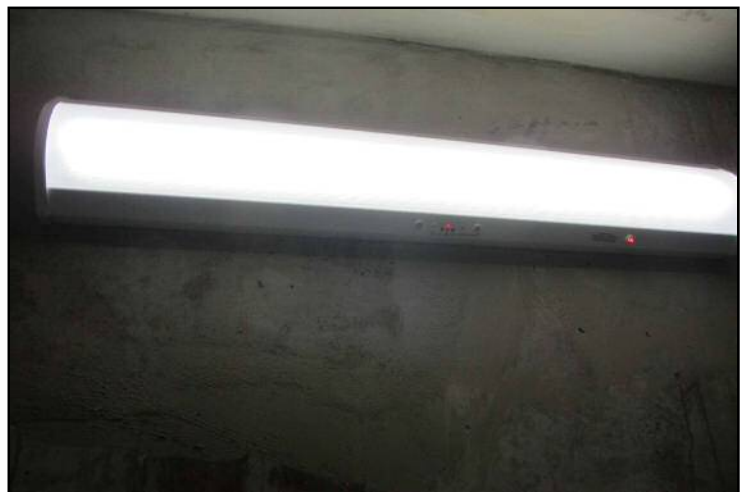
Component: 742 - Emergency Lights - Replace

Evaluation: Motion sensor emergency lighting is in good functional condition. Recommend individual replacement and repair as needed under the Operating Budget to avoid full replacement.

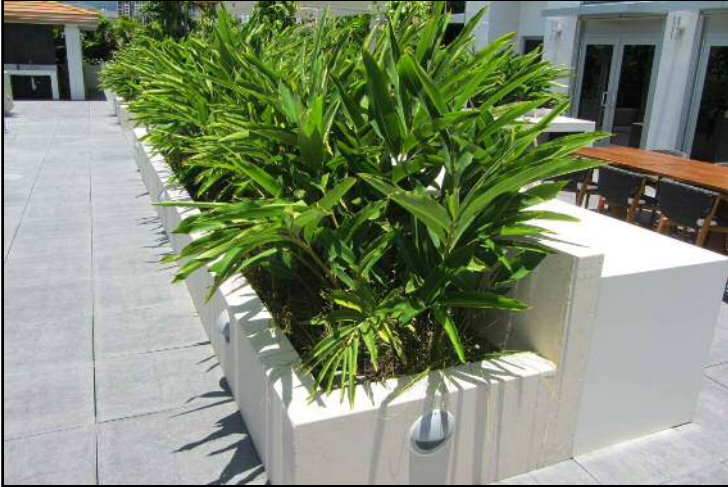
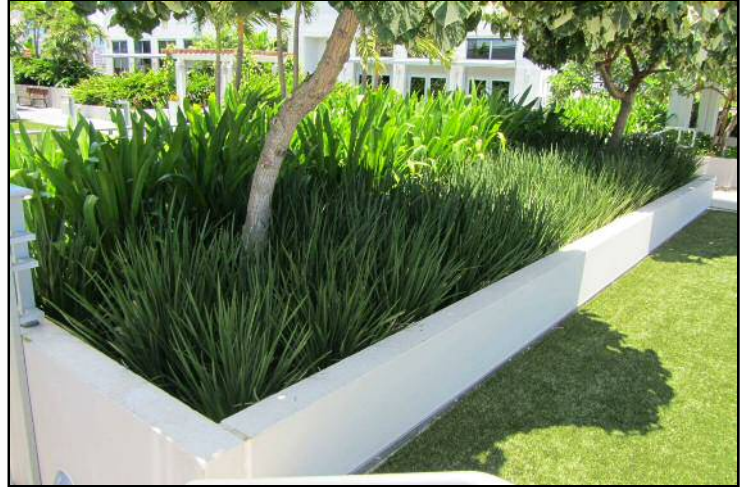
Component: 904 - Flower Planters - Replace

Evaluation: One planter was being repaired during site inspection due to drainage issue. Generally new and in good condition.

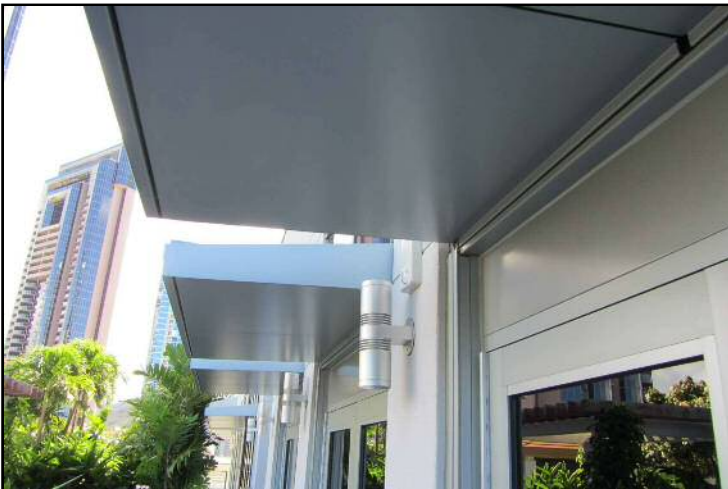
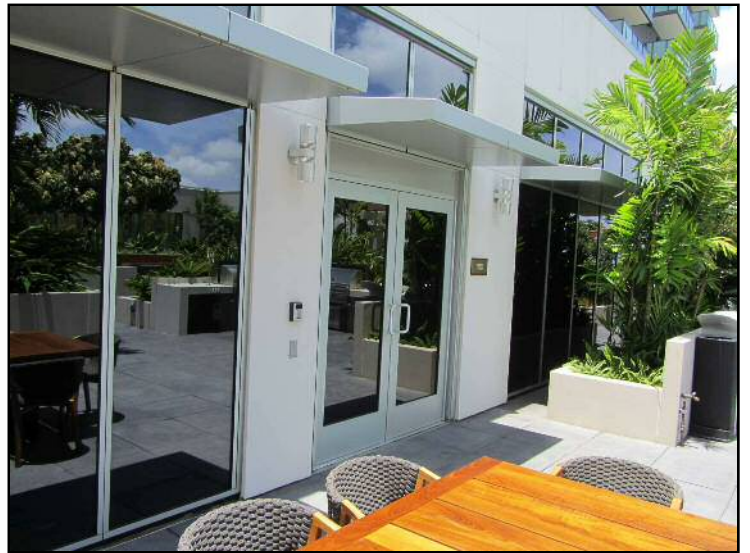
Component: 1019 - Metal Awnings - Repair/Replace

Evaluation: Awnings appear to be aluminum. Metal is in good attractive condition.

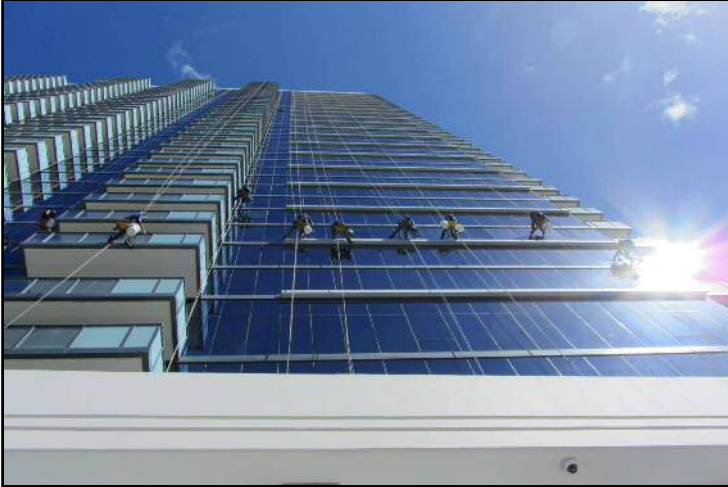
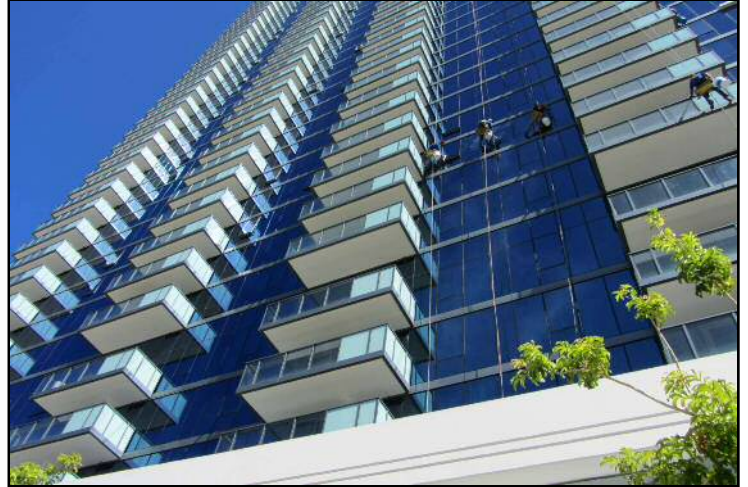
Component: 1025 - Window Seal - Test/Repair

Evaluation: Inspection and testing planned on a 10 year cycle. Windows are routinely cleaned under the Operating Budget. Testing will be necessary to determine seal replacement.

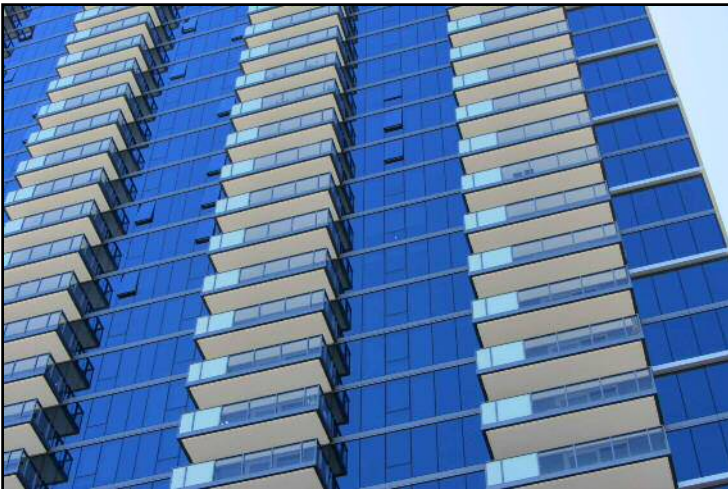
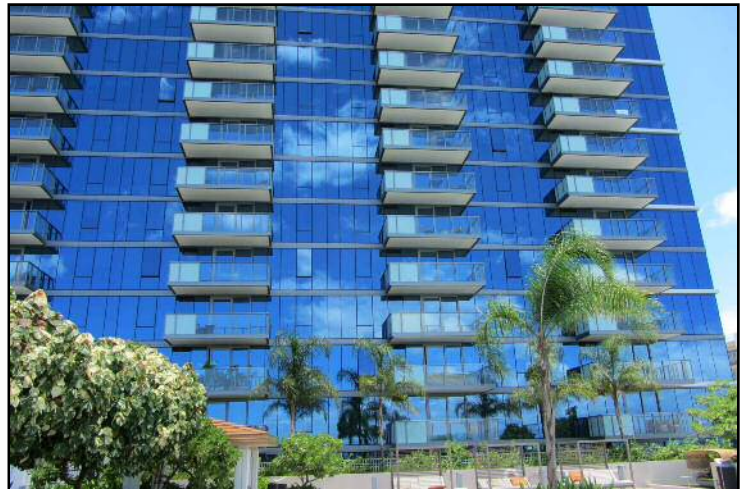
Component: 1026 - Window Seal - Replace

Evaluation: Future window seal full replacement will be determined during inspection and testing planned on a 10 year cycle. Old caulking will be removed and replaced with new silicone sealant.

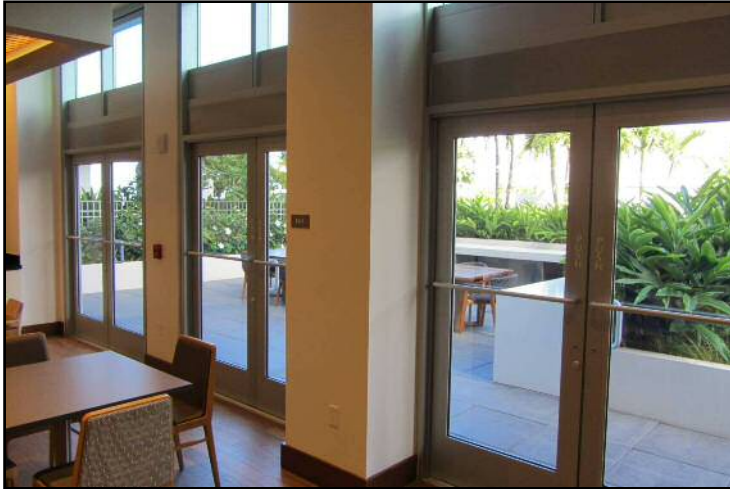
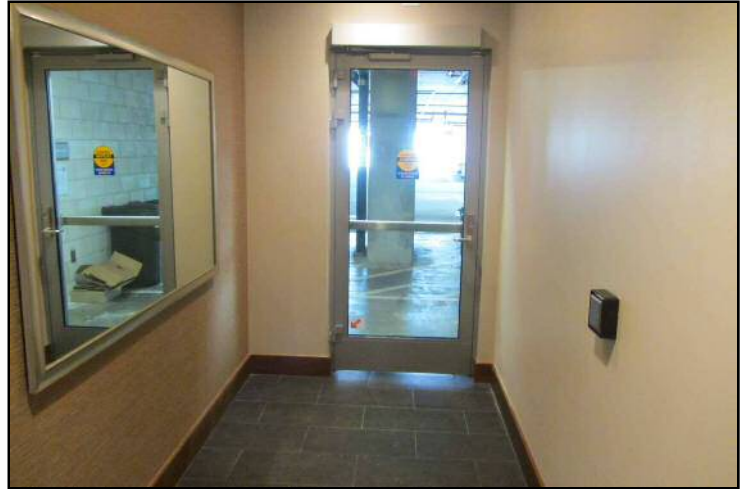
Evaluation: Glass doors are in good functional condition.
