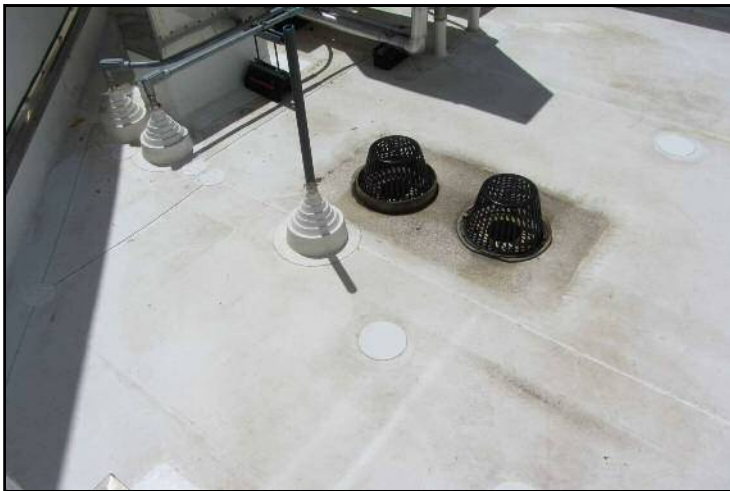
Evaluation: Membrane flat roofing is in good condition. Routine inspection and small repairs recommended under the Operating Budget. Annex and Tower roofs were inspected during site visit. Pool equipment and other small buildings are included in this component, these roofs were not inspected.

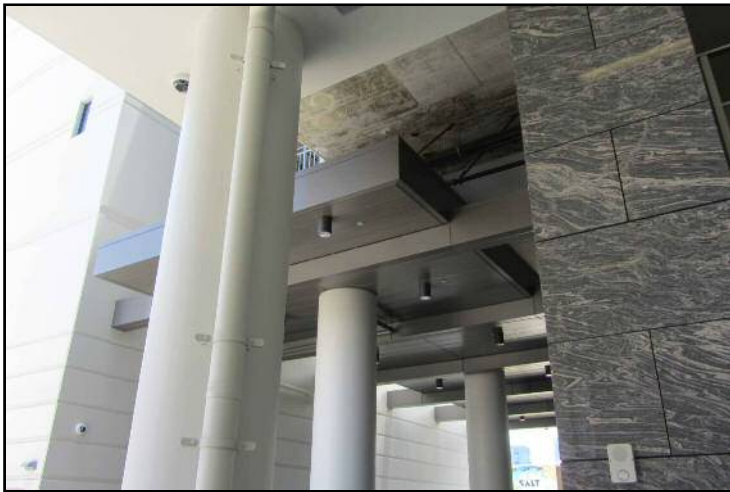
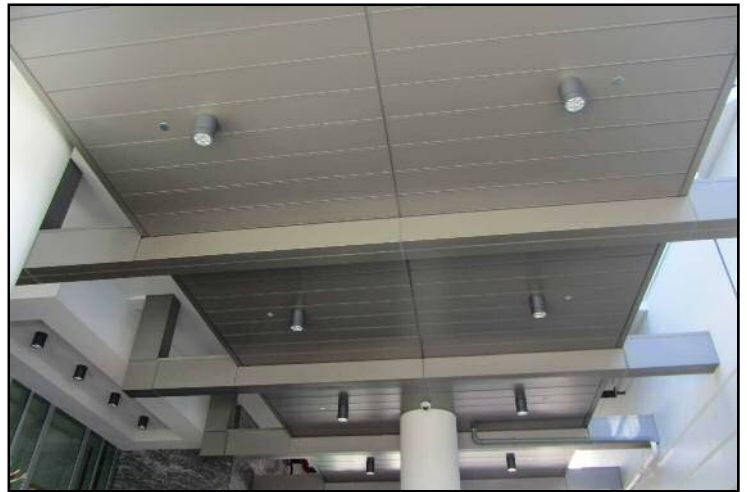
Component: 1110 - Metal Roof - Repair/Replace

Evaluation: Portico metal roof below corridor at lobby entrance.

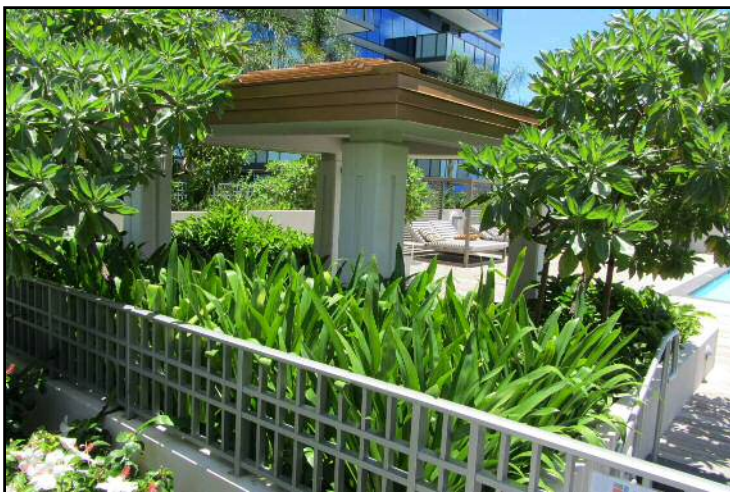
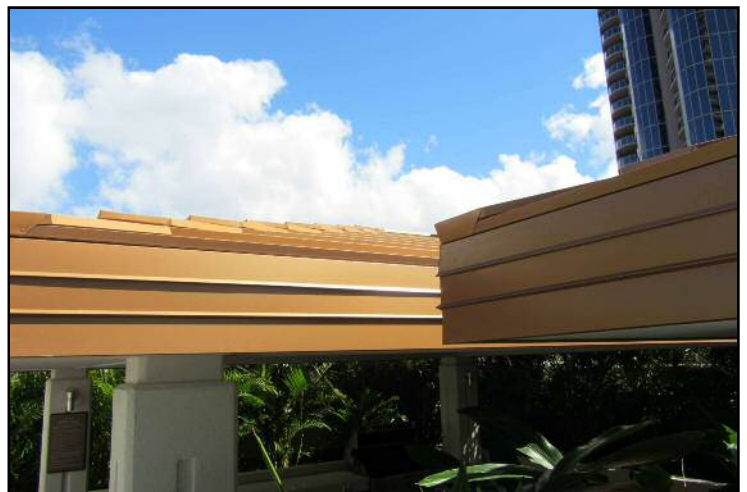
Component: 1115 - Pavilion Roof - Replace

Evaluation: Metal roofs are in good condition.

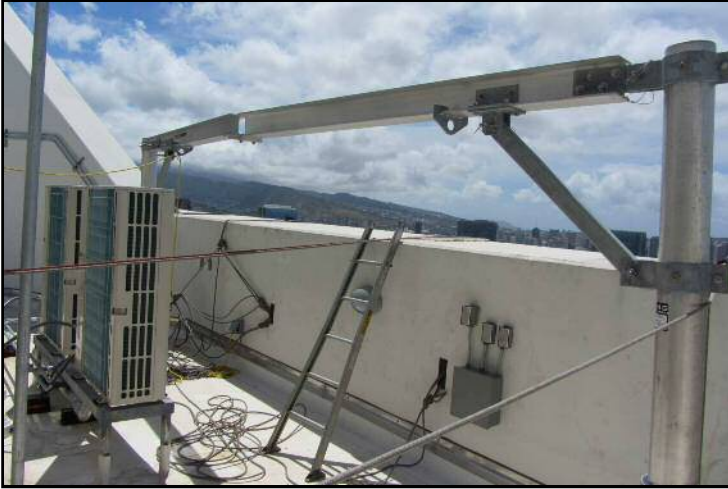
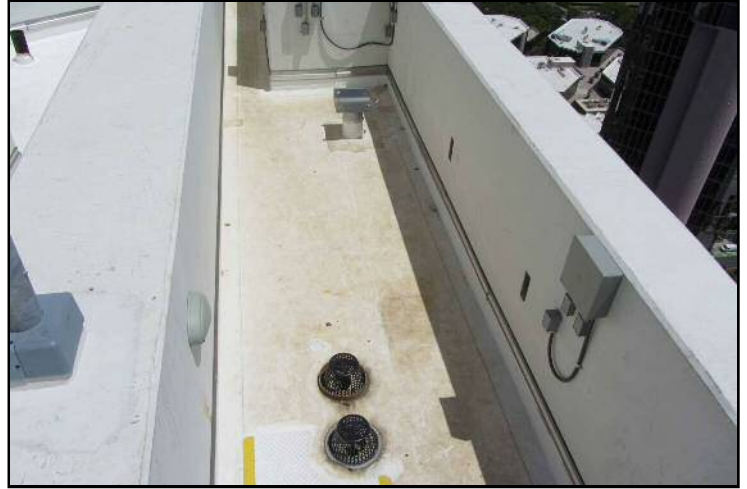
Component: 1125 - Window Wash Equip - Replace/Repair

Evaluation: Window washing davits are long life components with an undetermined useful life. Reported testing is scheduled in 10 years.

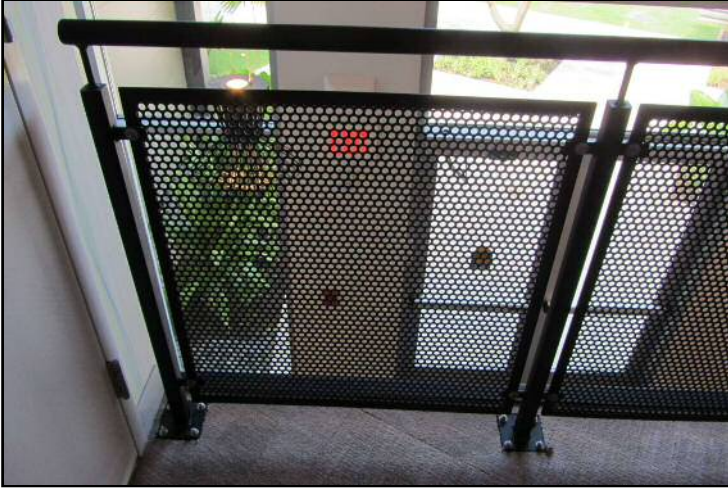
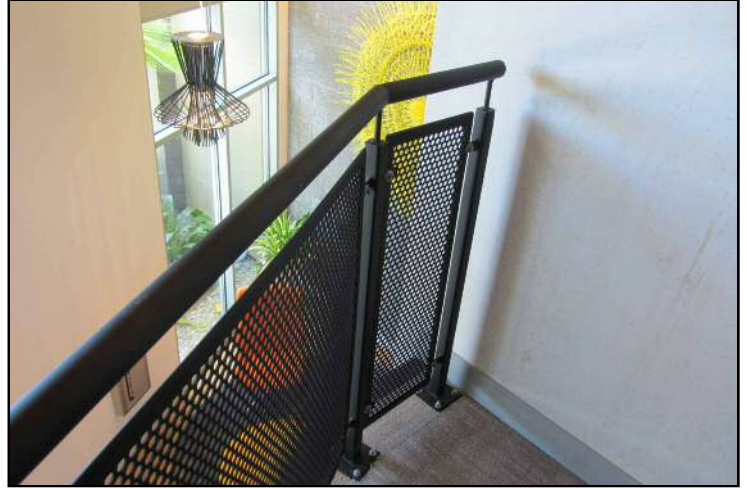
Evaluation: Balcony railing is in good condition. Recommend maintenance and replacement under the Operating Budget.

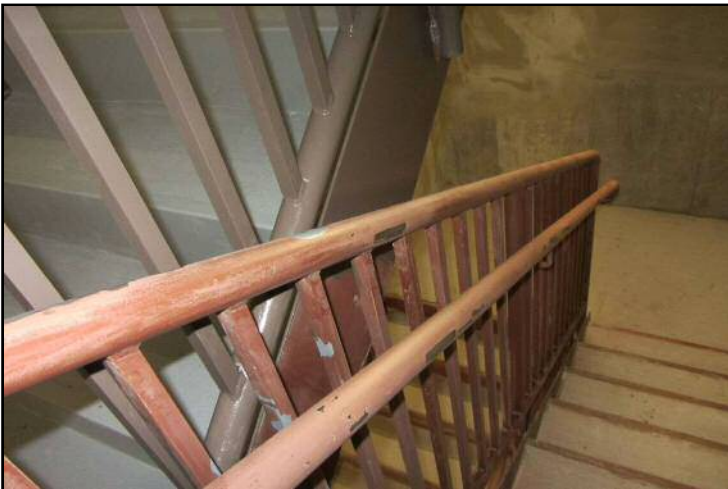
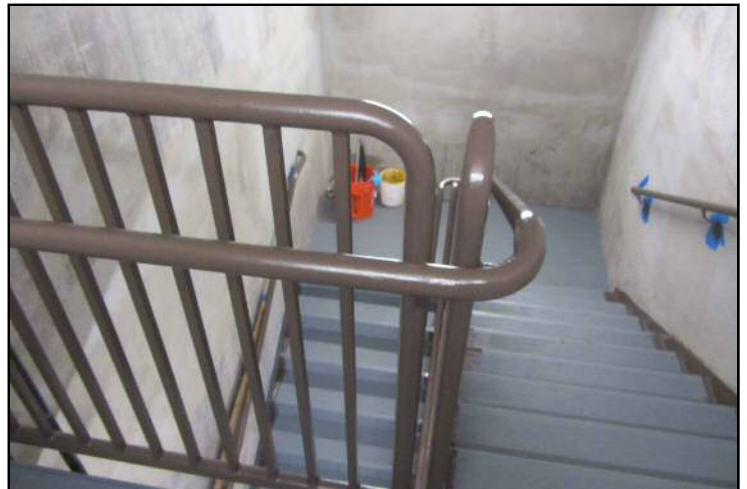
Evaluation: Stairs and hand rails were being painted during site inspection. With painting and small repairs performed in-house these components are long life with no expectation for full replacement.

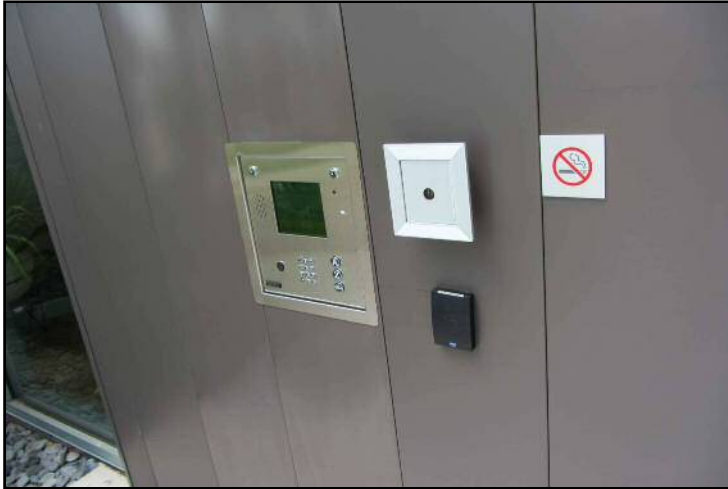
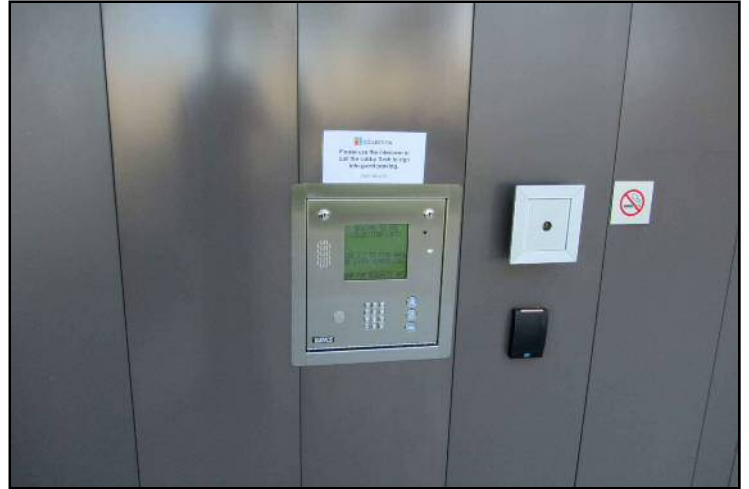
Evaluation: Keypads and fob entry system is functional and in good condition.

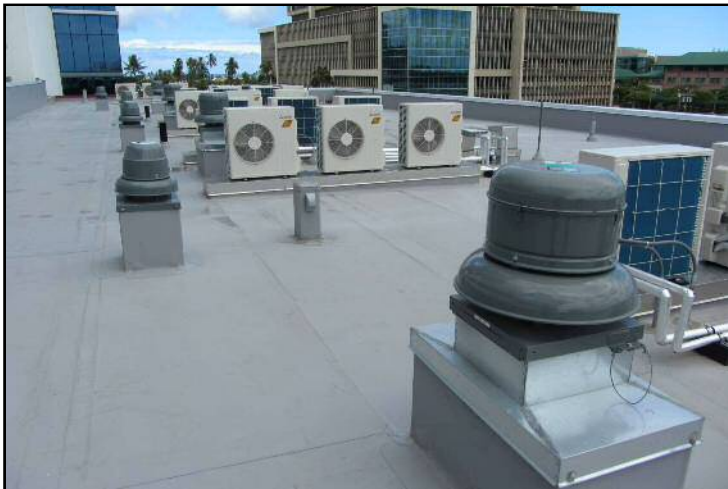
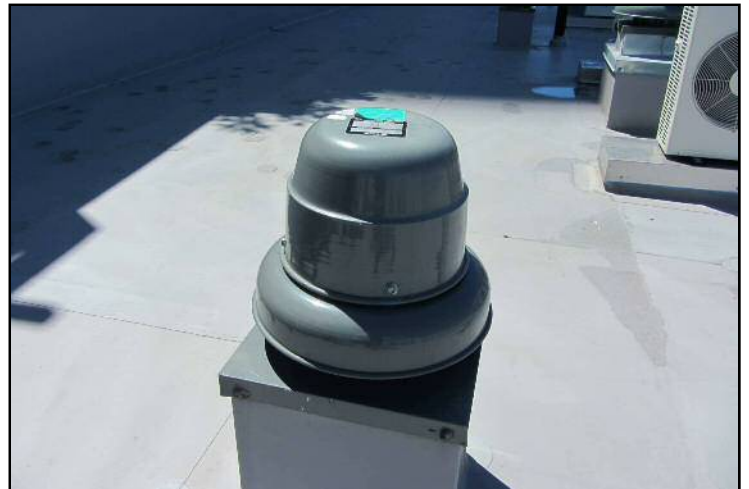
Evaluation: Exhaust fans are reported to be in good functional condition.

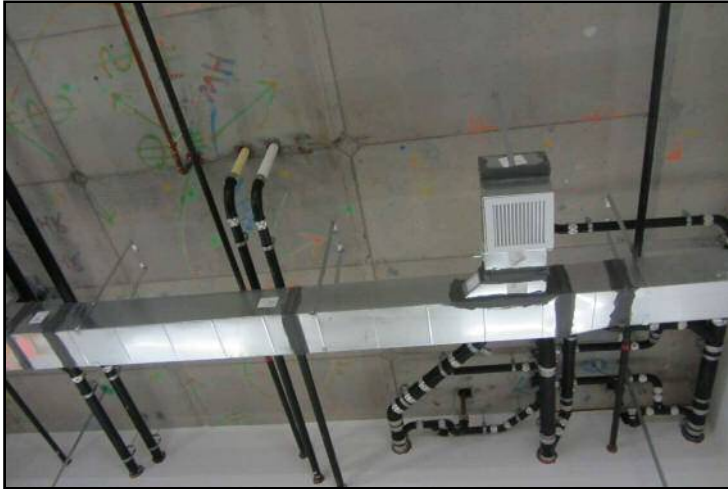
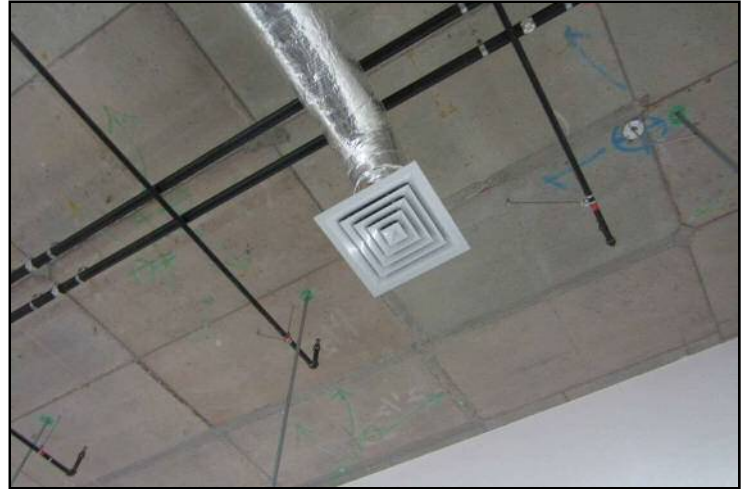
Evaluation: Small exhaust fans are reported in good condition. Recommend maintenance and replacement under the Operating Budget.

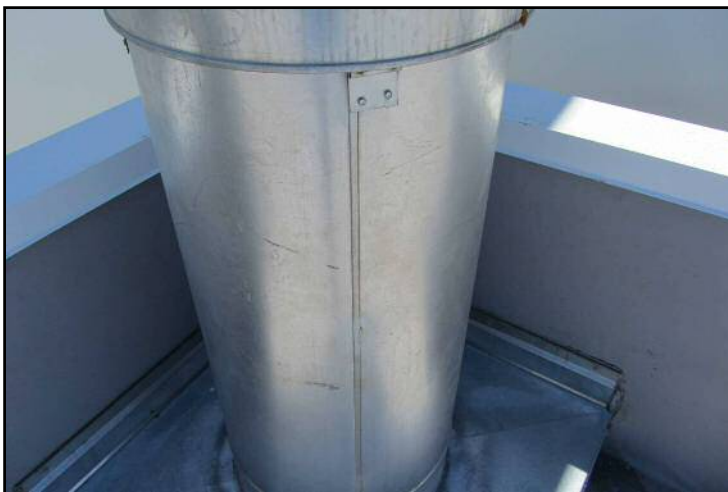
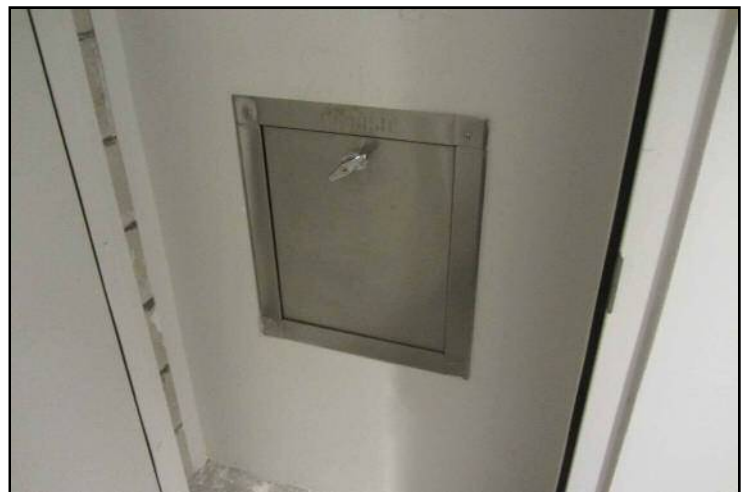
Evaluation: Trash chute is new and in good condition. Recommend planning for partial replacement of heavy used lower sections. Cleaning, door replacement, and maintenance under the Operating Budget.

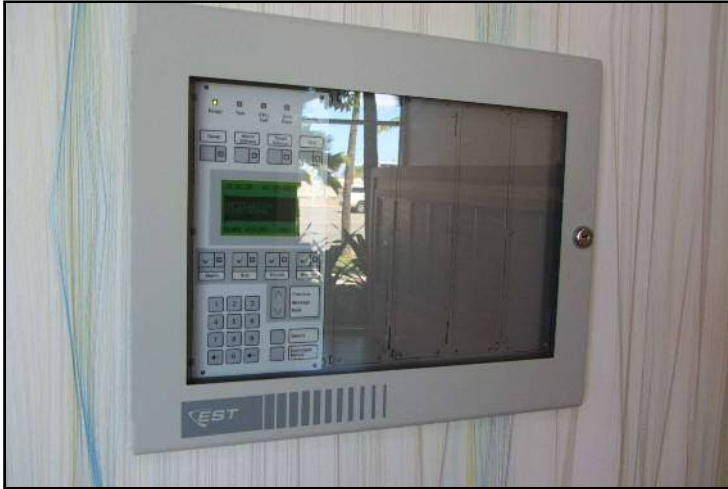
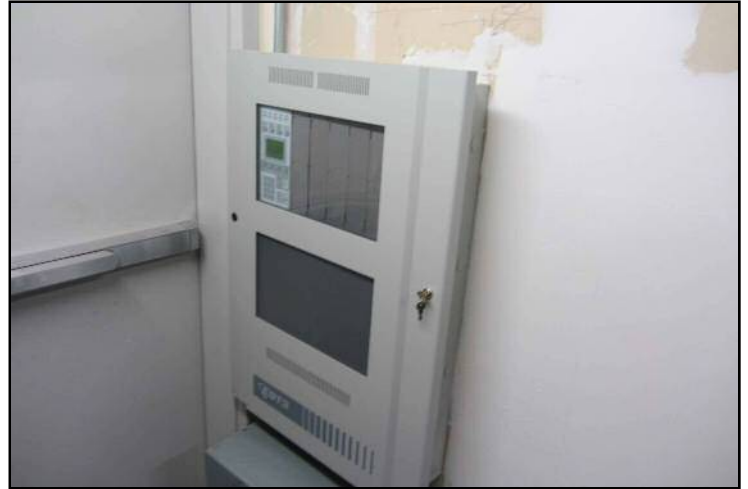
Component: 430 - Fire Alarm System - Replace/Upgrade
Location: Throughout building
Cost Source: Budget estimate
Best Case: \$40,000 Estimate for replacement system, installed
Worst Case: \$50,000 Higher estimate

Evaluation: Recently installed modern system is report in good functional condition. Routine inspection and maintenance handled under the Operating Budget. System upgrade costs are undetermined at this time.

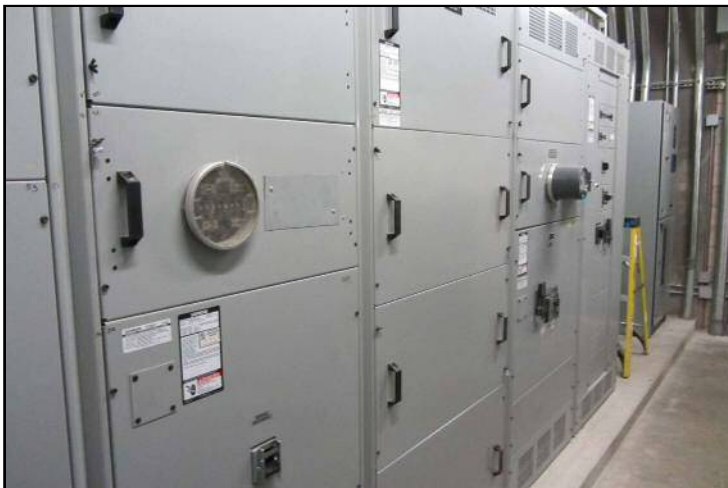
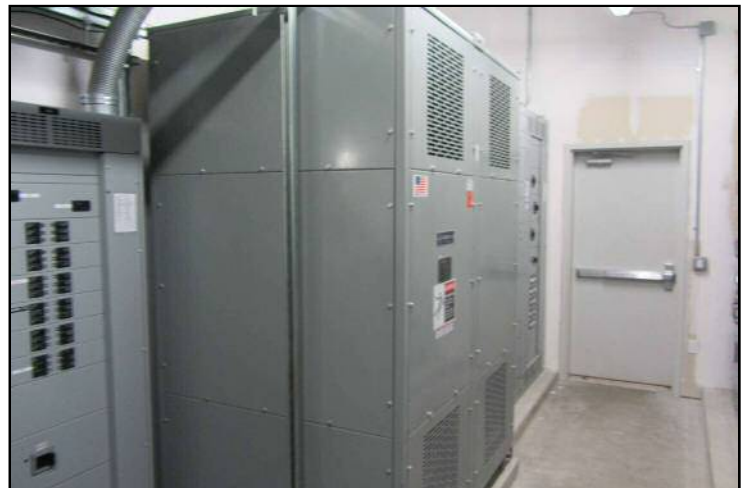
Component: 431 - Electrical Panels - Inspect/Repair
Location: All common electrical switches and panels
Cost Source:
Best Case: \$9,000
Worst Case: \$11,000

Evaluation: Electrical panels are heat scanned on this cycle. Eventual full electrical system upgrade may be required. Inspection and routine testing will help develop upgrade plan as system ages.

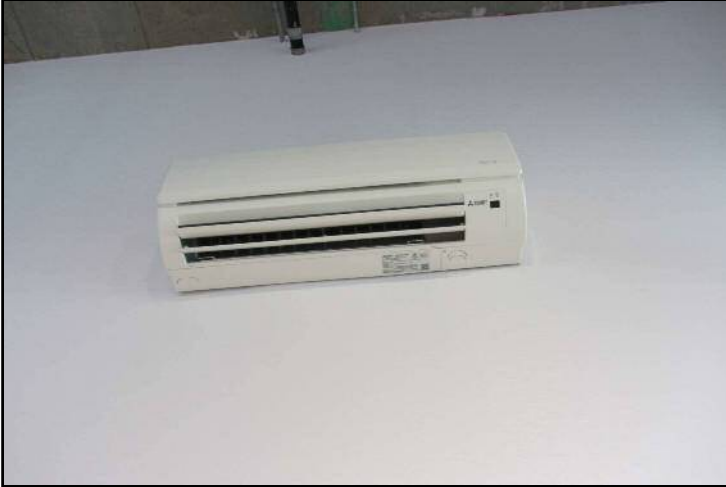
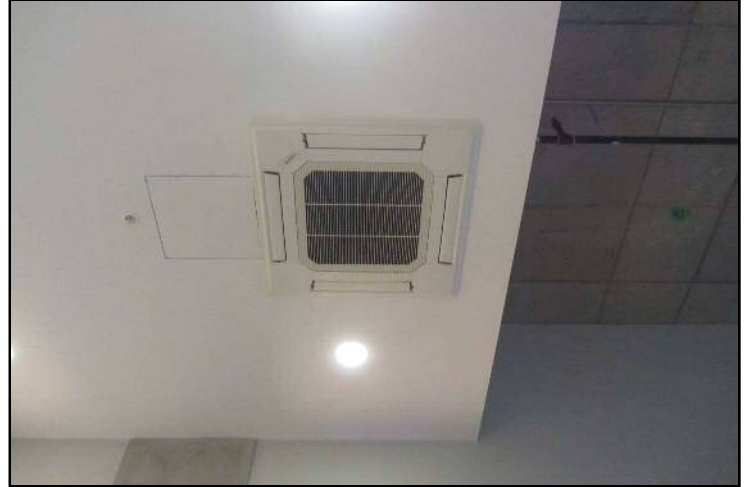
Component: 436 - Fan Coil - Replace
Location: Units are located inside building
Cost Source: Akamai Reserves Cost Database
Best Case: \$21,000 Estimate for similar unit
Worst Case: \$22,400 Higher estimate

Evaluation: Fan coils are in good functional condition.

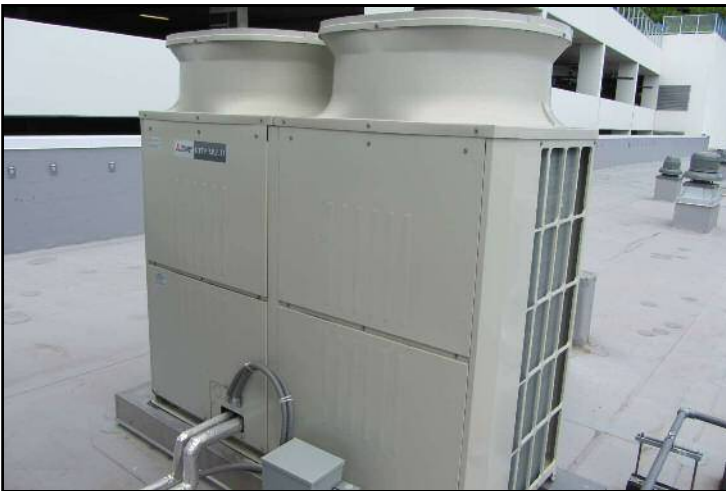
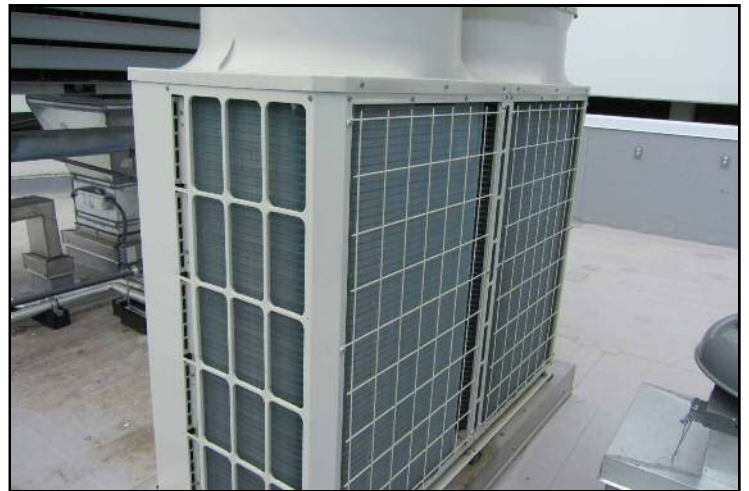
Component: 437 - Condenser - Replace
Location: Building Roof
Cost Source: Akamai Reserves Cost Database
Best Case: \$5,000 Estimate to replace
Worst Case: \$8,000 Higher estimate

Evaluation: Condenser is in good functional condition.

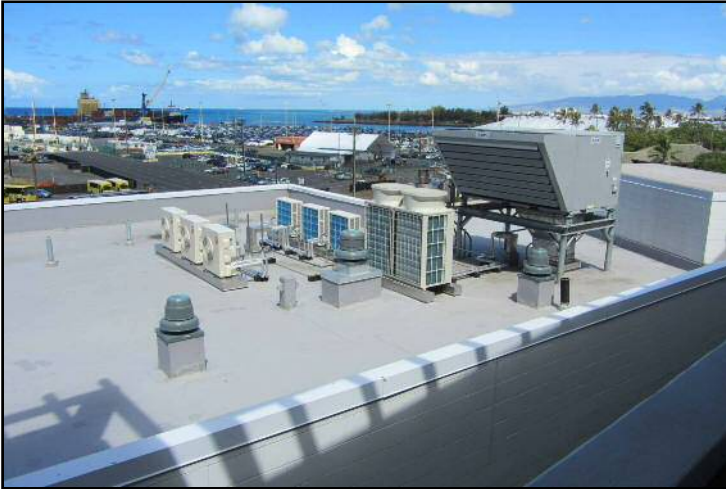
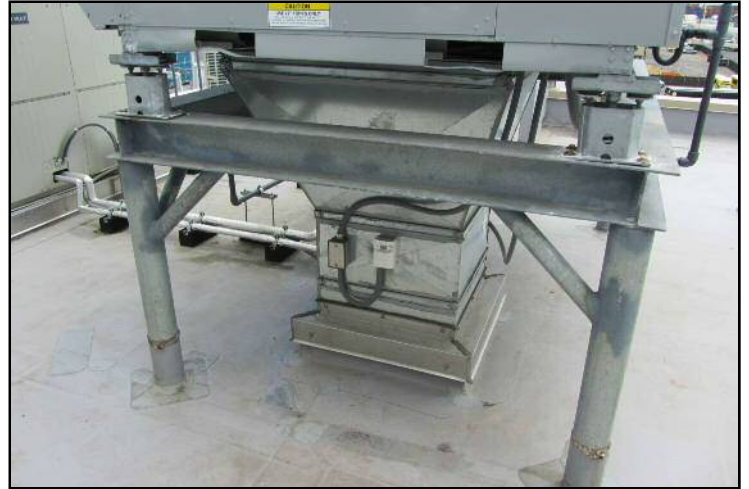
Component: 441 - Outdoor Air Handler - Replace
Location: Building Roof
Cost Source: Akamai Reserves Cost Database
Best Case: \$200,000 Estimate to replace
Worst Case: \$250,000 Higher estimate

Evaluation: AAON unit is new and in good condition. Inspection and maintained by in-house staff.

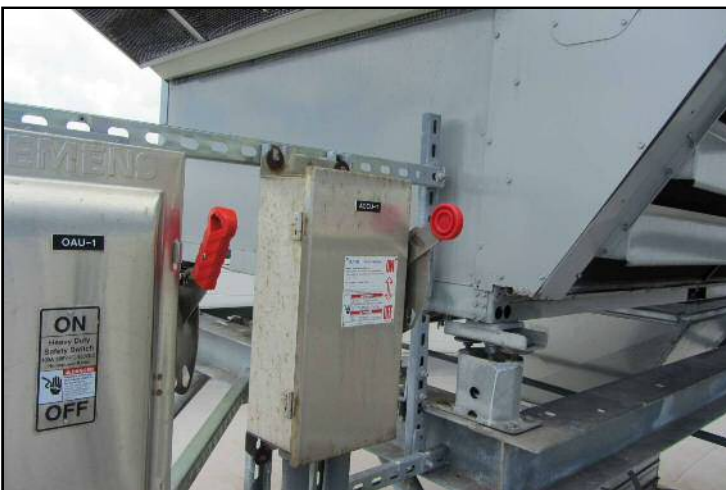
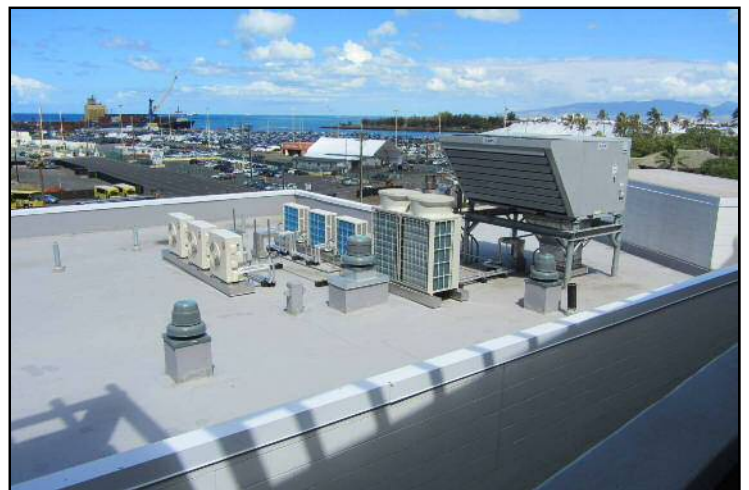
Component: 442 - Compressor - Replace
Location: Inside rooftop unit
Cost Source: Akamai Reserves Cost Database
Best Case: \$14,000 Estimate to replace
Worst Case: \$15,000 Higher estimate

Evaluation: Compressors are reported to be in good functional condition.

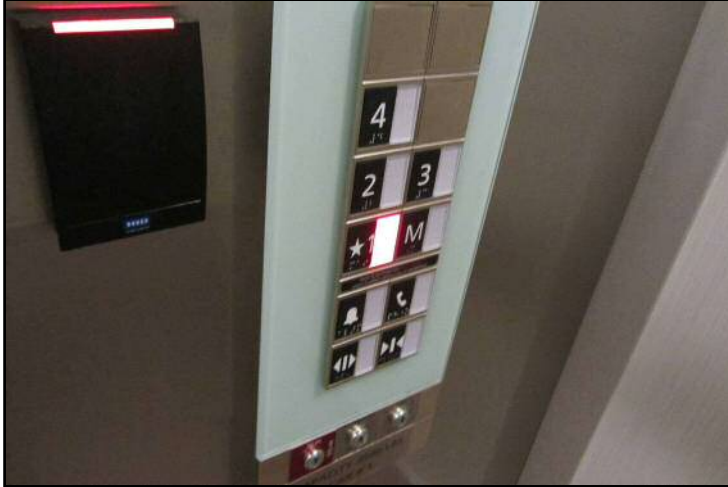
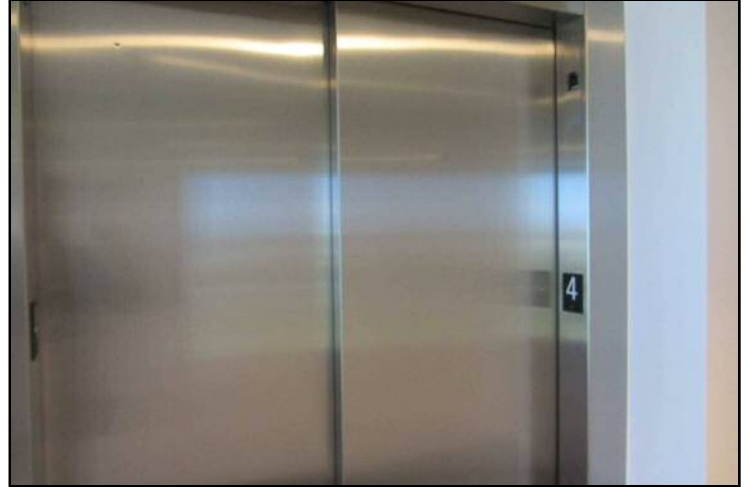
Component: 450 - Elevator - Modernize
Location: Adjacent to front entry
Cost Source: Akamai Reserves Cost Database
Best Case: \$240,000 Estimate to modernize
Worst Case: \$260,000 Higher estimate to modernize

Evaluation: New Schindler elevator are in good functional condition. Equipment is located on the top of the cabs, was not inspected.

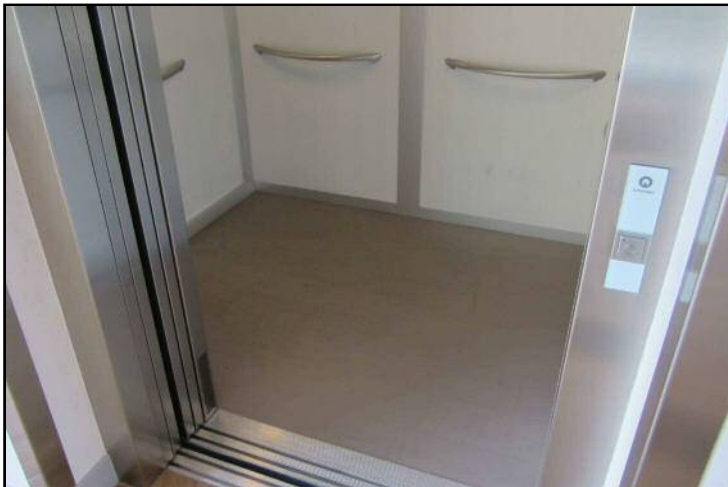
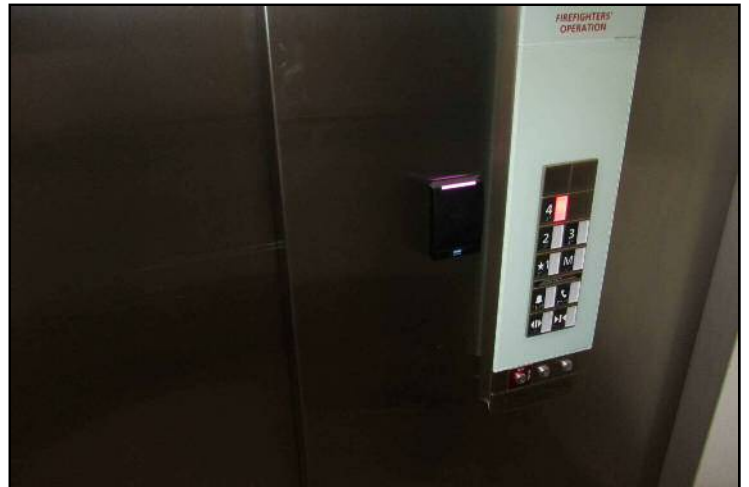
Component: 451 - Elevator Cab - Remodel
Location: Elevator interiors
Cost Source: Akamai Reserves Cost Database
Best Case: \$90,000 \$45,000/Cab; Remodel cab decor
Worst Case: \$110,000 \$55,000/Cab; Higher estimate

Evaluation: Interiors are new and in good condition.

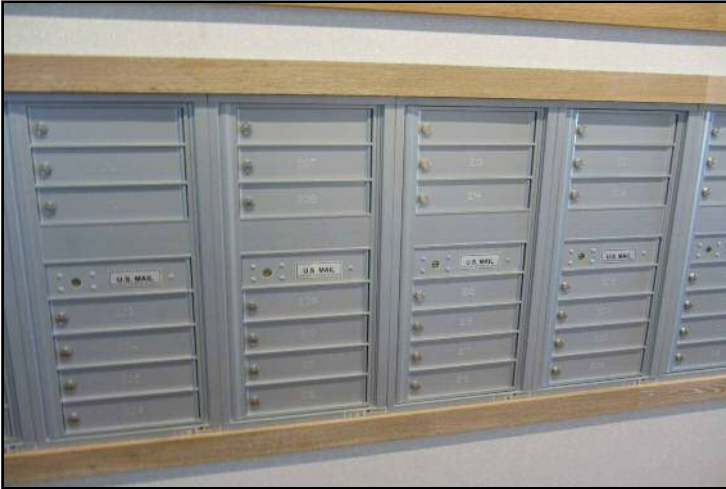
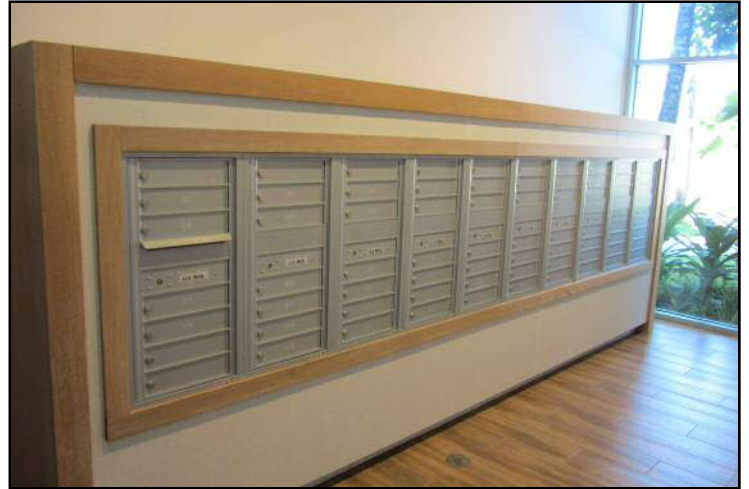
Component: 501 - Mailboxes - Replace
Location: Adjacent to building entrance
Cost Source: Akamai Reserves Cost Database
Best Case: \$17,500 Estimate to replace kiosks
Worst Case: \$24,500 Higher estimate

Evaluation: Mailboxes are not exposed outdoors and will have an extended Useful Life. Units are in good functional condition.

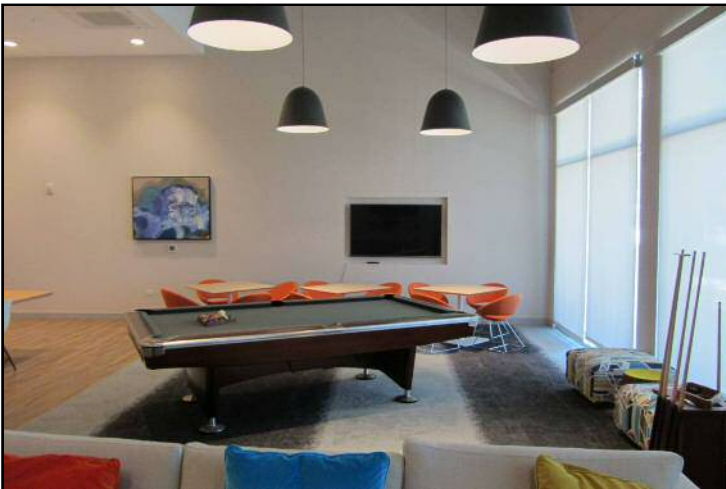
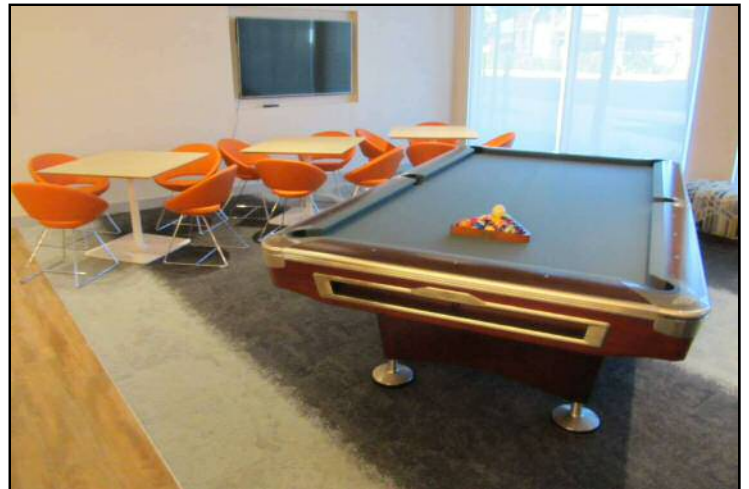
Component: 511 - Pool Table - Replace
Location: Club Room
Cost Source: Akamai Reserves Cost Database
Best Case: \$10,000 Estimate to replace
Worst Case: \$12,500 Higher estimate

Evaluation: Pool table is in good condition.

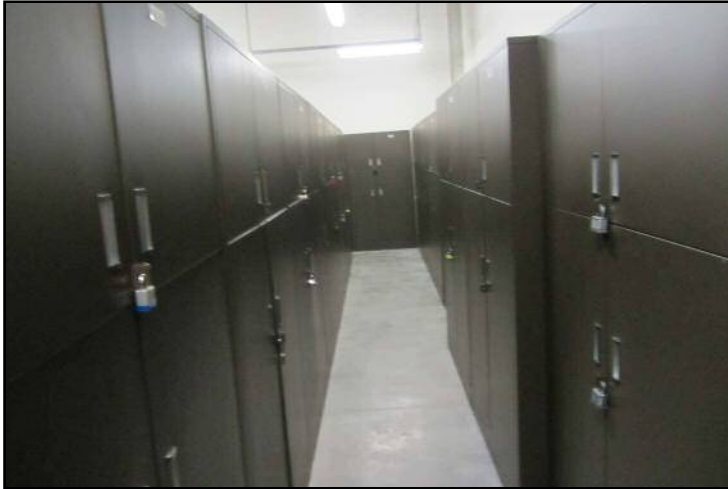
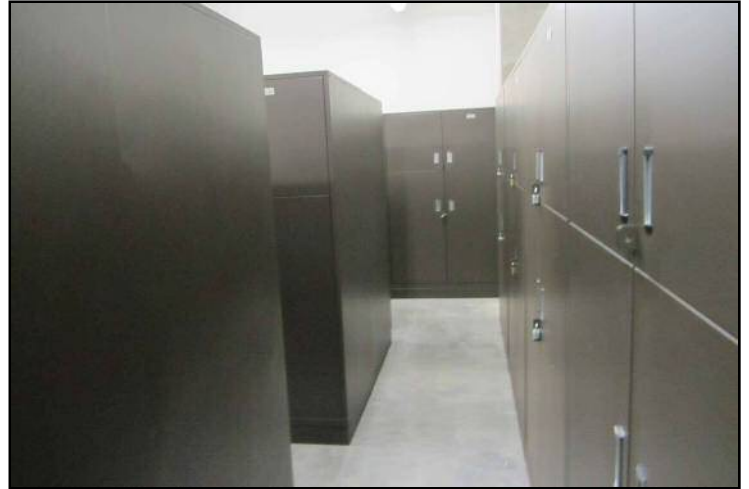
Component: 514 - Storage Lockers - Replace
Location: Storage Room
Cost Source:
Best Case:
Worst Case:

Evaluation: Lockers are in good functional condition. Maintenance and replacement under the Operating Budget as needed.

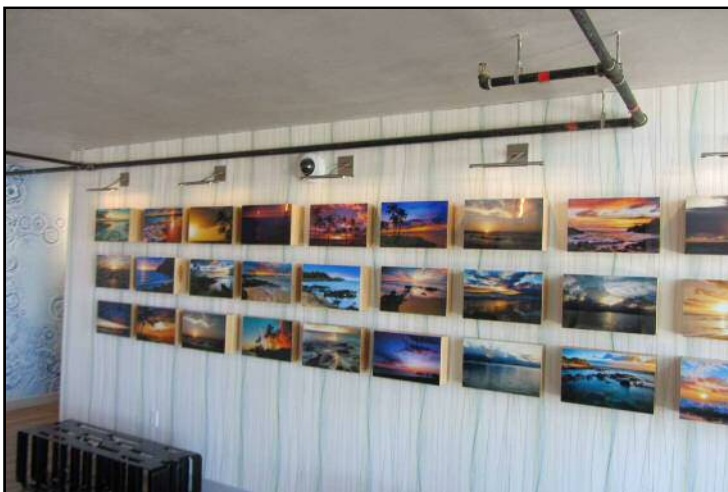
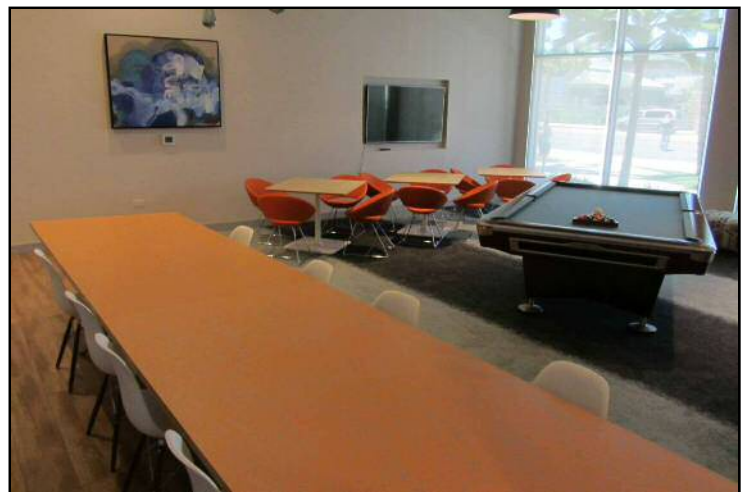
Component: 515 - Artwork - Replace
Location: Throughout building
Cost Source: Budget estimate
Best Case: \$35,000 Estimate to replace
Worst Case: \$50,000 Higher estimate

Evaluation: Artwork allowance for future replacement.

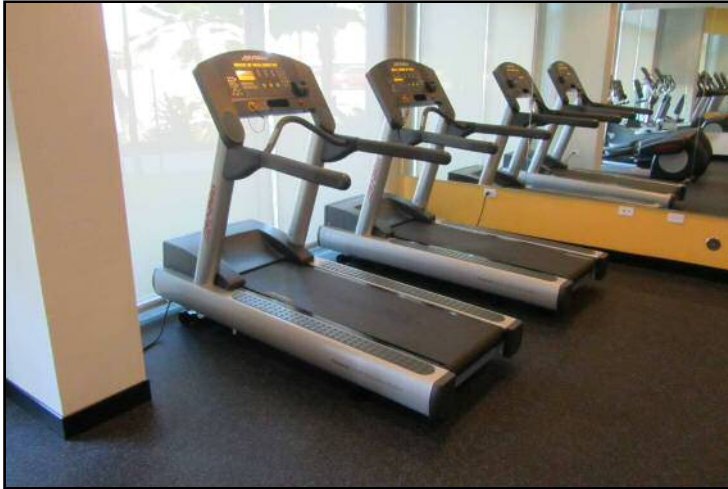
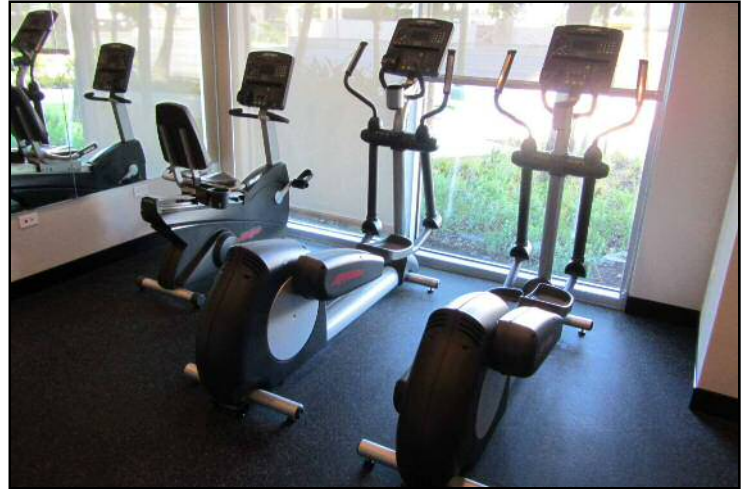
Component: 542 - Exercise Equipment - Replace
Location: Fitness room
Cost Source: Akamai Reserves Cost Database
Best Case: \$13,314 Estimate to replace
Worst Case: \$15,000 Higher estimate

Evaluation: Equipment is functional and in good condition.

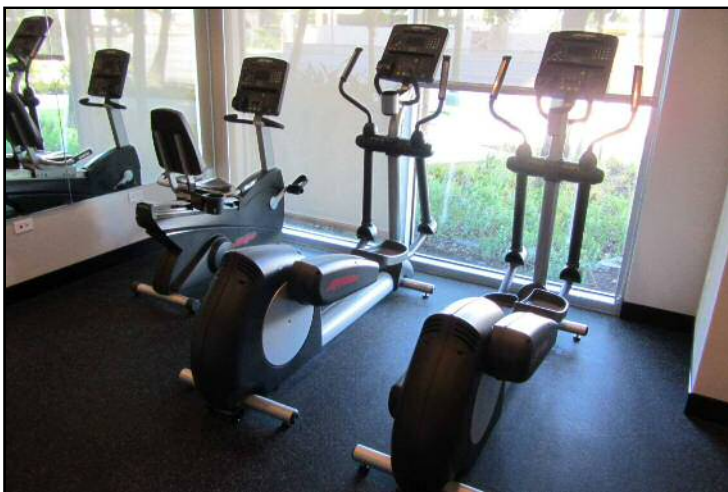
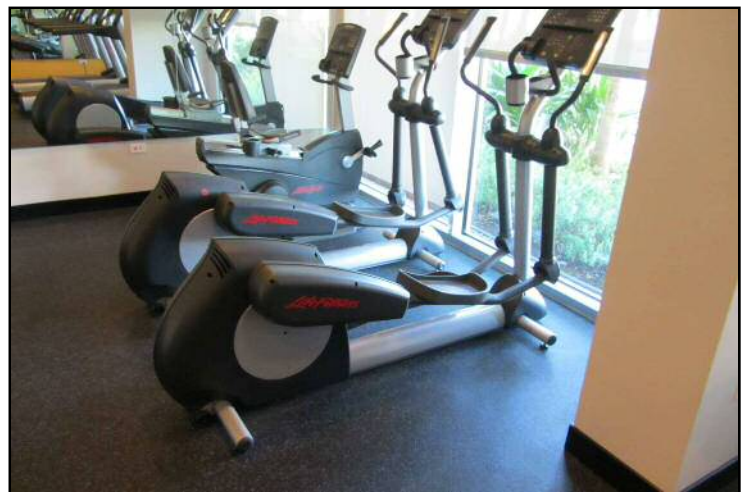
Component: 543 - Rubber Flooring - Replace
Location: Exercise Room
Cost Source: Akamai Reserves Cost Database
Best Case: \$4,500 \$10.00/GSF; Estimate for rubberized flooring
Worst Case: \$9,000 \$20.00/GSF; Higher estimate for rubberized flooring

Evaluation: Flooring is in good condition.

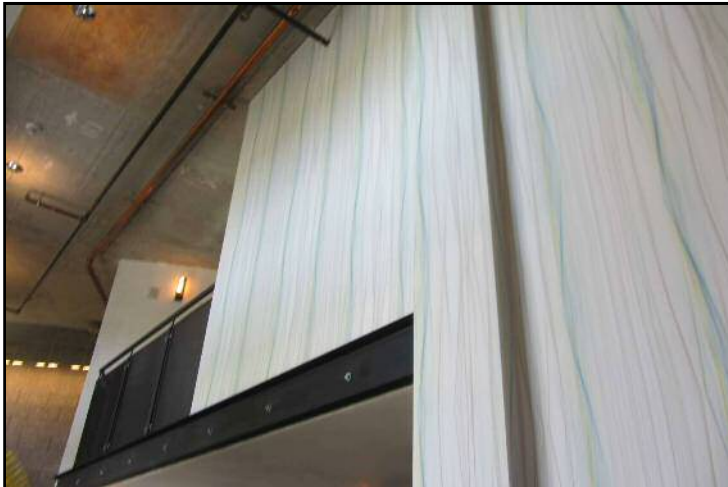
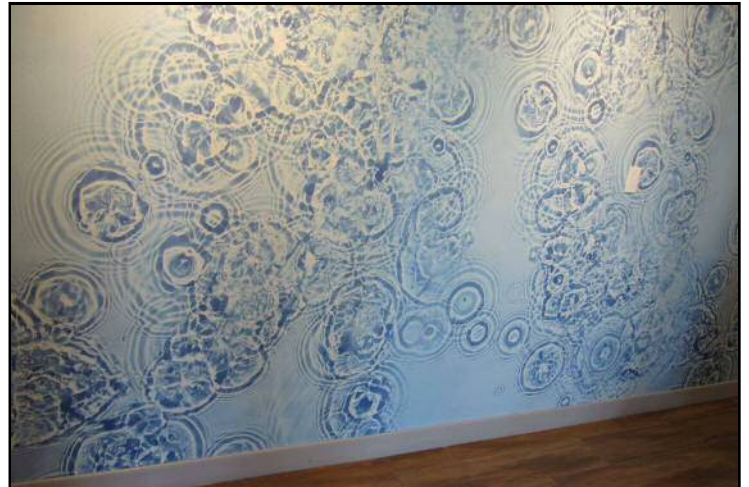
Component: 702 - Wall Covering - Replace

Evaluation: Wall paper is in good attractive condition.

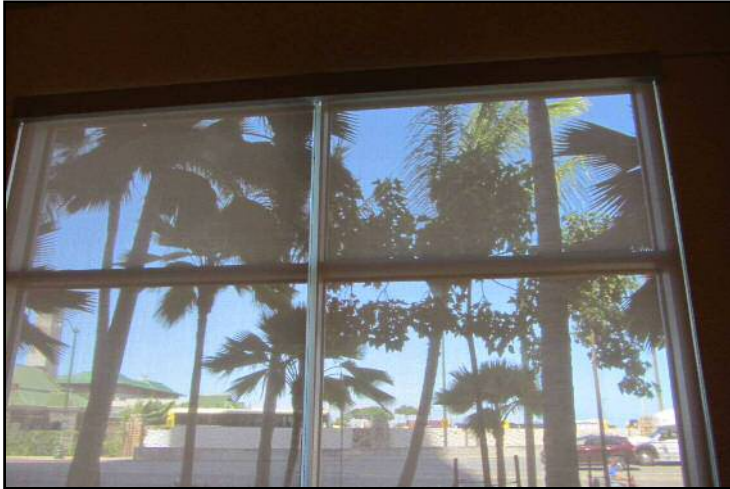
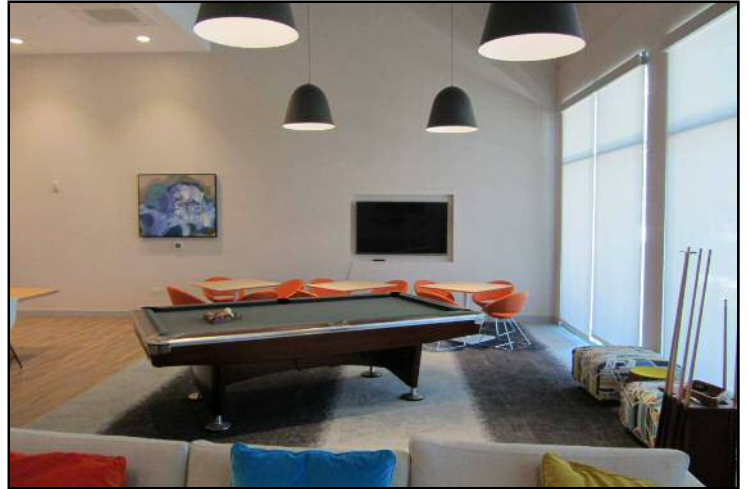
Component: 709 - Window Treatment - Replace
Location: Exterior Windows
Cost Source: Budget estimate
Best Case: \$15,000 Estimate to replace treatment
Worst Case: \$16,500 Higher estimate

Evaluation: Shades are functional and in good condition.

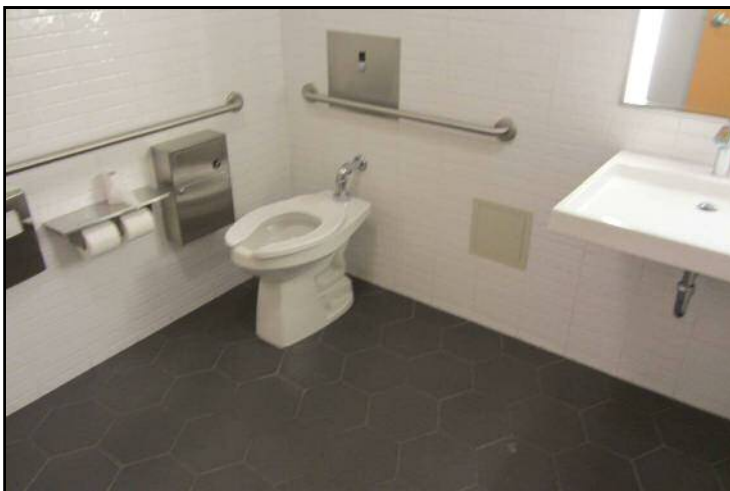
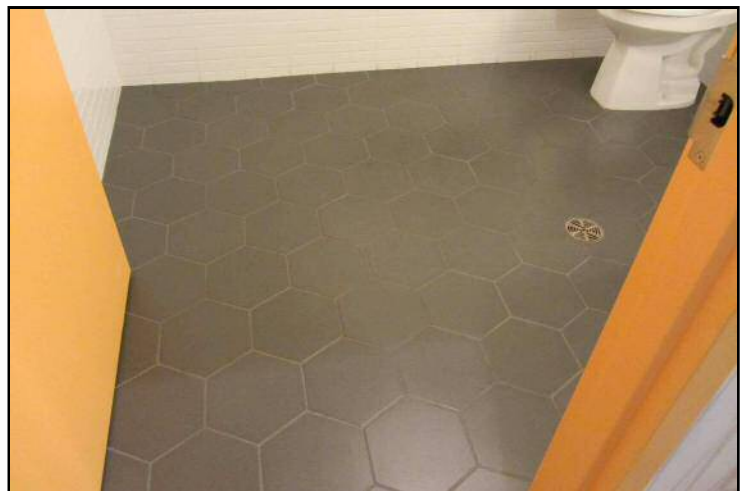
Component: 710 - Restroom - Remodel
Location: Adjacent to Club Room
Cost Source: Akamai Reserves Cost Database
Best Case: \$4,500 Estimate to refurbish restrooms
Worst Case: \$7,000 Higher estimate to refurbish

Evaluation: Small restroom is in good condition.

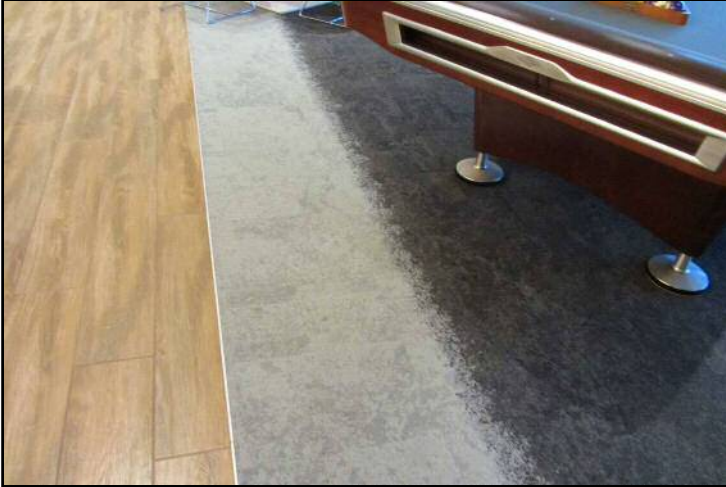
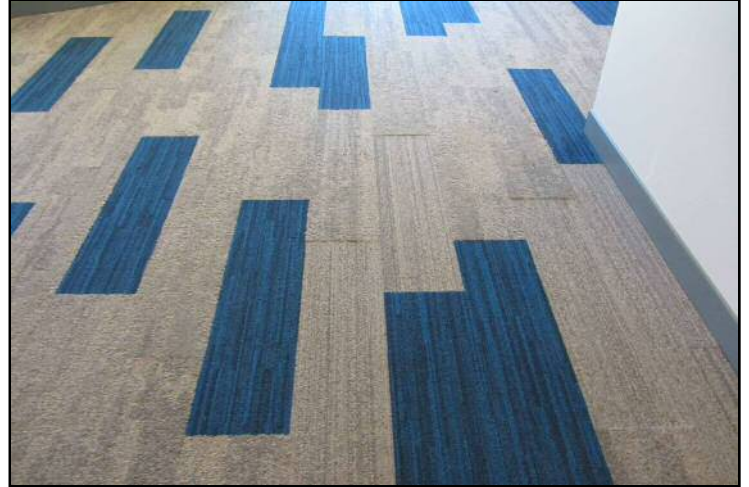
Component: 713 - Carpet - Replace
Location: Hallways and club room
Cost Source: Akamai Reserves Cost Database
Best Case: \$88,800 Estimate to replace carpet
Worst Case: \$96,000 Higher estimate

Evaluation: Generally in good condition. Carpet on the mezzanine garage entry is showing stains.

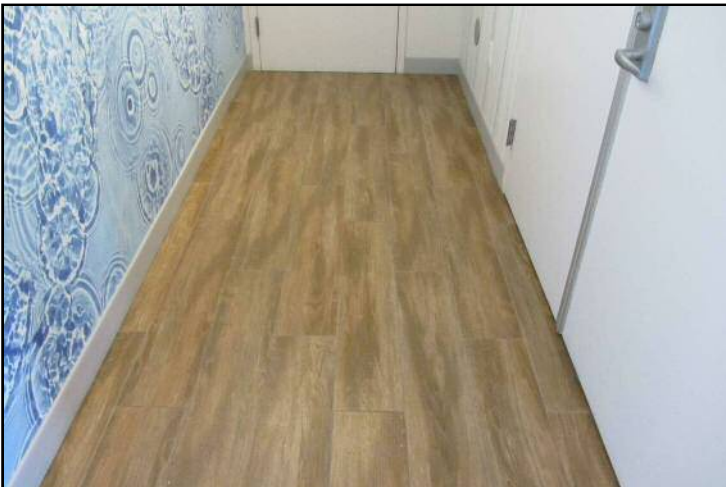
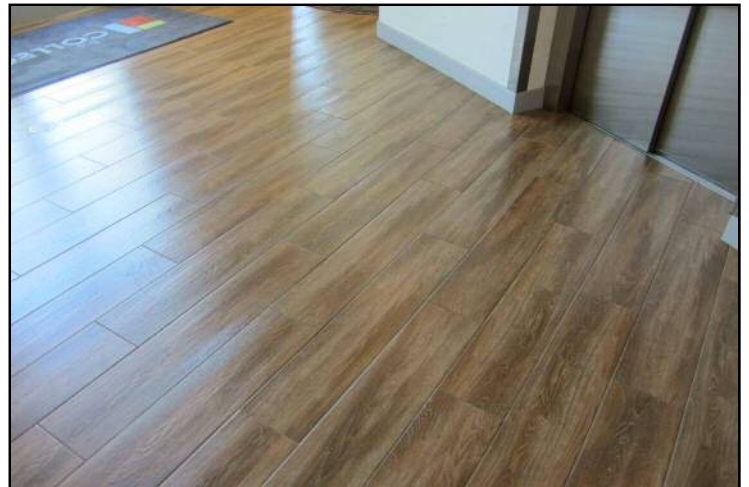
Component: 714 - Tile Floor - Replace
Location: Main lobby, club room, and adjacent hallways
Cost Source: Akamai Reserves Cost Database
Best Case: \$38,750 \$25/GSF; Estimate to replace tile
Worst Case: \$54,250 \$35/GSF; Higher estimate

Evaluation: Tile floor is in good attractive condition.

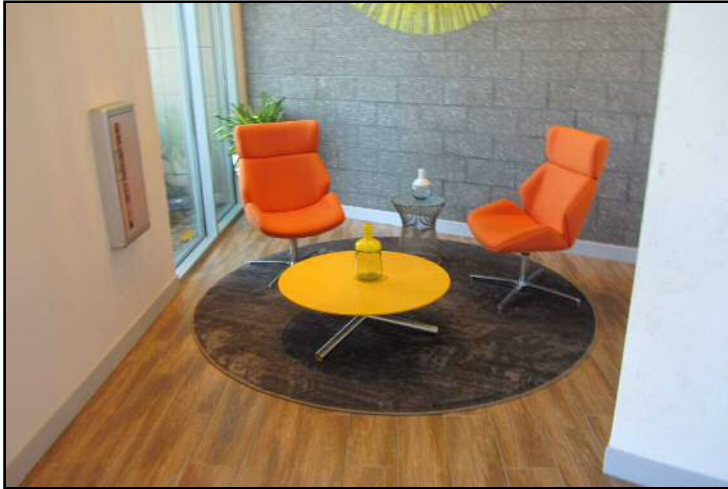
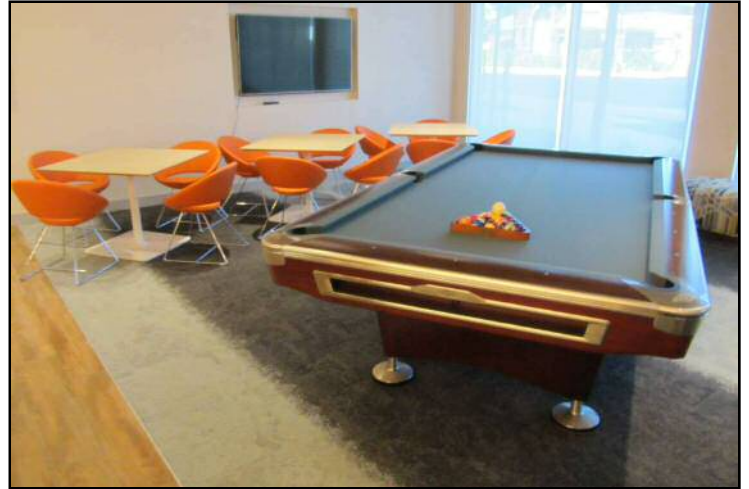
Component: 718 - Furniture - Replace
Location: Lounge and common areas
Cost Source: Akamai Reserves Cost Database
Best Case: \$49,000 Estimate for replacement pieces
Worst Case: \$52,500 Higher estimate

Evaluation: Furniture is new and in good condition.
