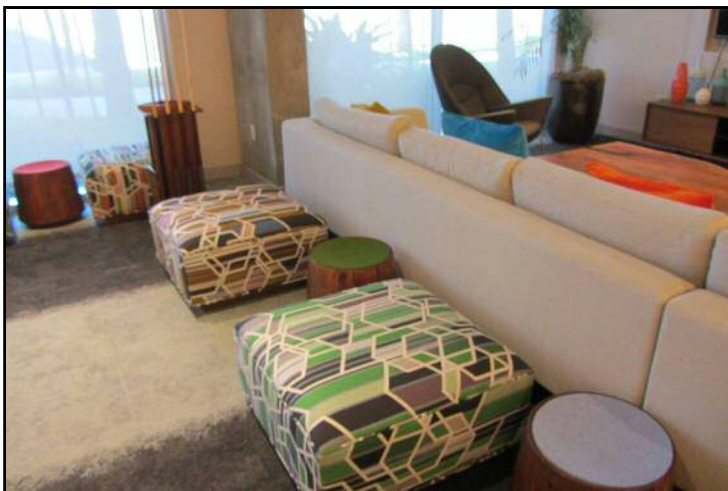
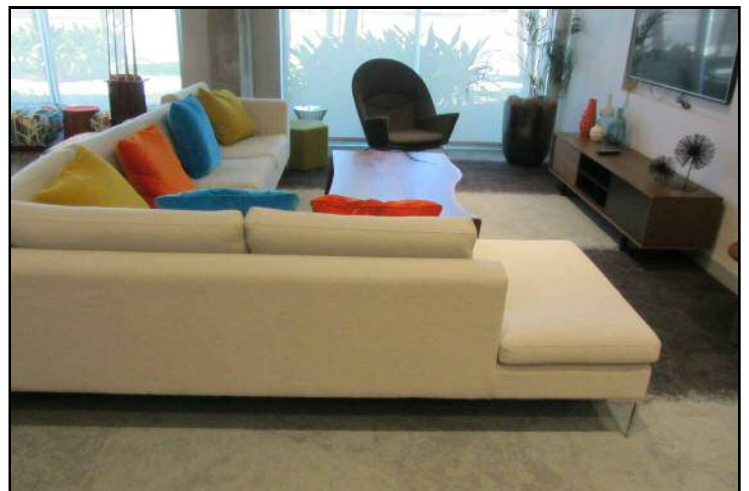
Component: 726 - Soft Goods - Replace
Location: Interior room furniture
Cost Source: Akamai Reserves Cost Database
Best Case: \$17,500 Estimate to replace cushions and fabric
Worst Case: \$18,500 Higher estimate

Evaluation: Fabric, area rug, and soft goods are in good attractive condition.

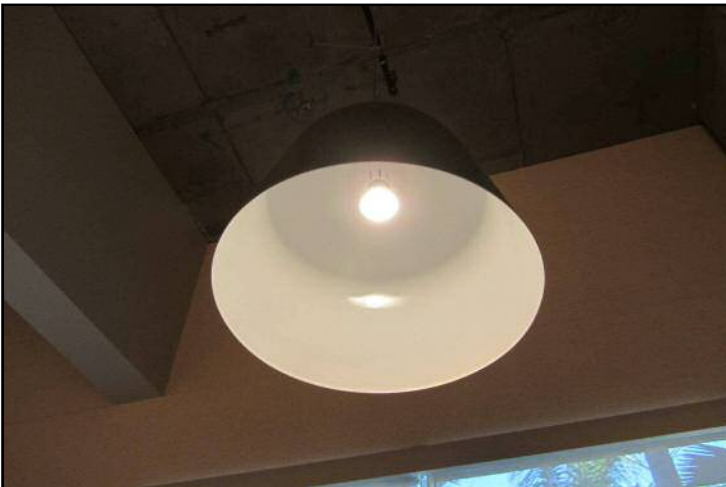
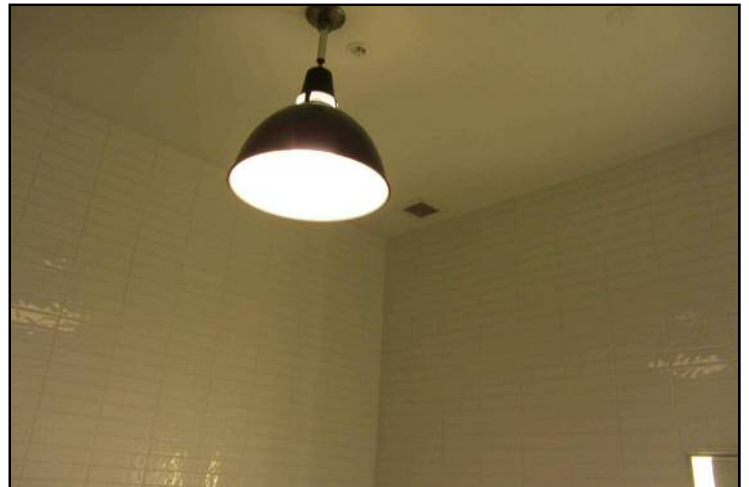
Component: 740 - Interior Lighting - Replace

Evaluation: Small interior lights are maintained and replaced as needed under the Operating Budget. Estimate for eventual major upgrade.

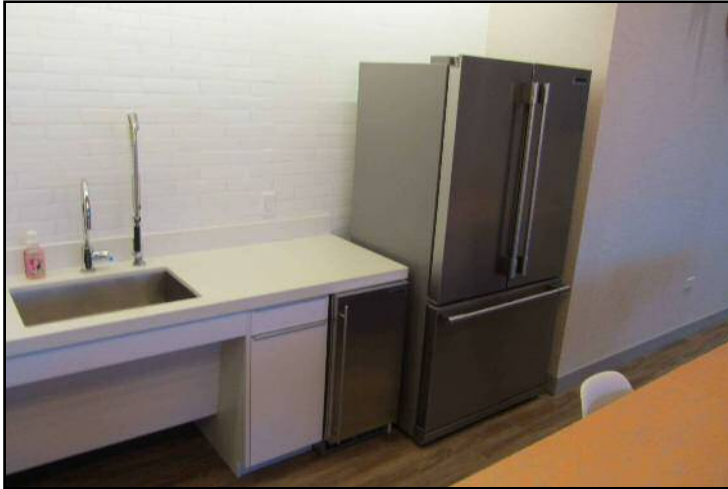
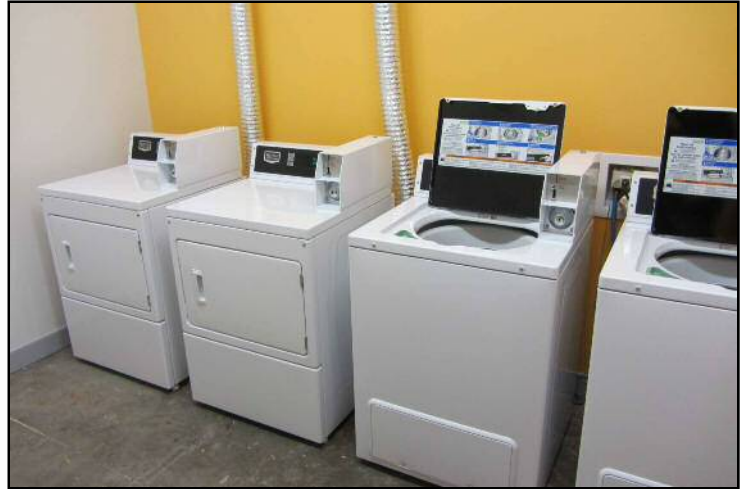
Component: 772 - Appliances - Replace
Location: Kitchen
Cost Source: Budget estimate
Best Case: \$9,000 Estimate to replace installed
Worst Case: \$11,000 Higher estimate

Evaluation: Units are in good functional condition.

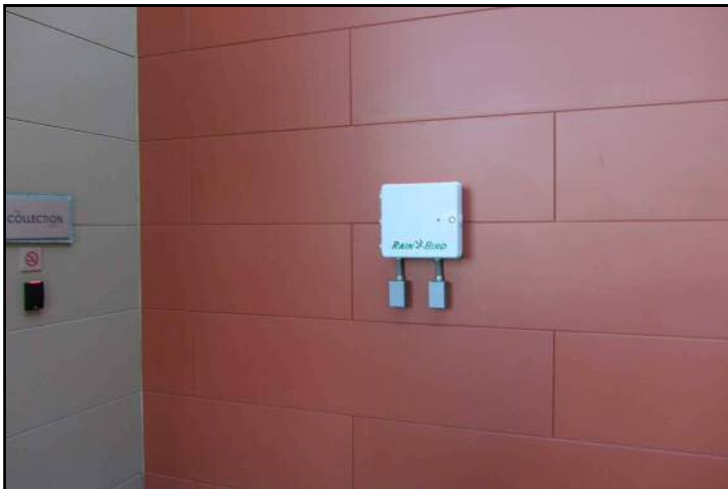
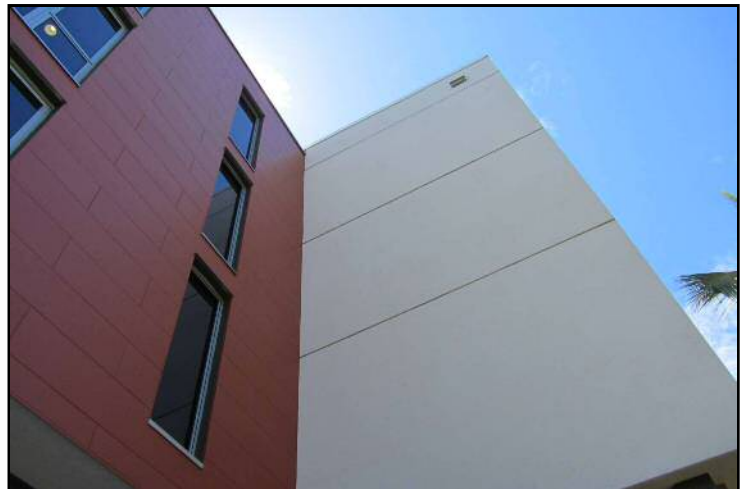
Component: 1002 - Exterior Concrete - Paint
Location: Building exterior
Cost Source: Akamai Reserves Cost Database
Best Case: \$82,500 Estimate to paint
Worst Case: \$105,000 Higher estimate to paint

Evaluation: Paint is in good condition.

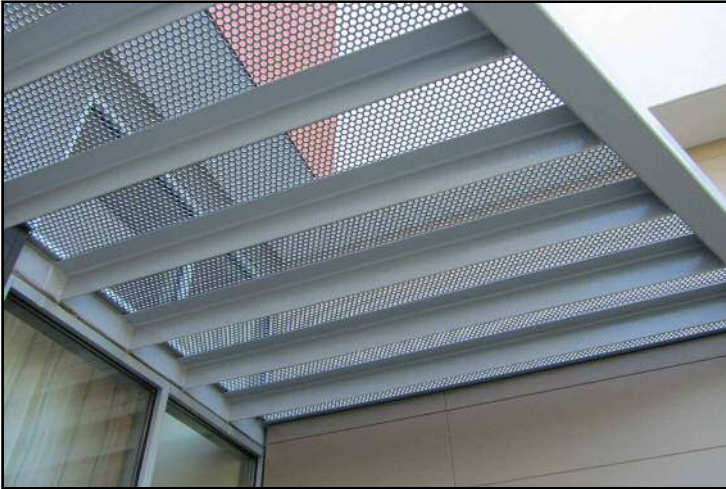
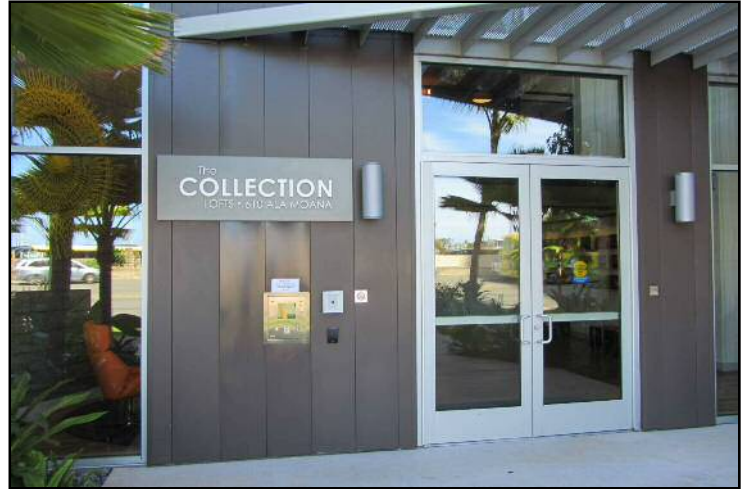
Component: 1019 - Awnings - Replace
Location: Entrance
Cost Source: Budget estimate
Best Case: \$9,100 Estimate to replace
Worst Case: \$11,700 Higher estimate

Evaluation: Metal awning above main entry is in good condition.

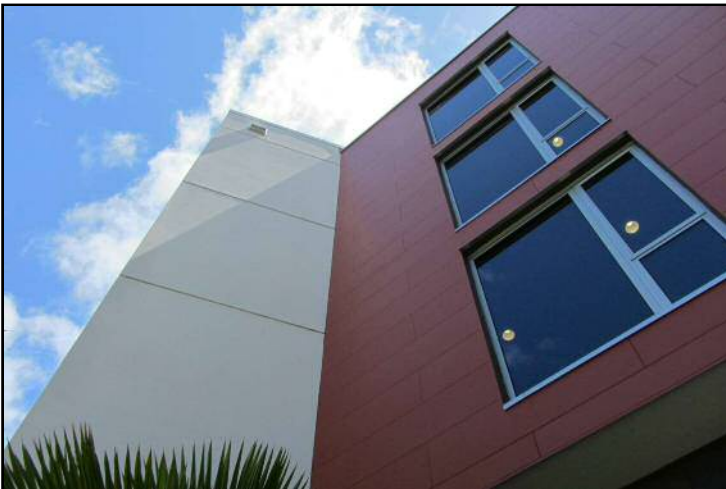
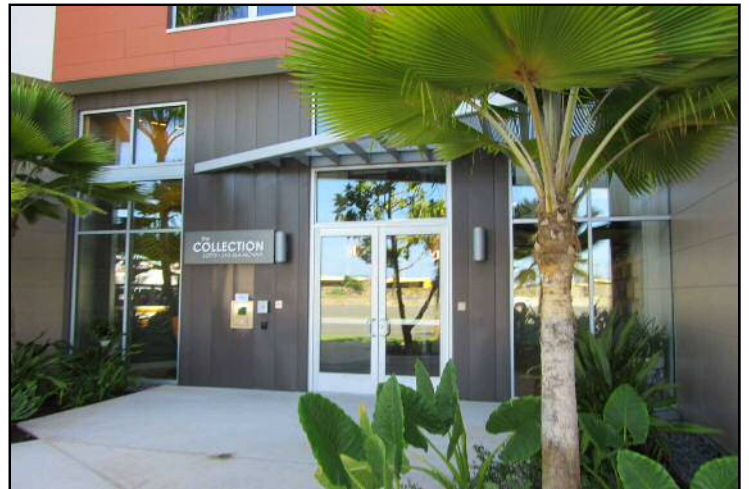
Component: 1070 - Glass Doors and Windows - Replace
Location: Building exterior
Cost Source: Akamai Reserves Cost Database
Best Case: \$230,000 Estimate to refurbish
Worst Case: \$280,000 Higher estimate

Evaluation: Windows and glass doors are in good functional condition.

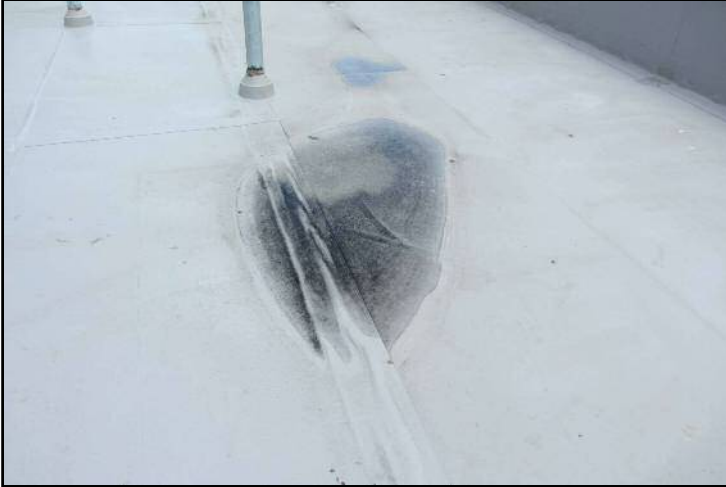
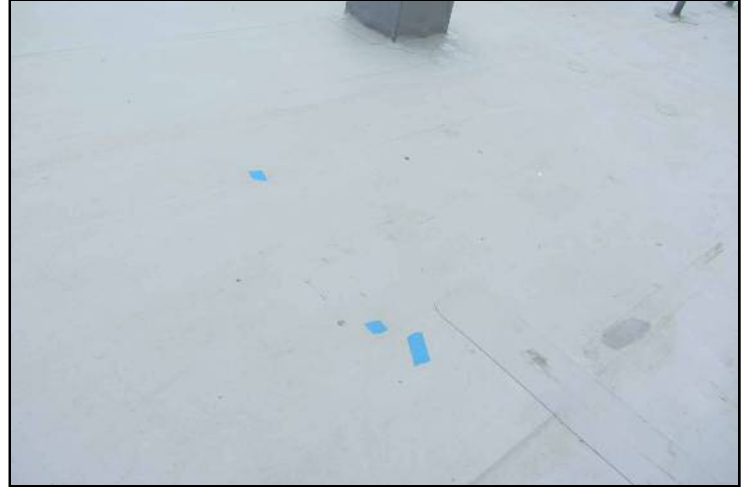
Component: 1107 - Single Ply Membrane - Replace

Evaluation: Membrane roof is in good condition.

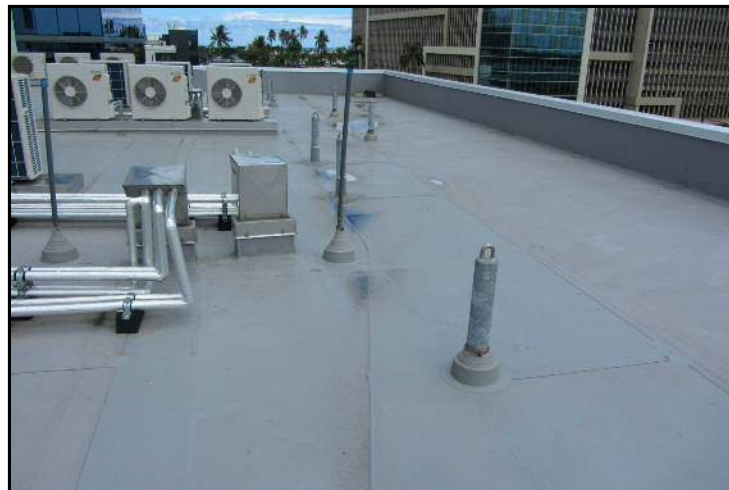
Component: 1125 - Window Wash Equip - Repr/Repl

Evaluation: Window washing davits are long life components with an undetermined useful life. Reported testing is scheduled in 10 years.
